# CARIBBEAN HYDRO-TECH, INC.

Re: Four Winds Test Well Logs

Enclosed you will find copies of a description of a shallow PVC sump ("WO Well") installed and well logs for test holes drilled on Four Winds Plaza Partnership Property (Four Winds Shopping Center) by Caribbean Hydro-Tech, INC. (CHT) during 1992.

Re: Meeting at Tutu "Splash and Dash" Car Wash

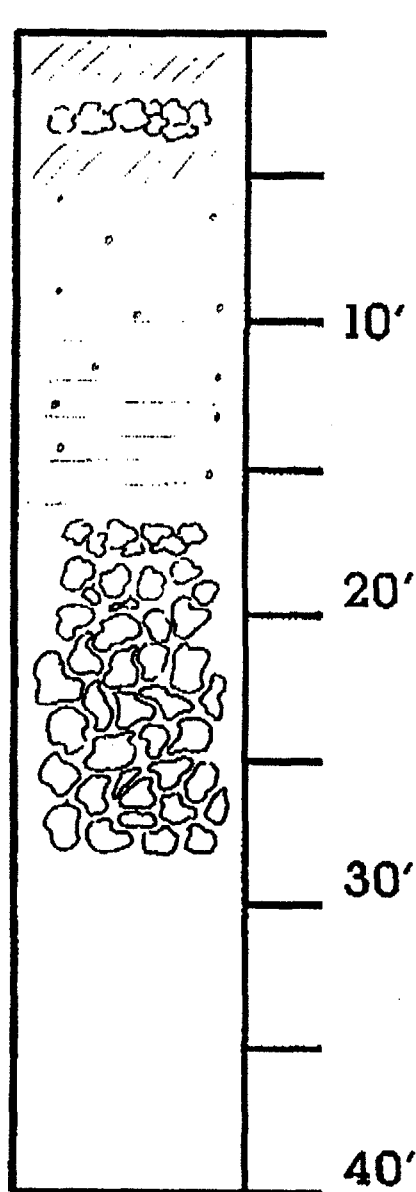
# MW-1 LITHOLOGY LOG

0-2' fill

2-3' hard (boulder?)

3-4.5' fill

5-10' tan to brown natural soil

10-15' tan to brown natural soil

17' formation change to hard

19' very hard -- bit destroyed

20-24' no return

24-28' very hard

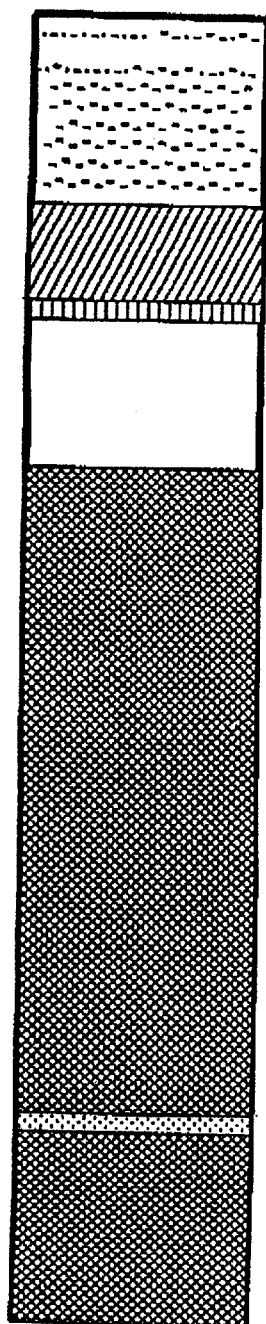
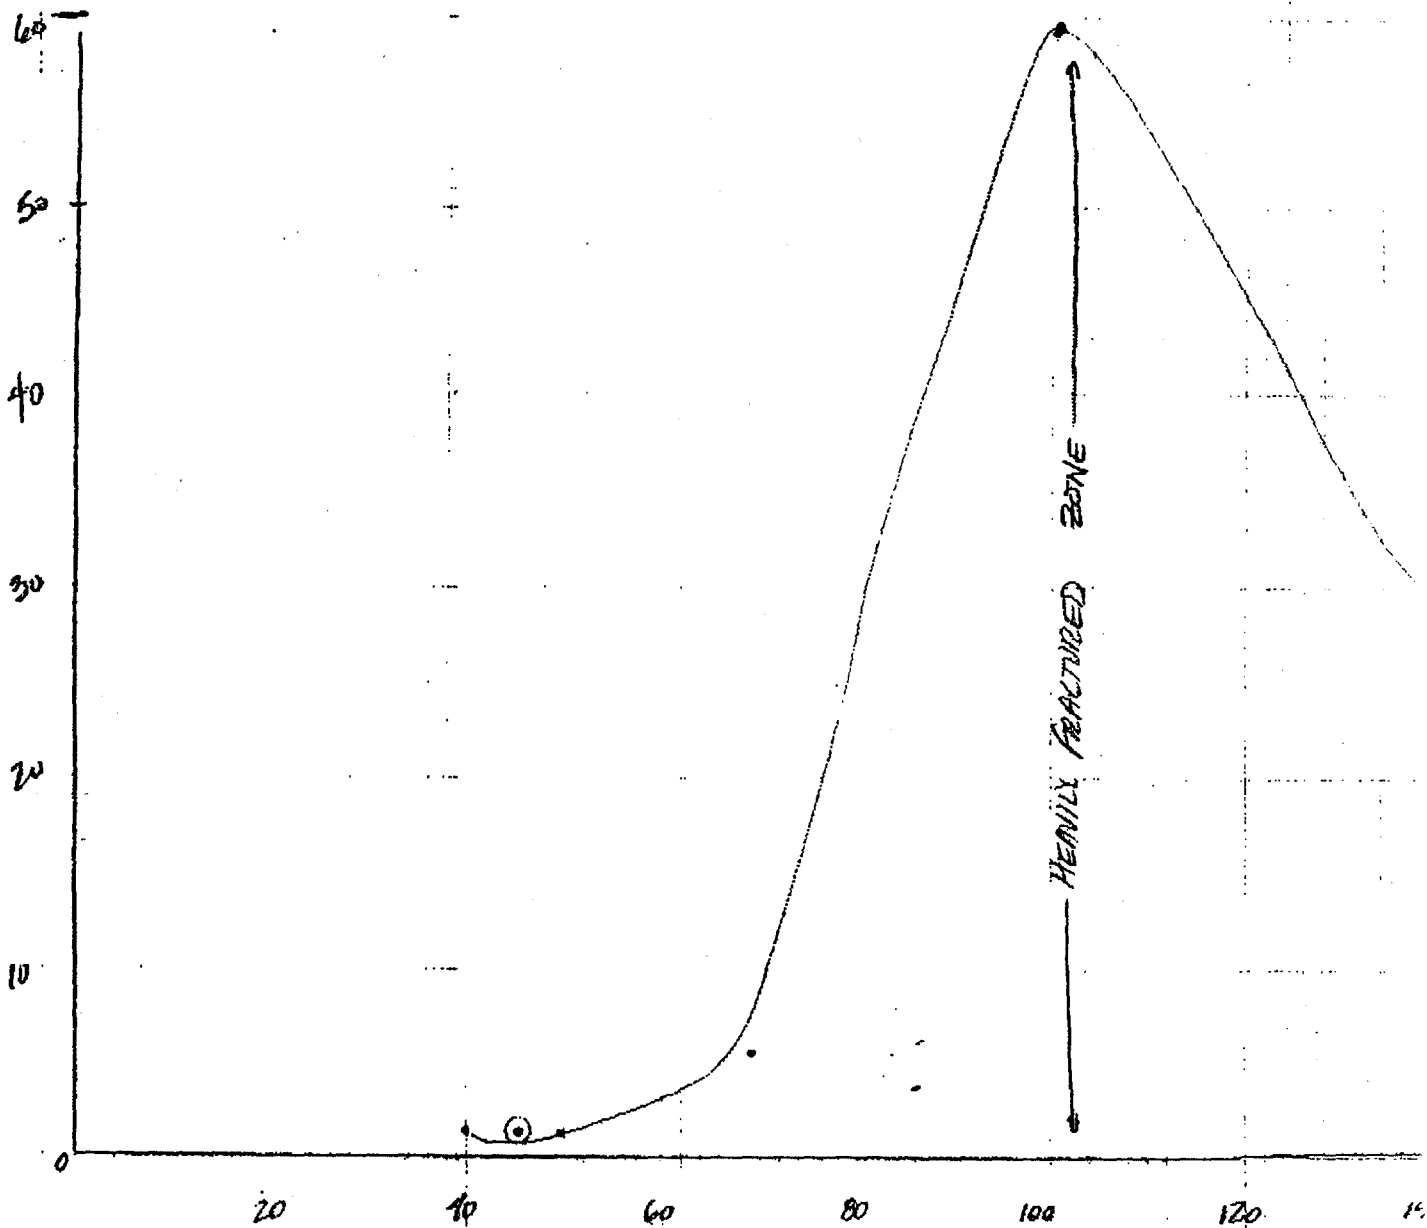
## DEEP TEST HOLE 1

Flow (GPM) \* Flow increases  
with fracture  
intensity (intensity)
