Historic Structure Report  
**The Steeple Building**  
**Christiansted National Historic Site**  
*Final*

# **The Steeple Building**

## **Historic Structure Report**

May 2024

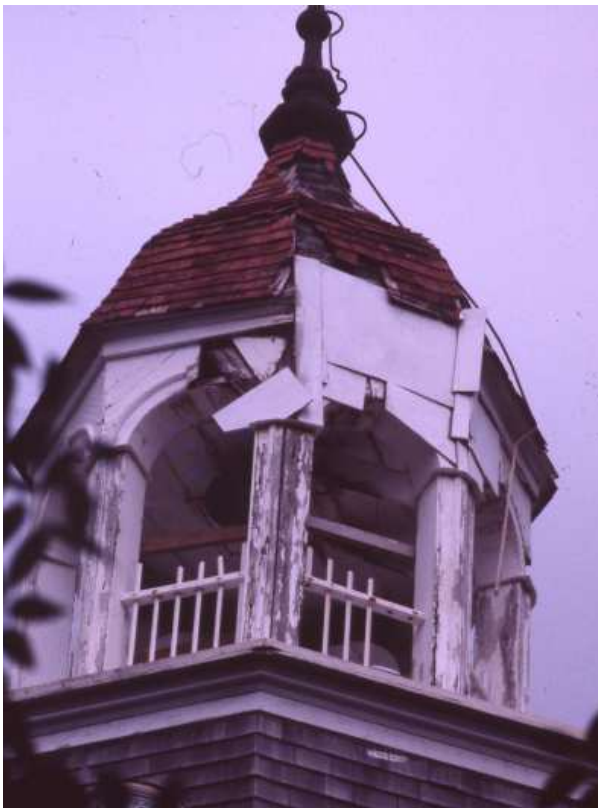
FIGURE 2-37. 1981 photograph of deteriorated cupola on Steeple Building. Photo: Christiansted National Historic Site Archives.

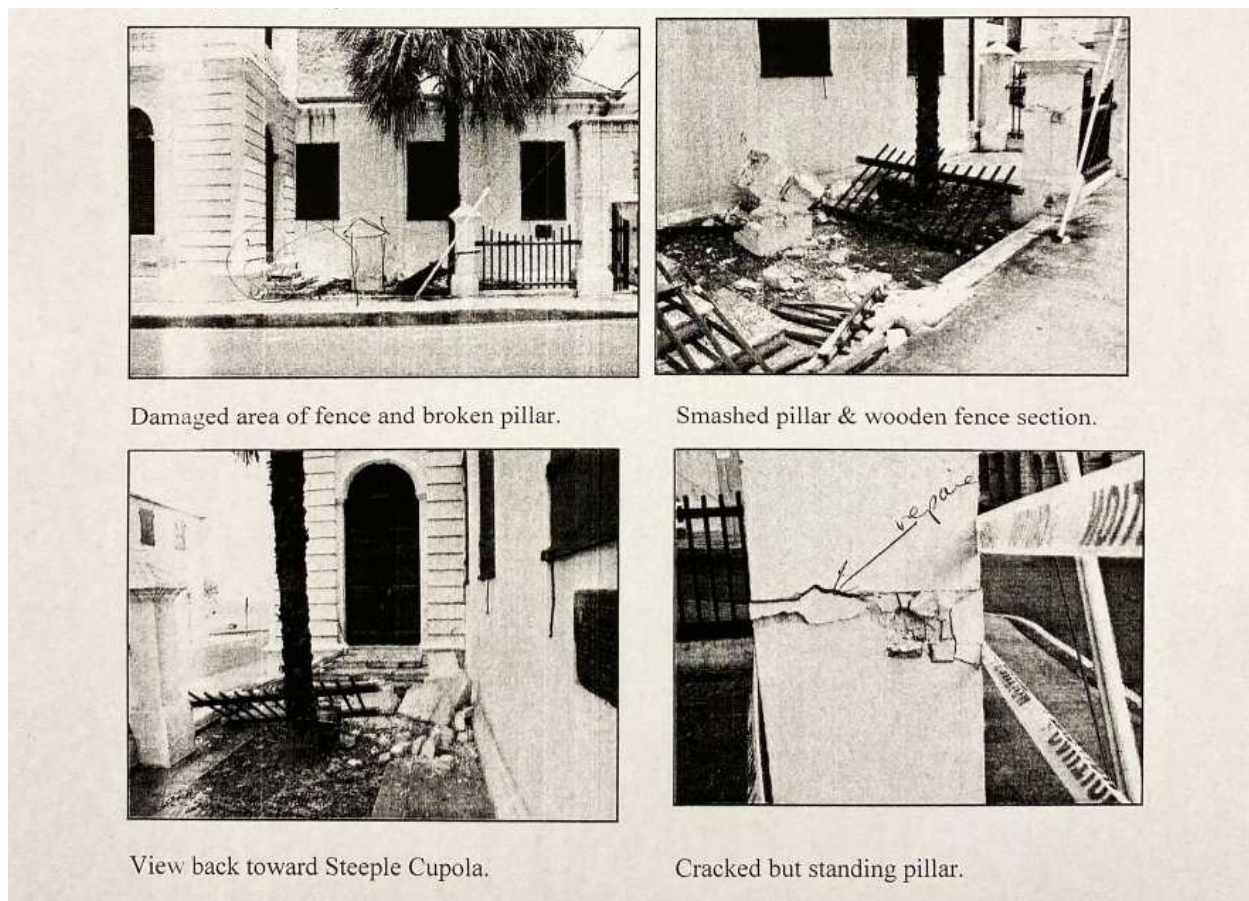
FIGURE 2-55. 2005 vehicular damage to Steeple Building fence. Photos: Joe Hollins, TipTop Construction, from a memorandum to Joel Tutein, Superintendent, May 20, 2005.

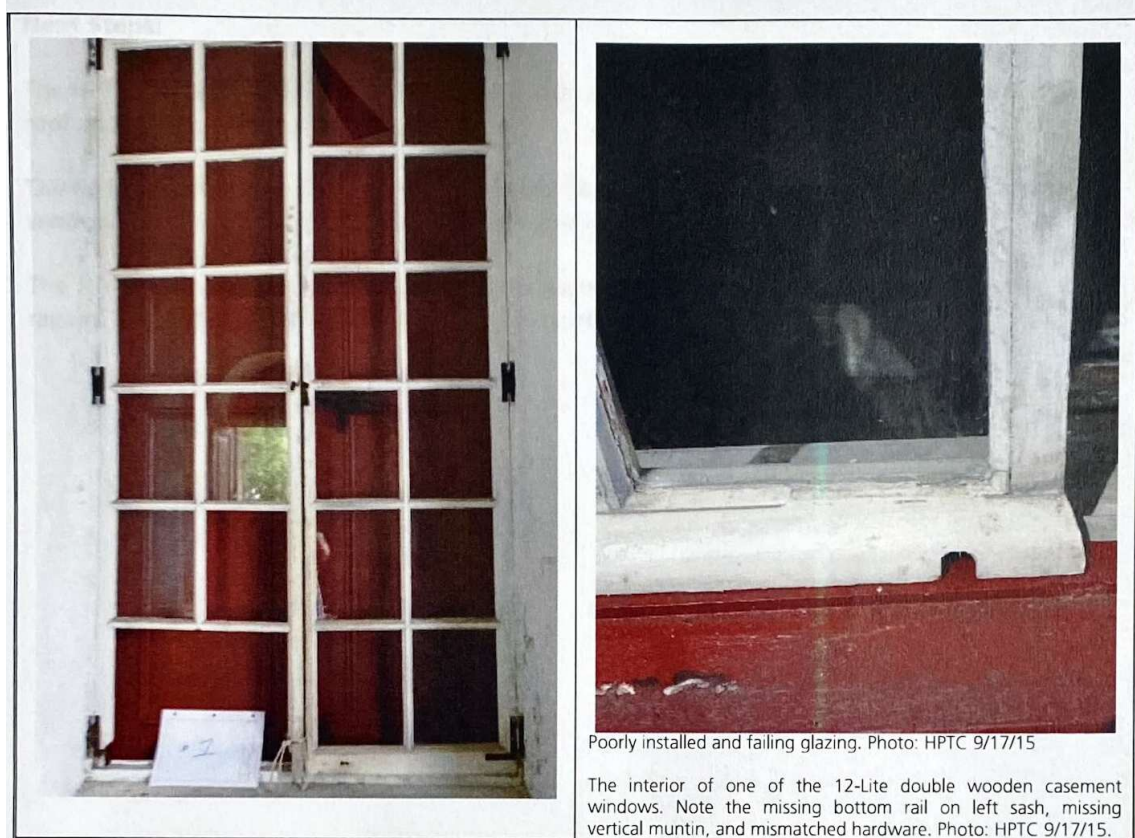
FIGURE 2-62. Examples of damaged windows identified by the HPTC during their site visit in September 2015. Photos: HPTC, Site Visit Trip Report, 2015, p. 19.

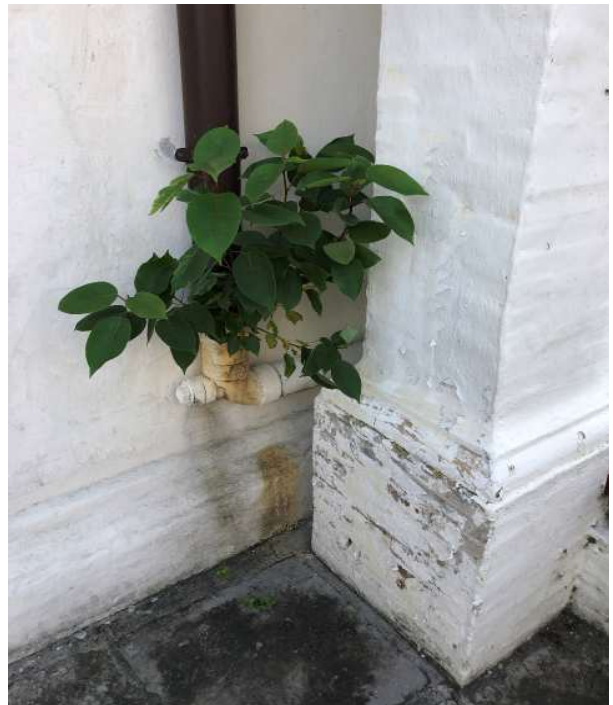
FIGURE 3-6. Plant growing from rain leader.

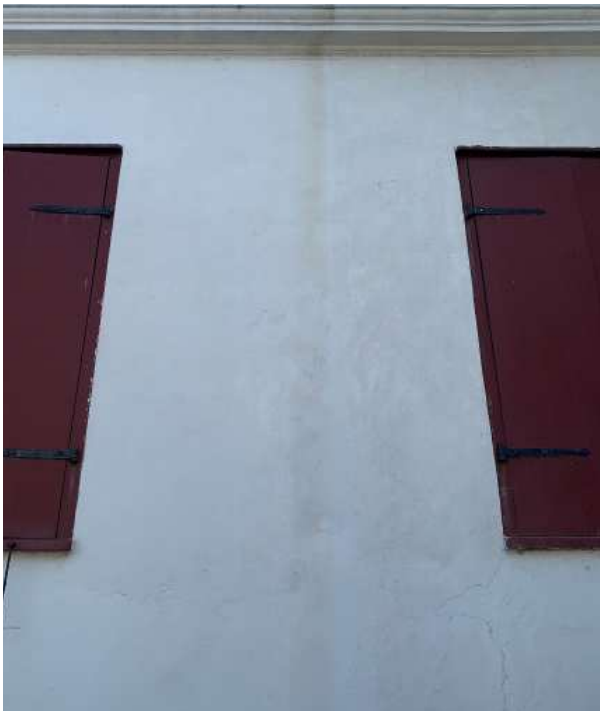
FIGURE 3-17. Staining between Windows 4 and 5.

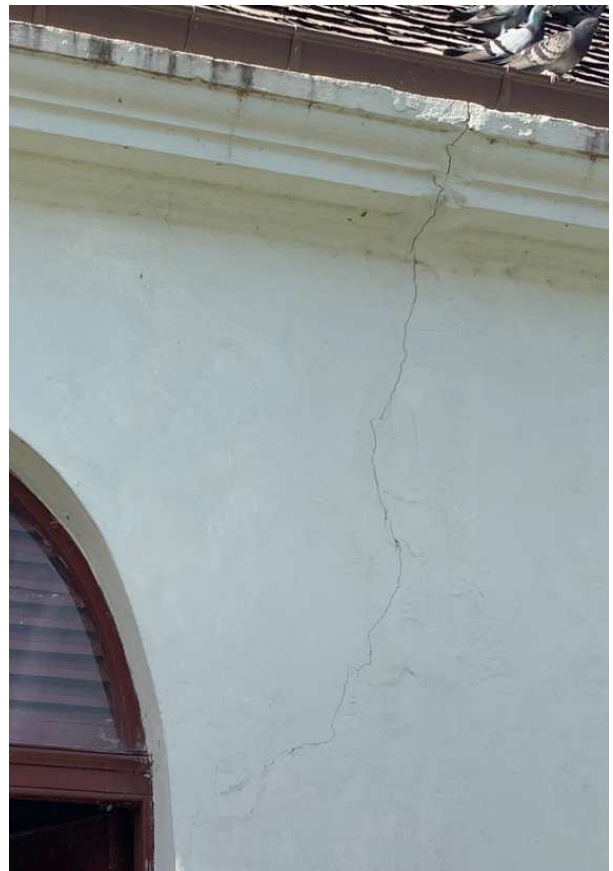
FIGURE 3-24. Large crack near Door E.

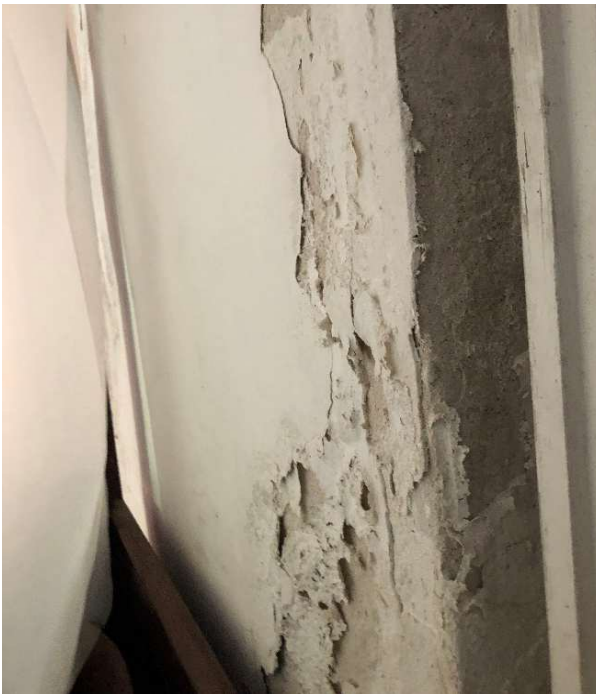
FIGURE 3-53. Plaster damage behind plastic near Window 3.

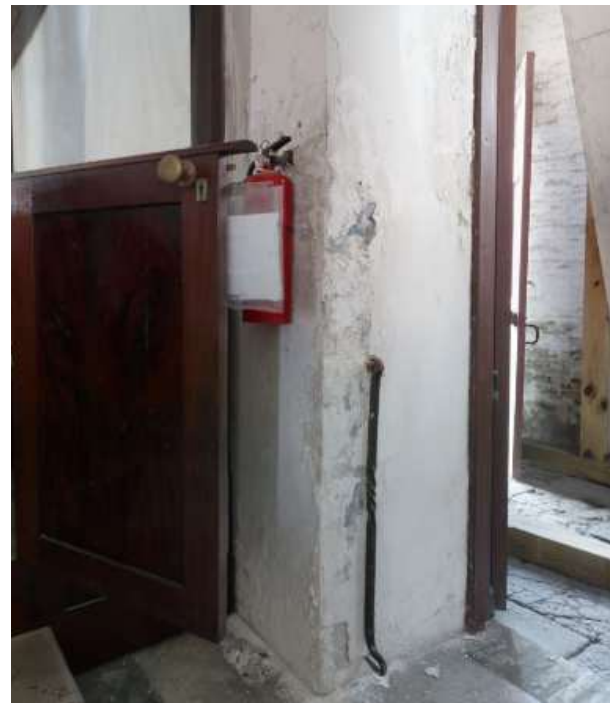
FIGURE 3-54. Plaster damage around Door A's left side.

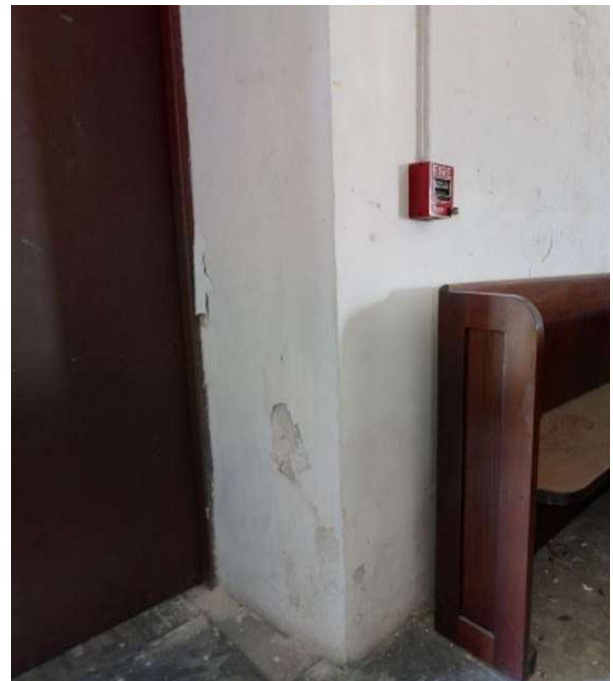
FIGURE 3-55. Plaster damage around Door A's right side.

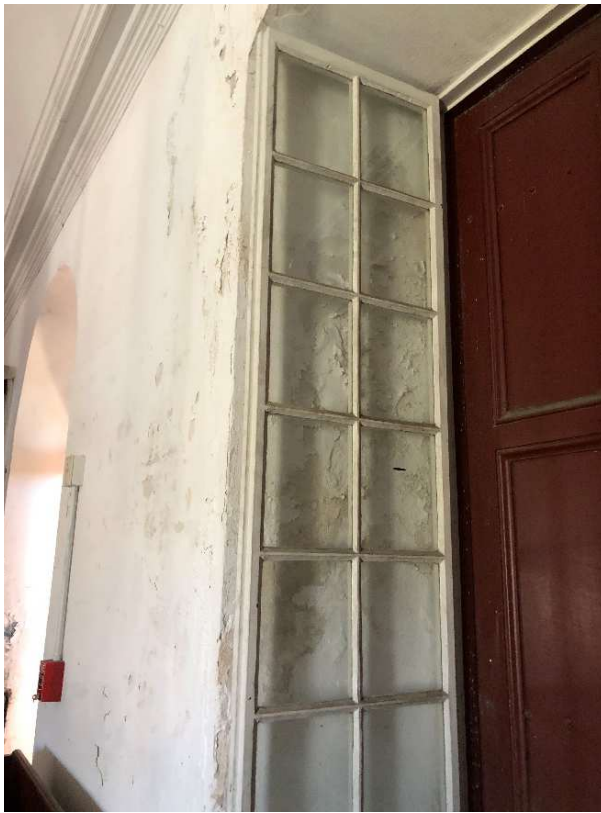
FIGURE 3-56. Plaster damage around Window 4.

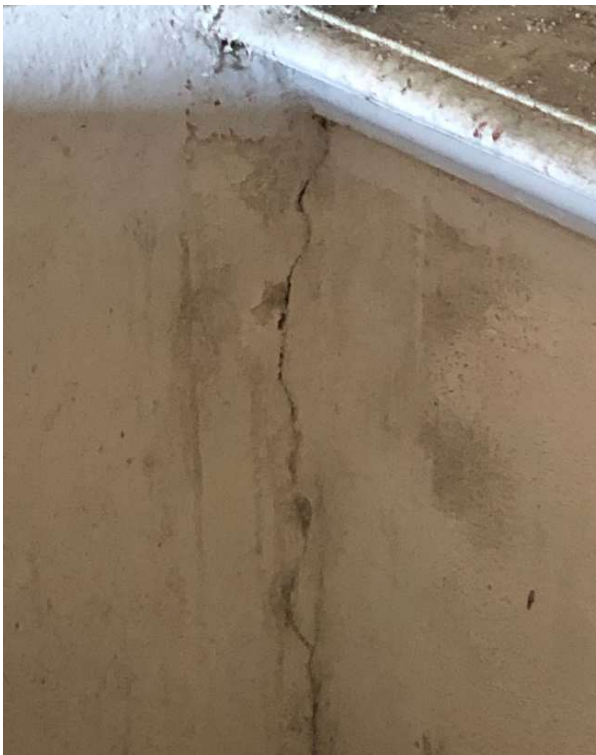
FIGURE 3-62. Crack under Window 4.

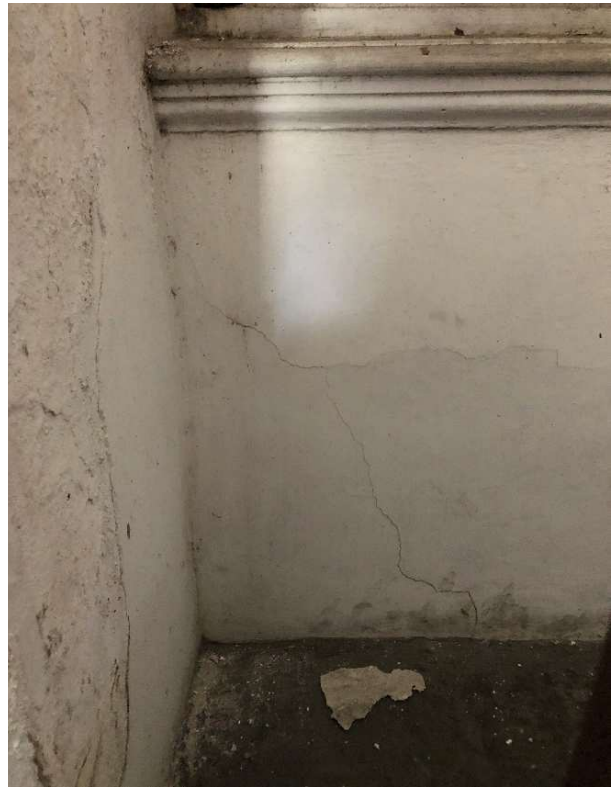
FIGURE 3-64. Cracks under Window 6.

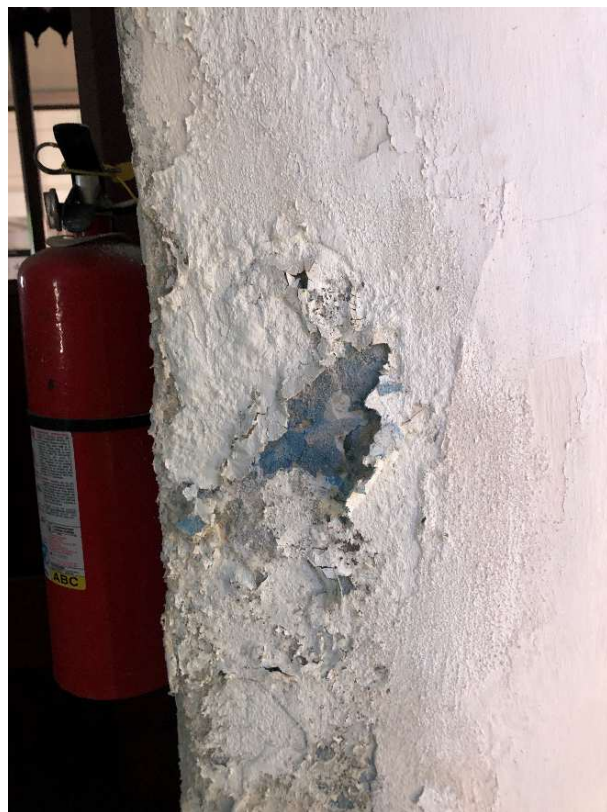
FIGURE 3-66. Blue substance behind plaster.

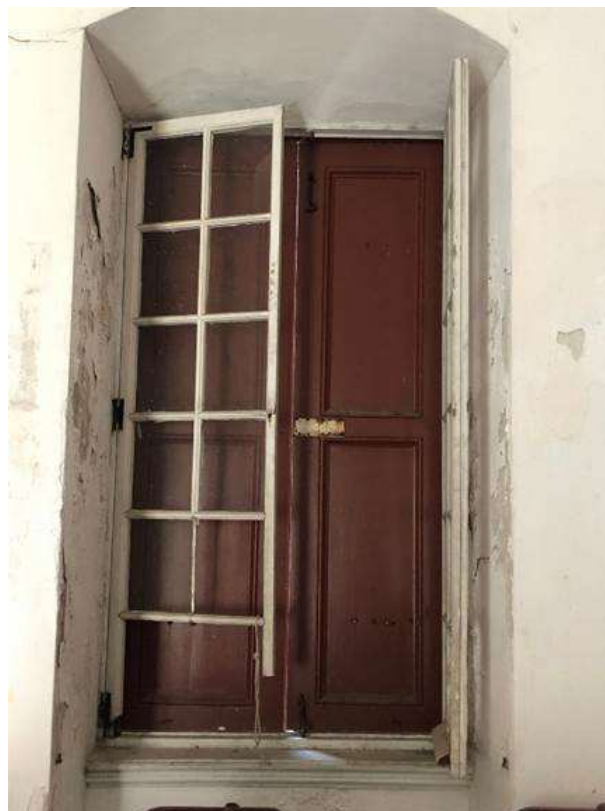
FIGURE 3-68. Broken Window 6.

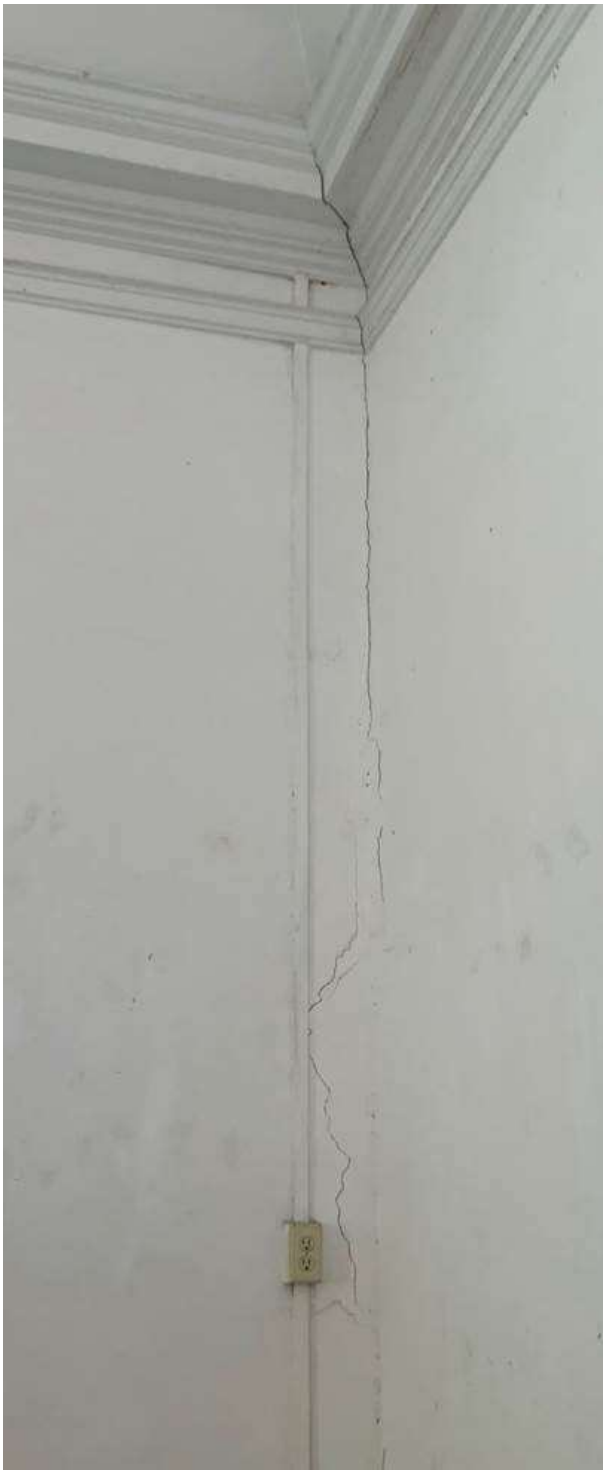
FIGURE 3-69. Crack on right side of northeast wall.

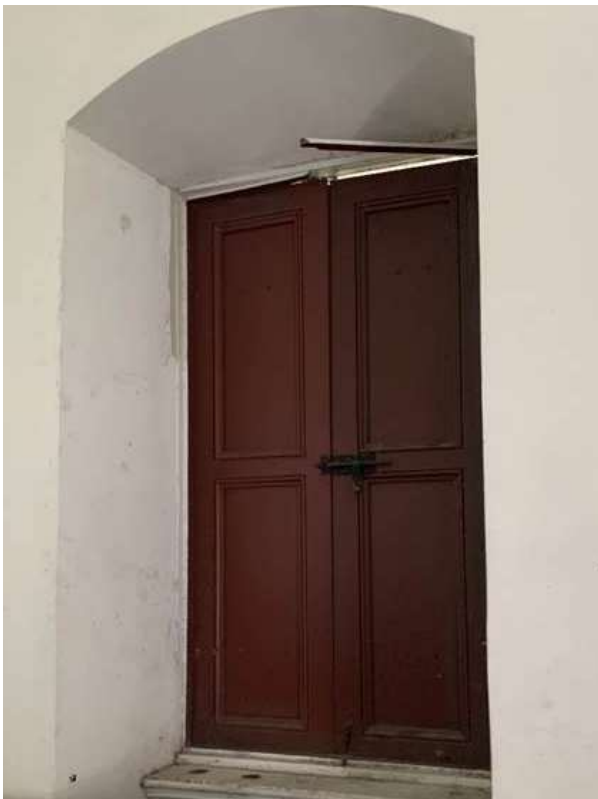
FIGURE 3–71. Missing Window 7.

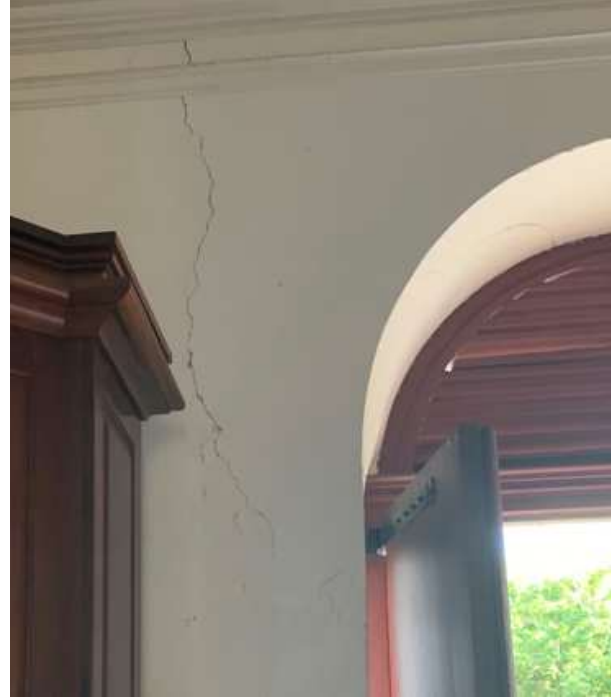
Adjacent to Door E is a large crack (1/8”–1/4” in width) that runs from the ceiling treatment toward the spring point of the opening (Figure 3–77). This crack (as well as the others around Door E on the

FIGURE 3-77. Large crack next to Door E.

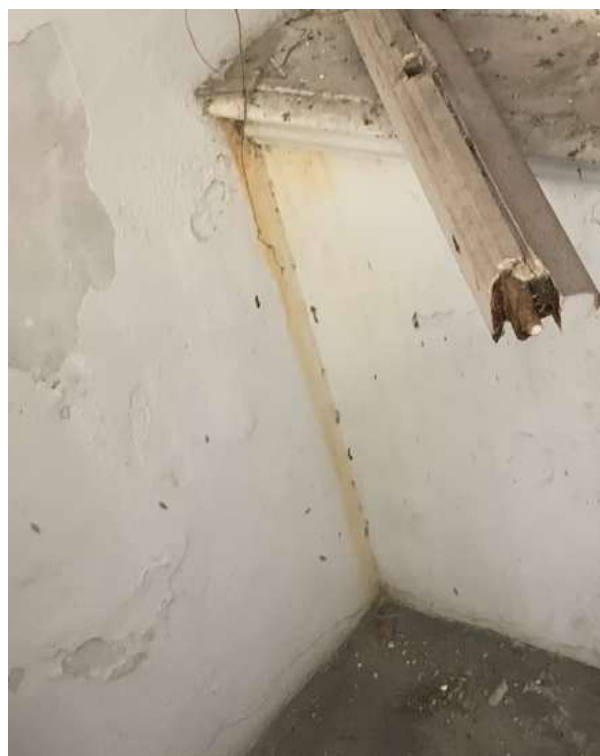
FIGURE 3-83. Rust-colored stain under Window 9.

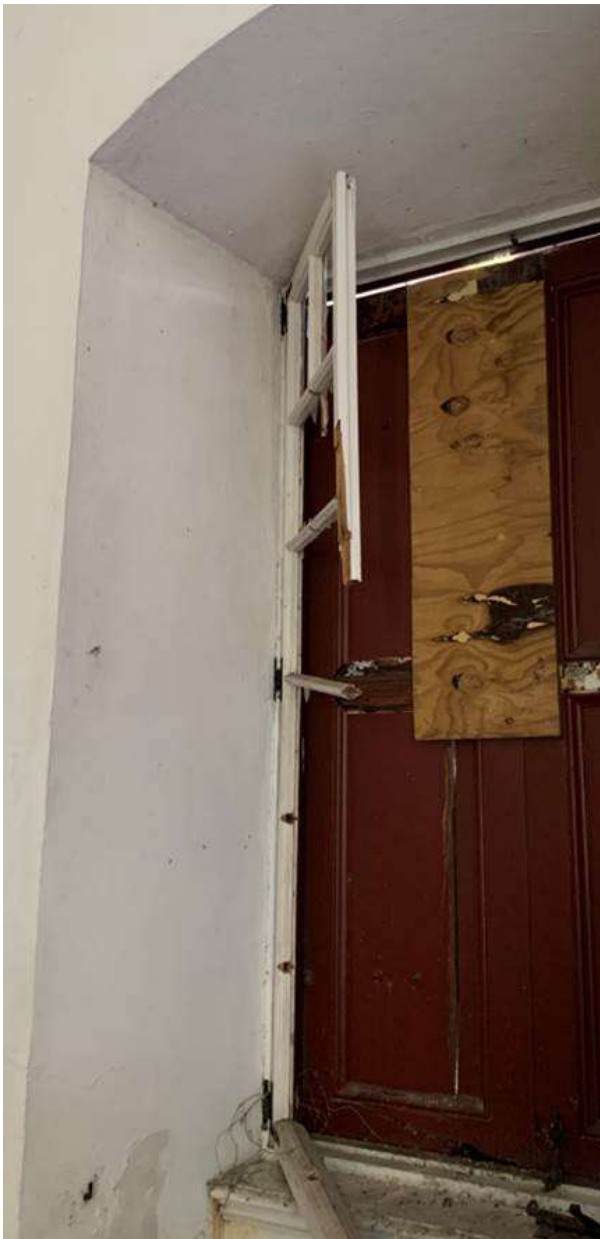
Window 9 is also broken on the left side. Several panes of glass and wood muntins are missing and broken off (Figure 3-84).

FIGURE 3-84. Broken left half of Window 9.

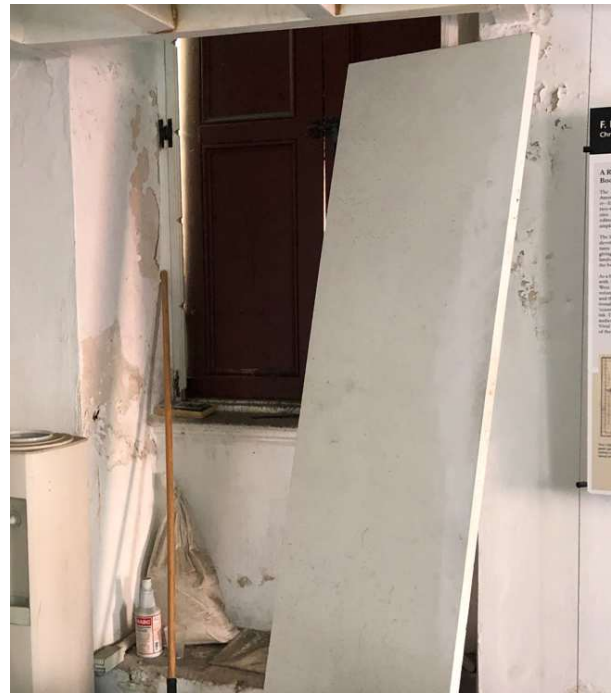
Significant plaster damage exists throughout the wall. Around the opening of Window 11, plaster and paint are peeling away from the wall (Figure 3-85). This same condition continues down the wall behind the educational posters toward Window 12 (Figure 3-86).

FIGURE 3-85. Plaster damage around Window 11.

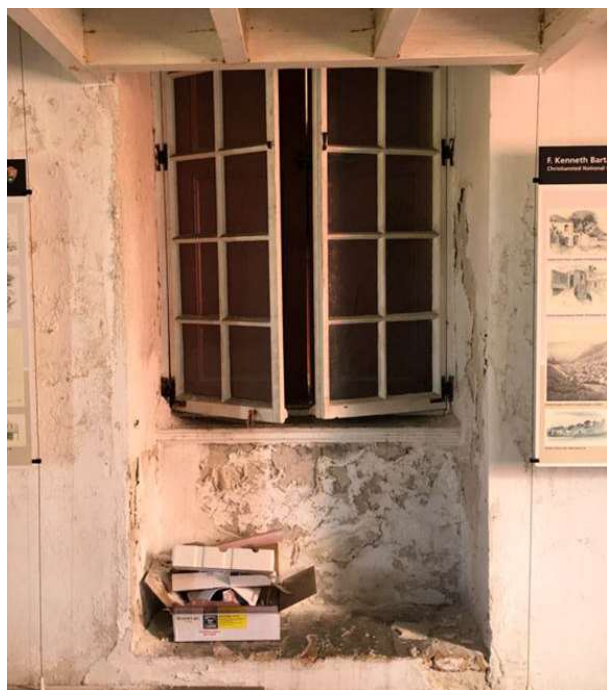
FIGURE 3-87. Plaster damage around Window 12.

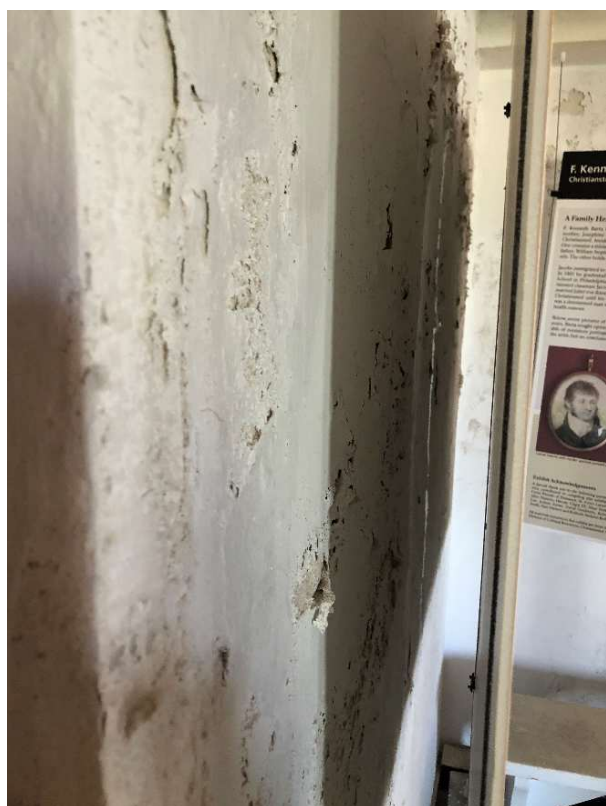
FIGURE 3-88. Plaster damage down wall.

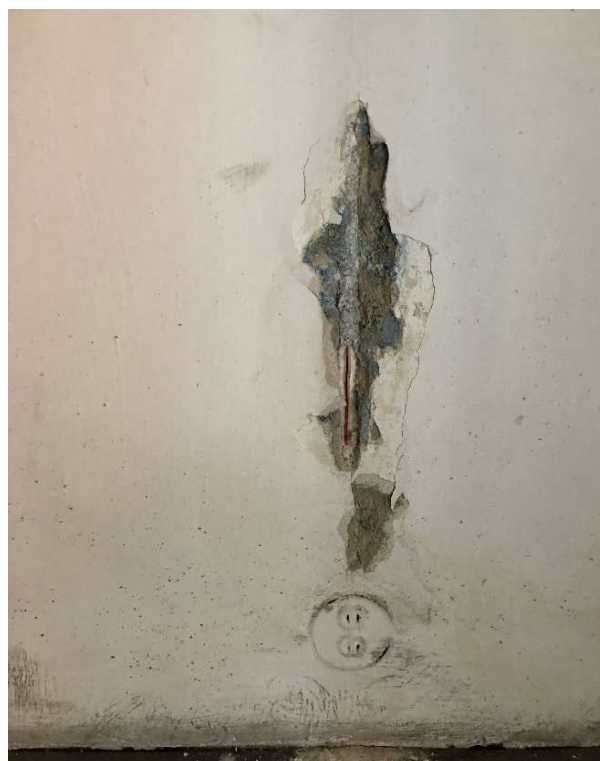
FIGURE 3-91. Plaster damage at right outlet.

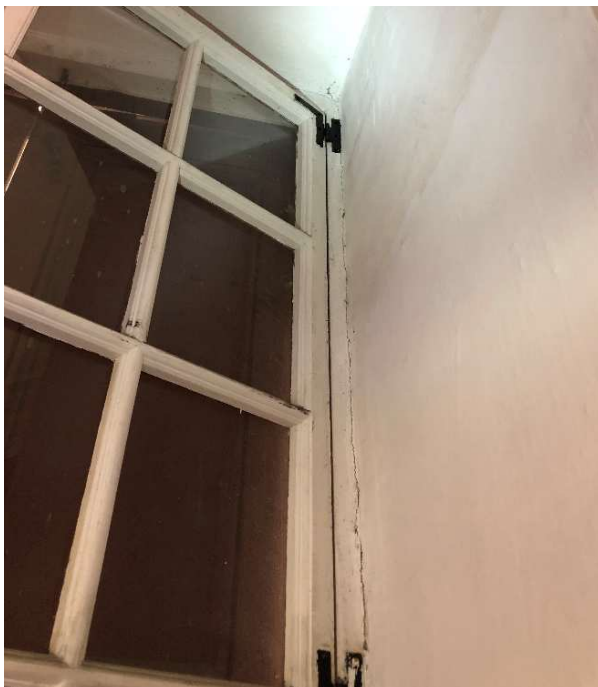
FIGURE 3-92. Crack at edge of Window 12.

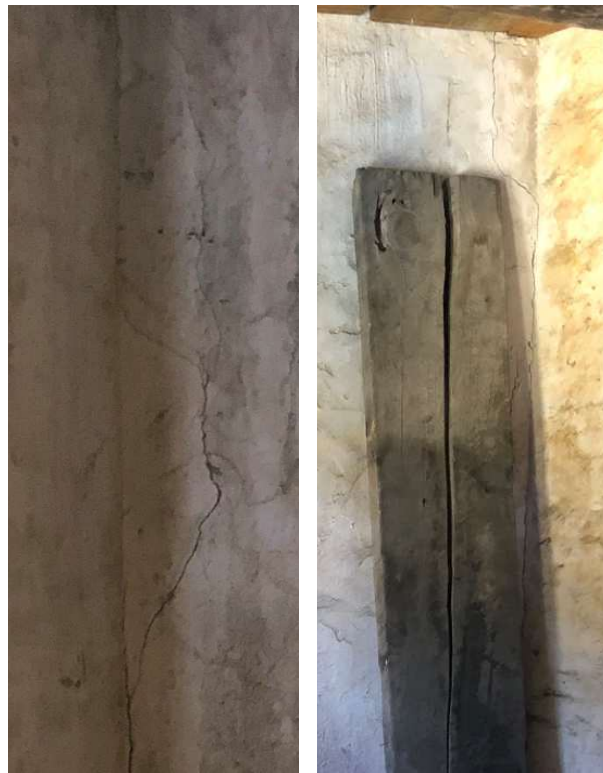
A series of cracks on either side of the horizontal plane are relatively small and are roughly 1/16"–1/8" in thickness (Figure 3-112). They appear to only be surface level in the plaster and they run down the height of the wall. These cracks originate

FIGURE 3-112. Cracking on left and right side of wall of second tier, northeast wall.

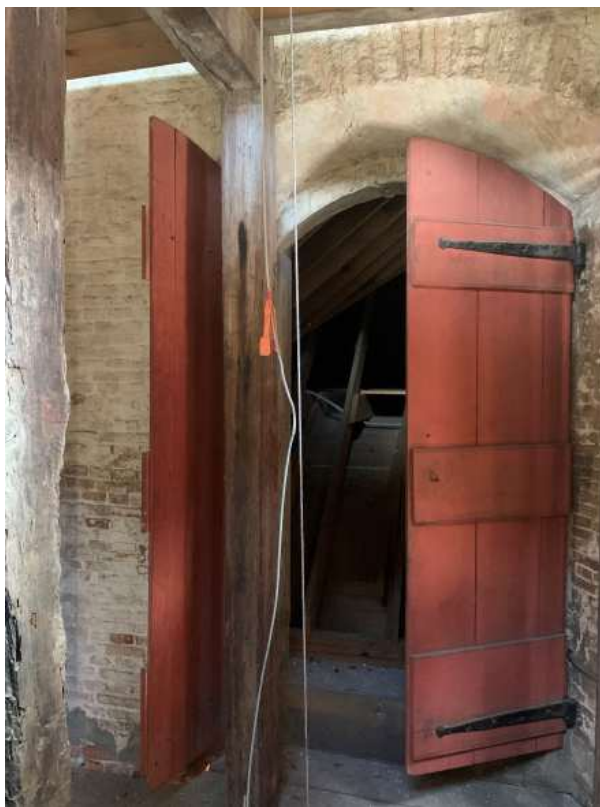
FIGURE 3-115. Door F unable to close left side.

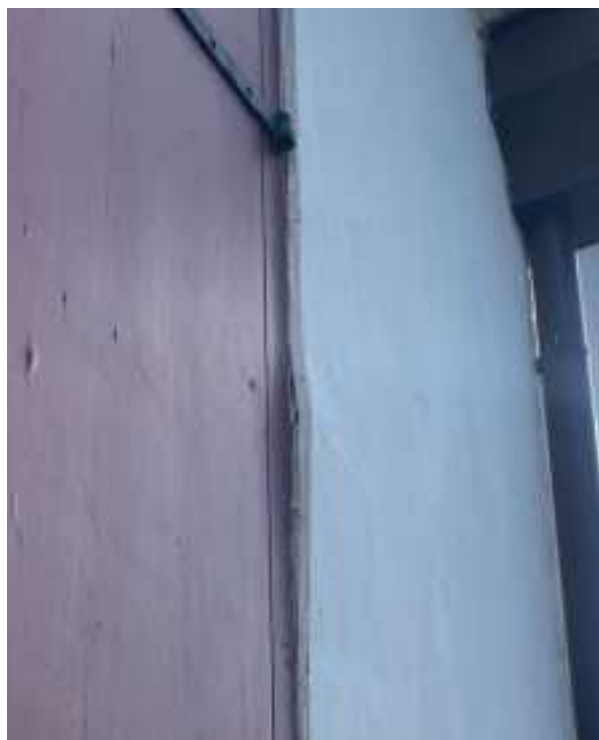
FIGURE 5-4. Bulging at window.

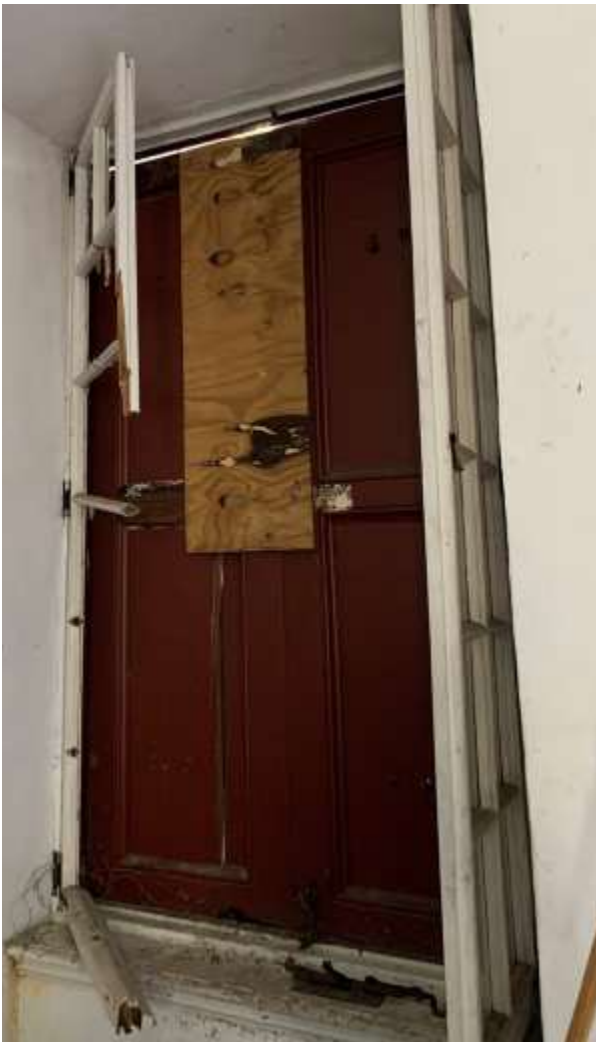
FIGURE 5-5. Example of broken elements at Window 9.

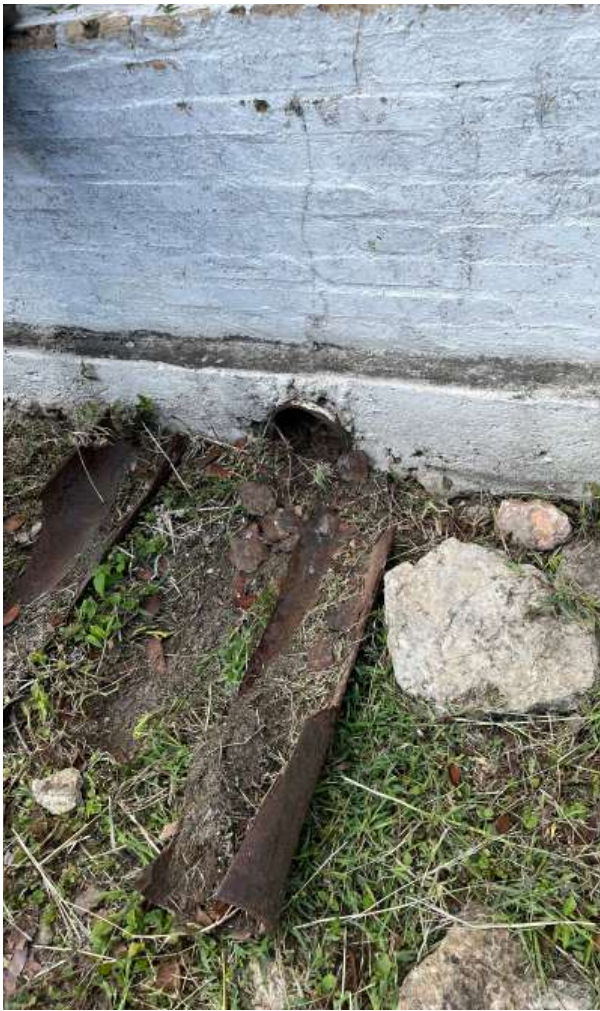
FIGURE 5–8. Broken Hospital Street drain. effects. High pressure washers or other abrasive techniques should not be employed.
