APPENDIX B  
L'ESPERANCE HISTORIC DISTRICT

# CLASSIFIED STRUCTURE FIELD INVENTORY REPORT

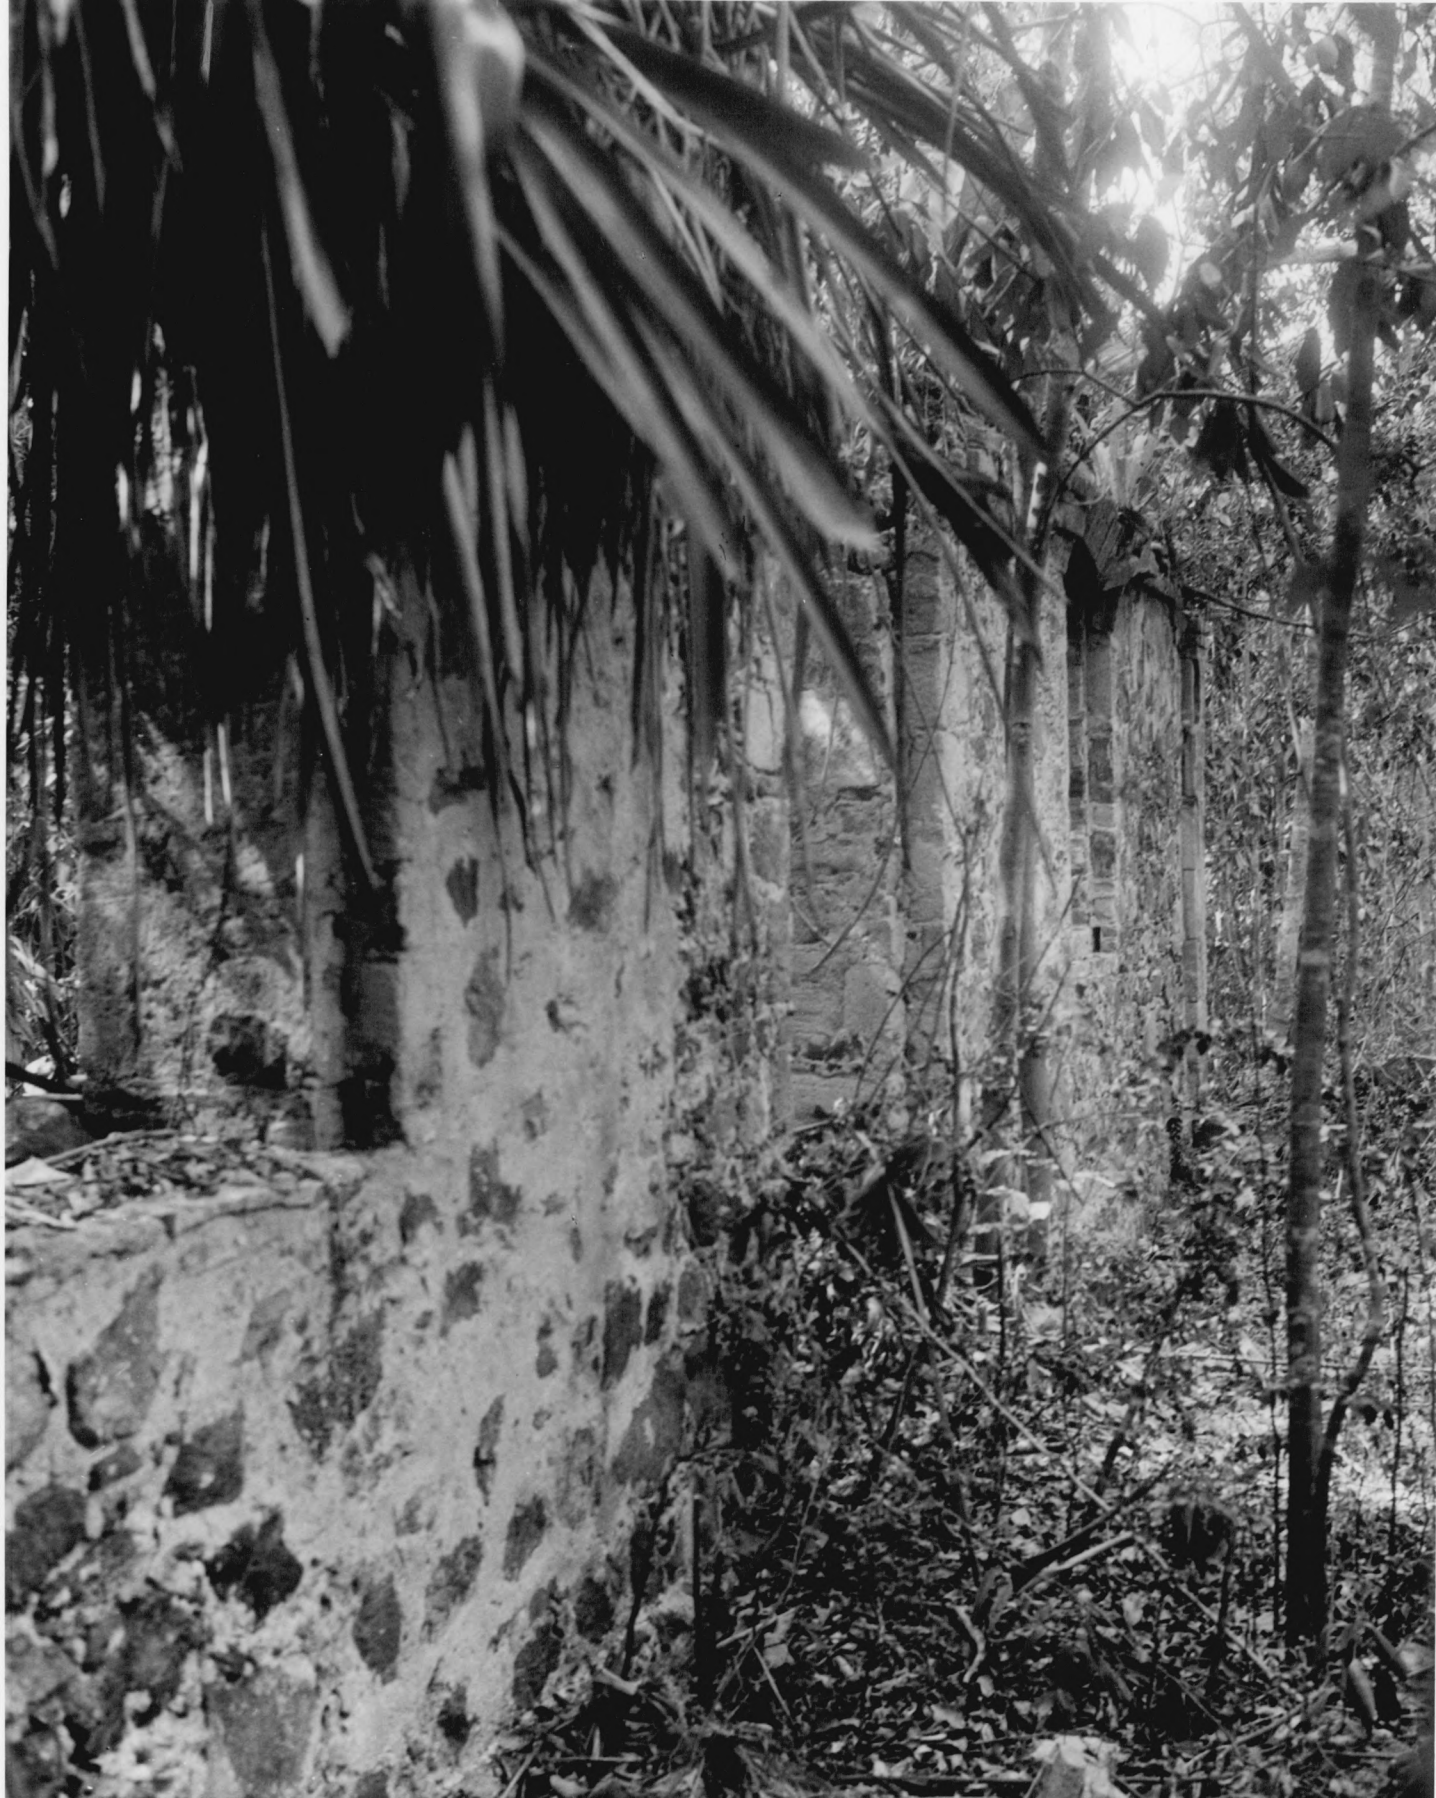
# Plantation House

Physical Description: The Great House ruin is the best preserved of all structures of the L'Esperance Plantation site. It is located 30' west of the new horsemill and 45' north and uphill of the factory. The considerable grade difference between the site of the latter and the Great House is regulated by a narrow terrace fronting the Great House, supported on a fragmented retaining wall and a steep bank. The house had a masonry ground floor measuring 46'x34' that supported a wood superstructure. The ground floor walls stand to their full height. The north and part of the west wall act as retaining wall for the level area that fronted the yard side of the Great House. The walls are rubble masonry with cut and dressed stone around openings and at corners and with articulated quoins on the free-standing exterior faces. In plan it is divided into an enclosed room 20' wide that runs the full length of the building and a 12' wide, partially open gallery on the south and factory side of the building. The east wall of the structure continues as a retaining wall for the terrace to the north and masonry steps along the west wall of the building lead up to this terrace level. The stonework is handsomely finished and the execution very workmanlike. Except for traces of beams and plates nothing remains of the wood superstructure. Probable dates of construction is late 18th century.

West wall of Plantation House viewed from the north (H-5, 6).

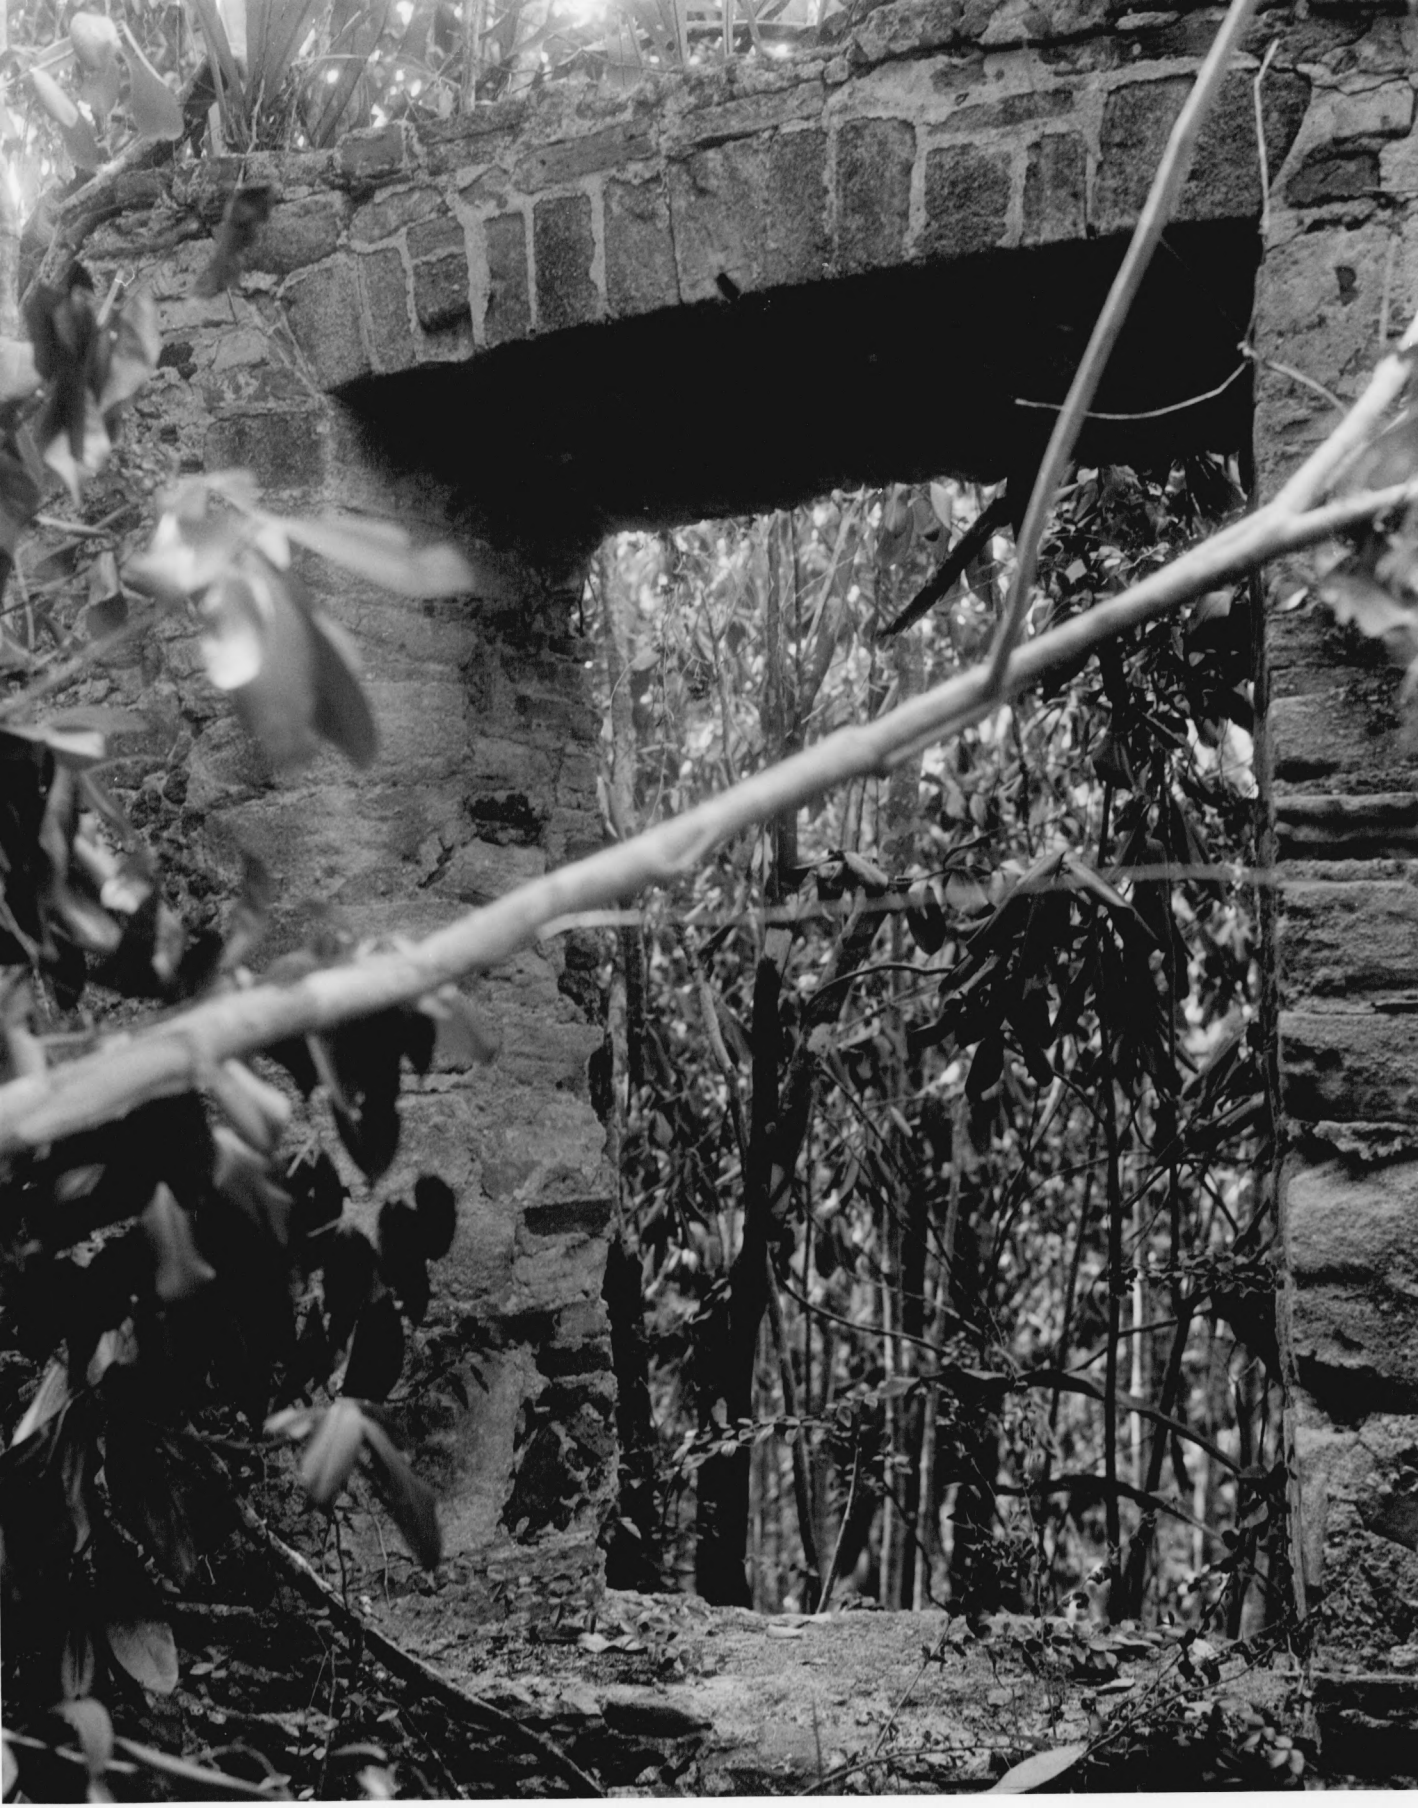
# Plantation House

Window in south wall of PlantationHouse (H-5, 6).

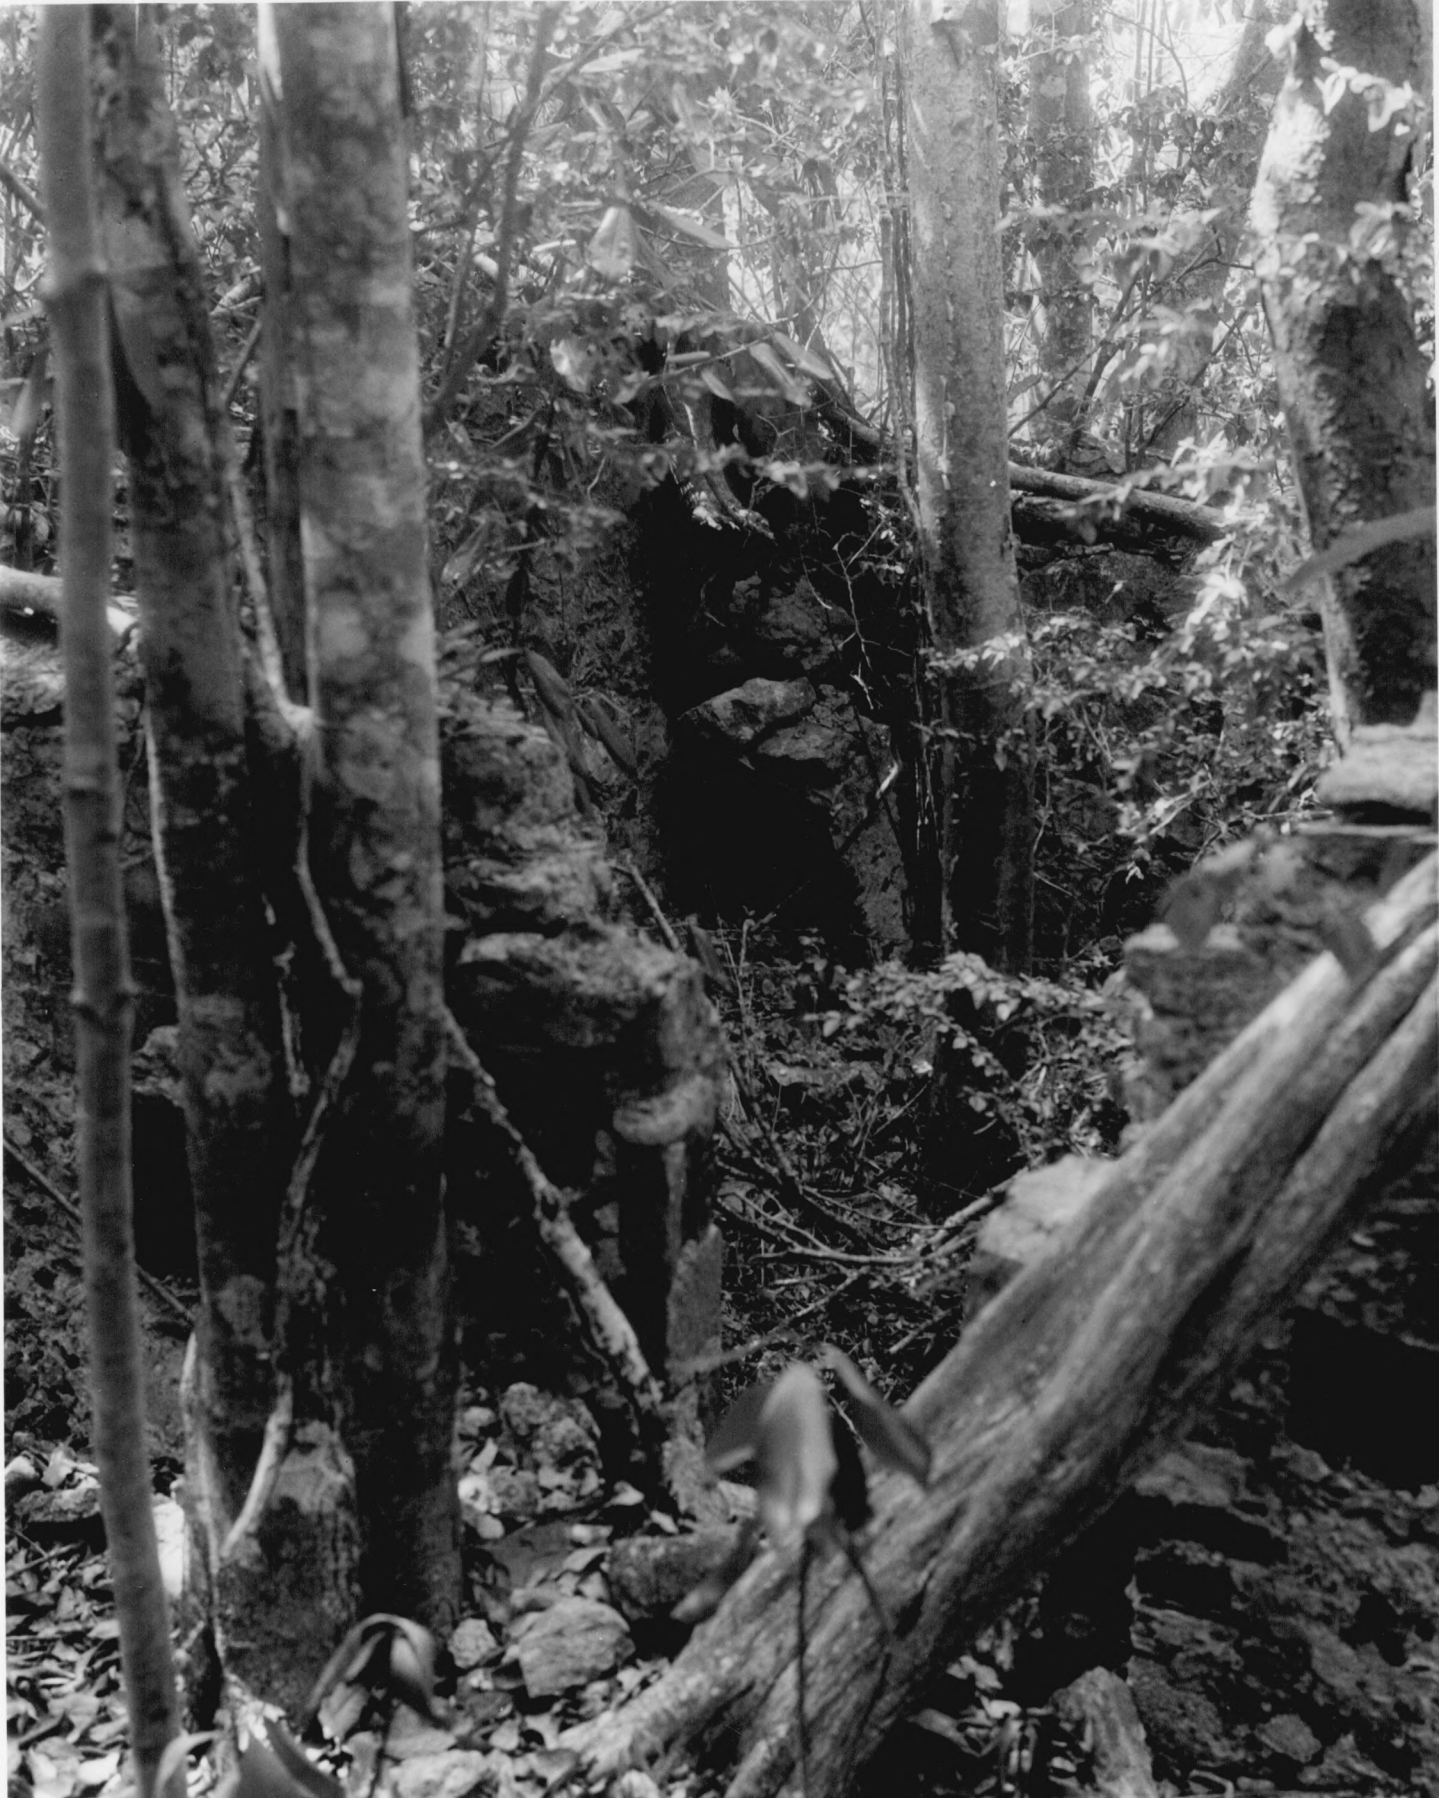
Cook House (H-5, 7) viewed from the south.

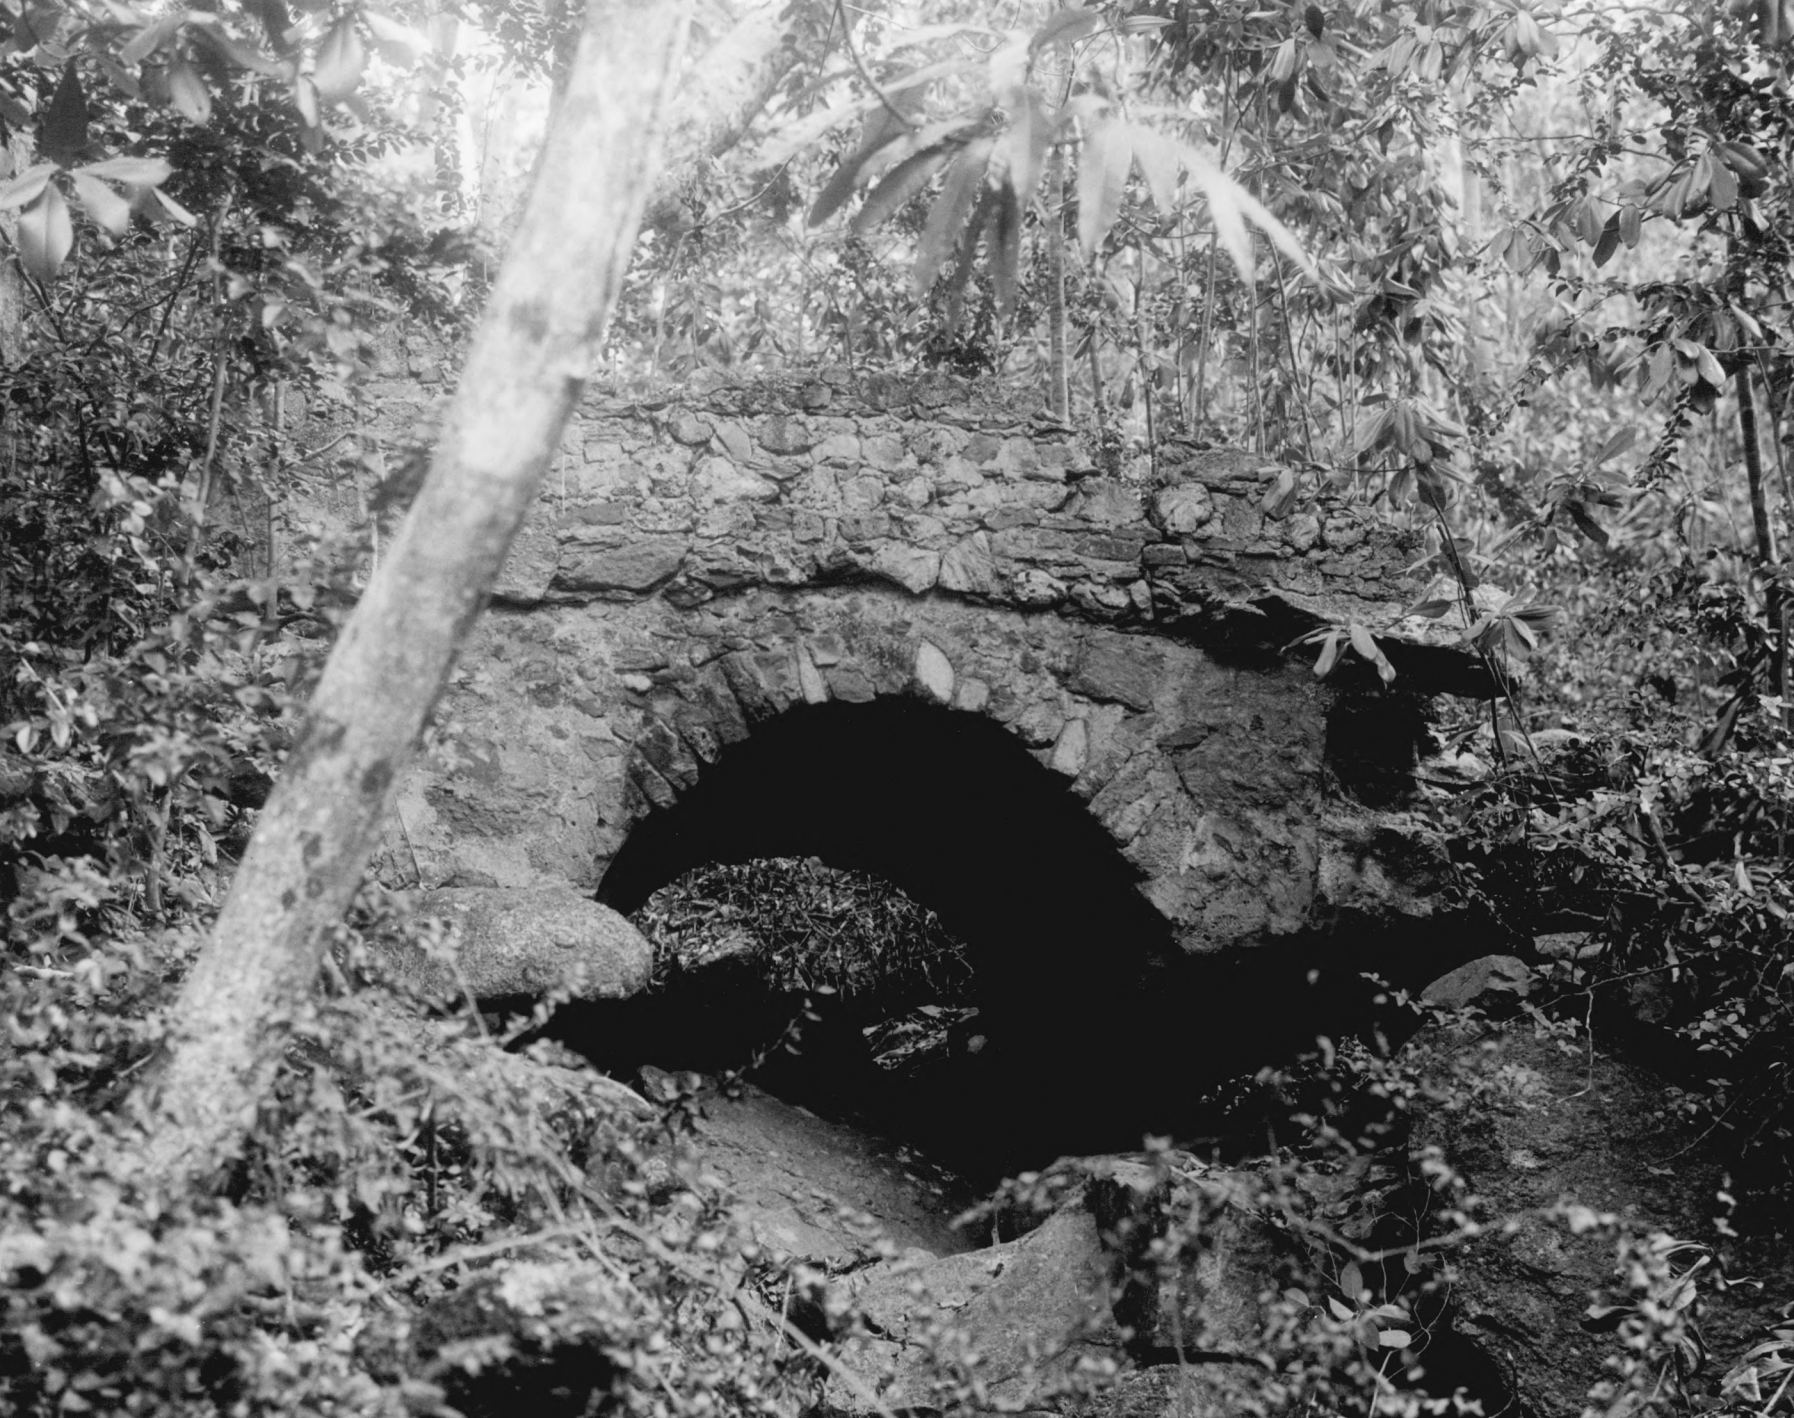
Physical Description: The entrance road to L'Esperance from the old card road that from Centerline Road leads to Sieben and Mollendal crosses a small gut. It is bridged by a small stone arch with a span of eight feet and a width of 6'6". Although still standing the bridge abutments towards the north show signs of failure and in their present condition are subjected to serious erosion.

Bridge to Plantation site (H-5, 9) from Mollendal Road  
viewed from the south.
