APPENDIX B  
HERMITAGE PLANTATION HISTORIC DISTRICT

REGION Southeast PARK/AREA NAME Virgin Islands Nat'l Park CODE NO. 5360

STRUCTURE NAME Plantation House, Hermitage STRUCTURE NO. H-37.1

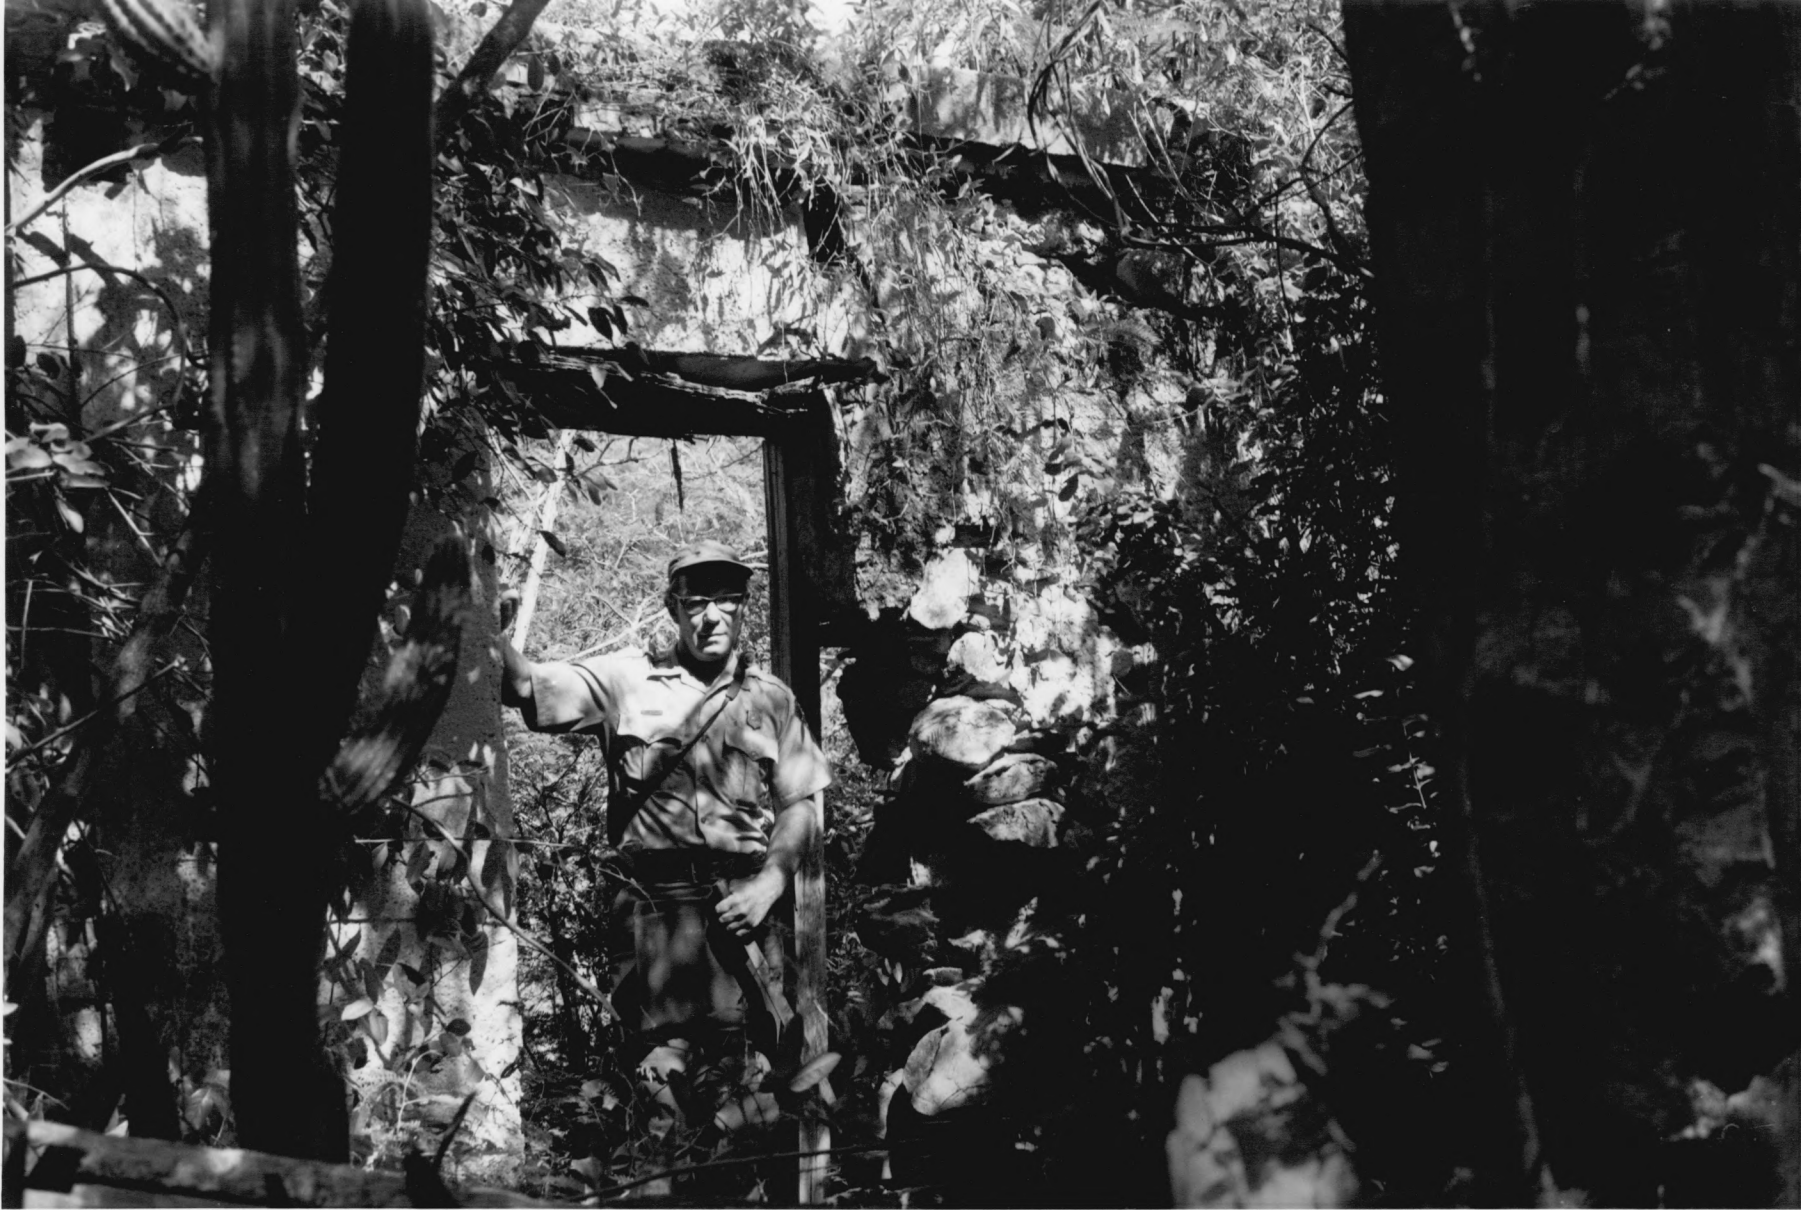
North entrance to ground floor of Plantation House  
H-37,1 viewed from the interior (south).

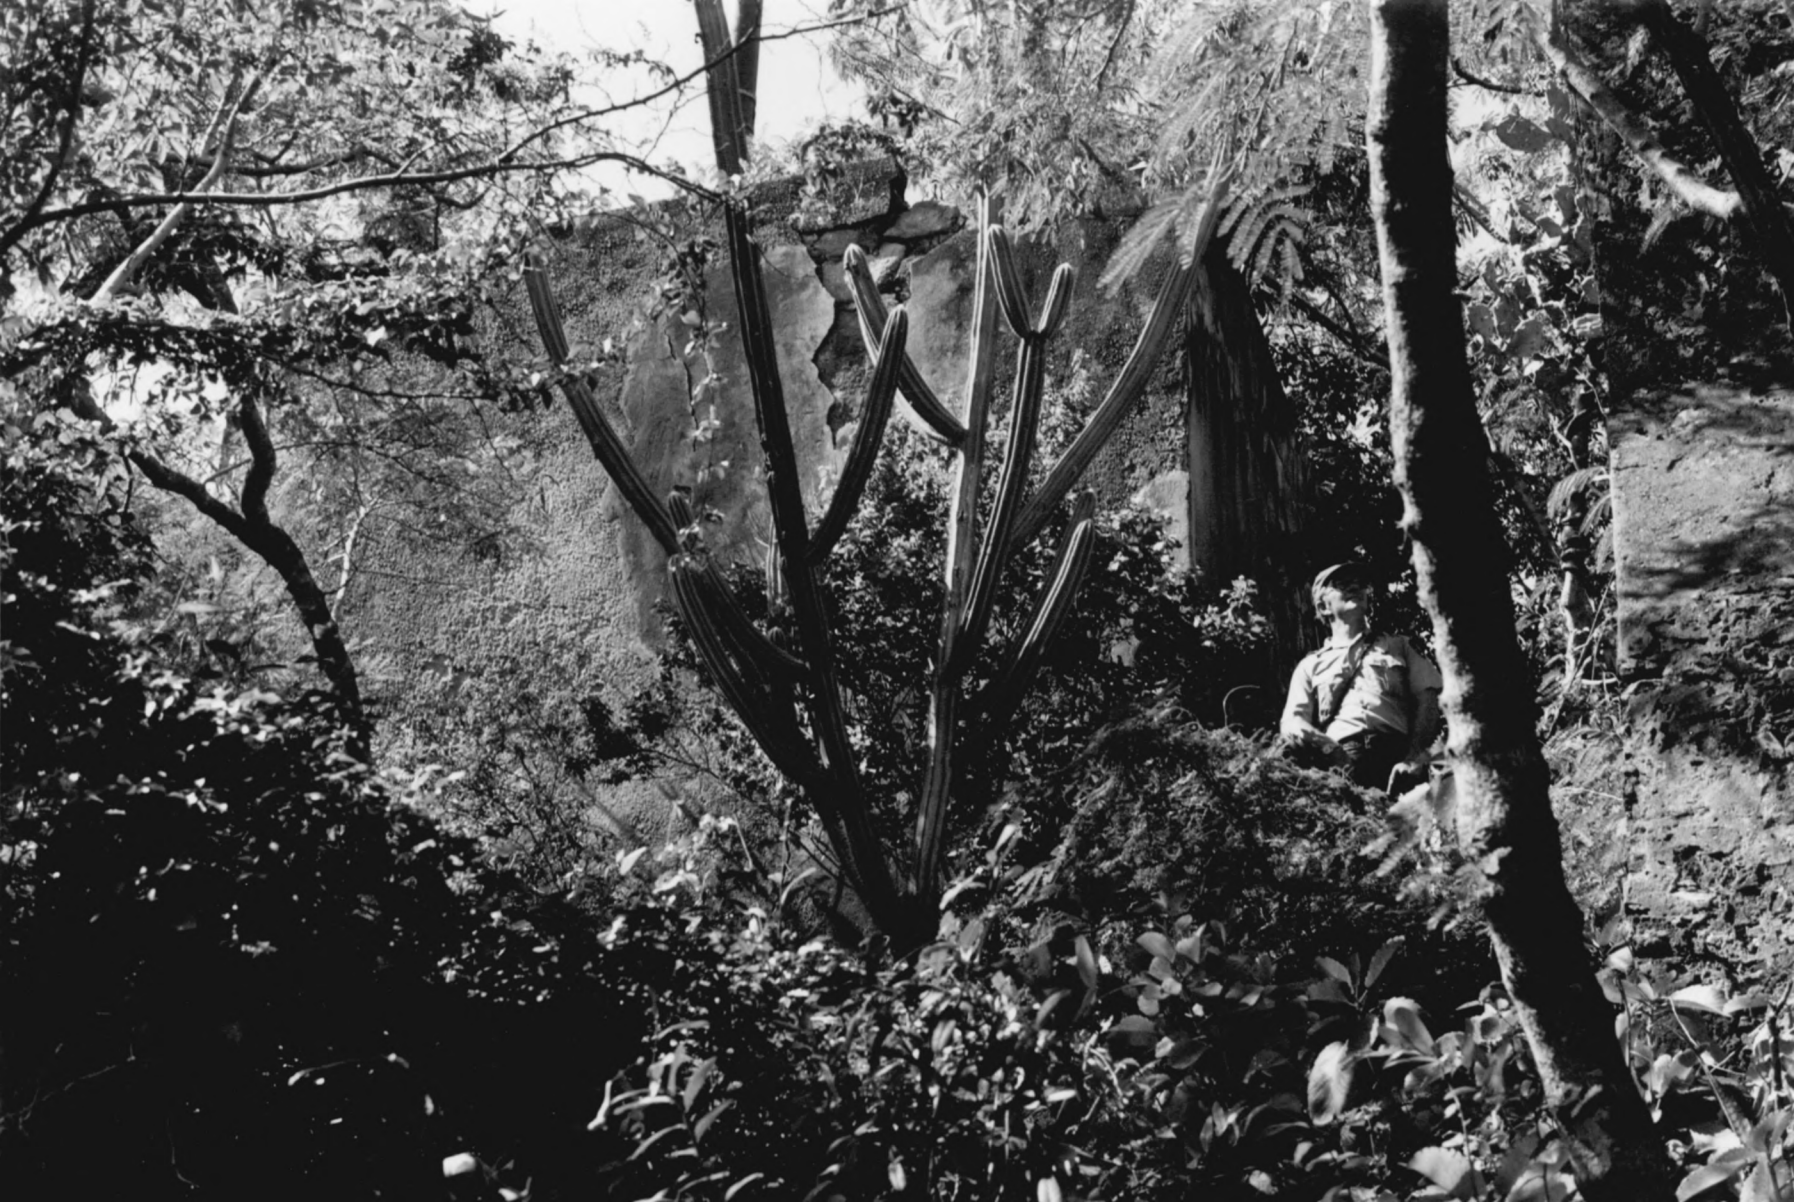
Cook House

Cook houlse (left) and cistern of plantation house  
H-37,1 viewed from the east.

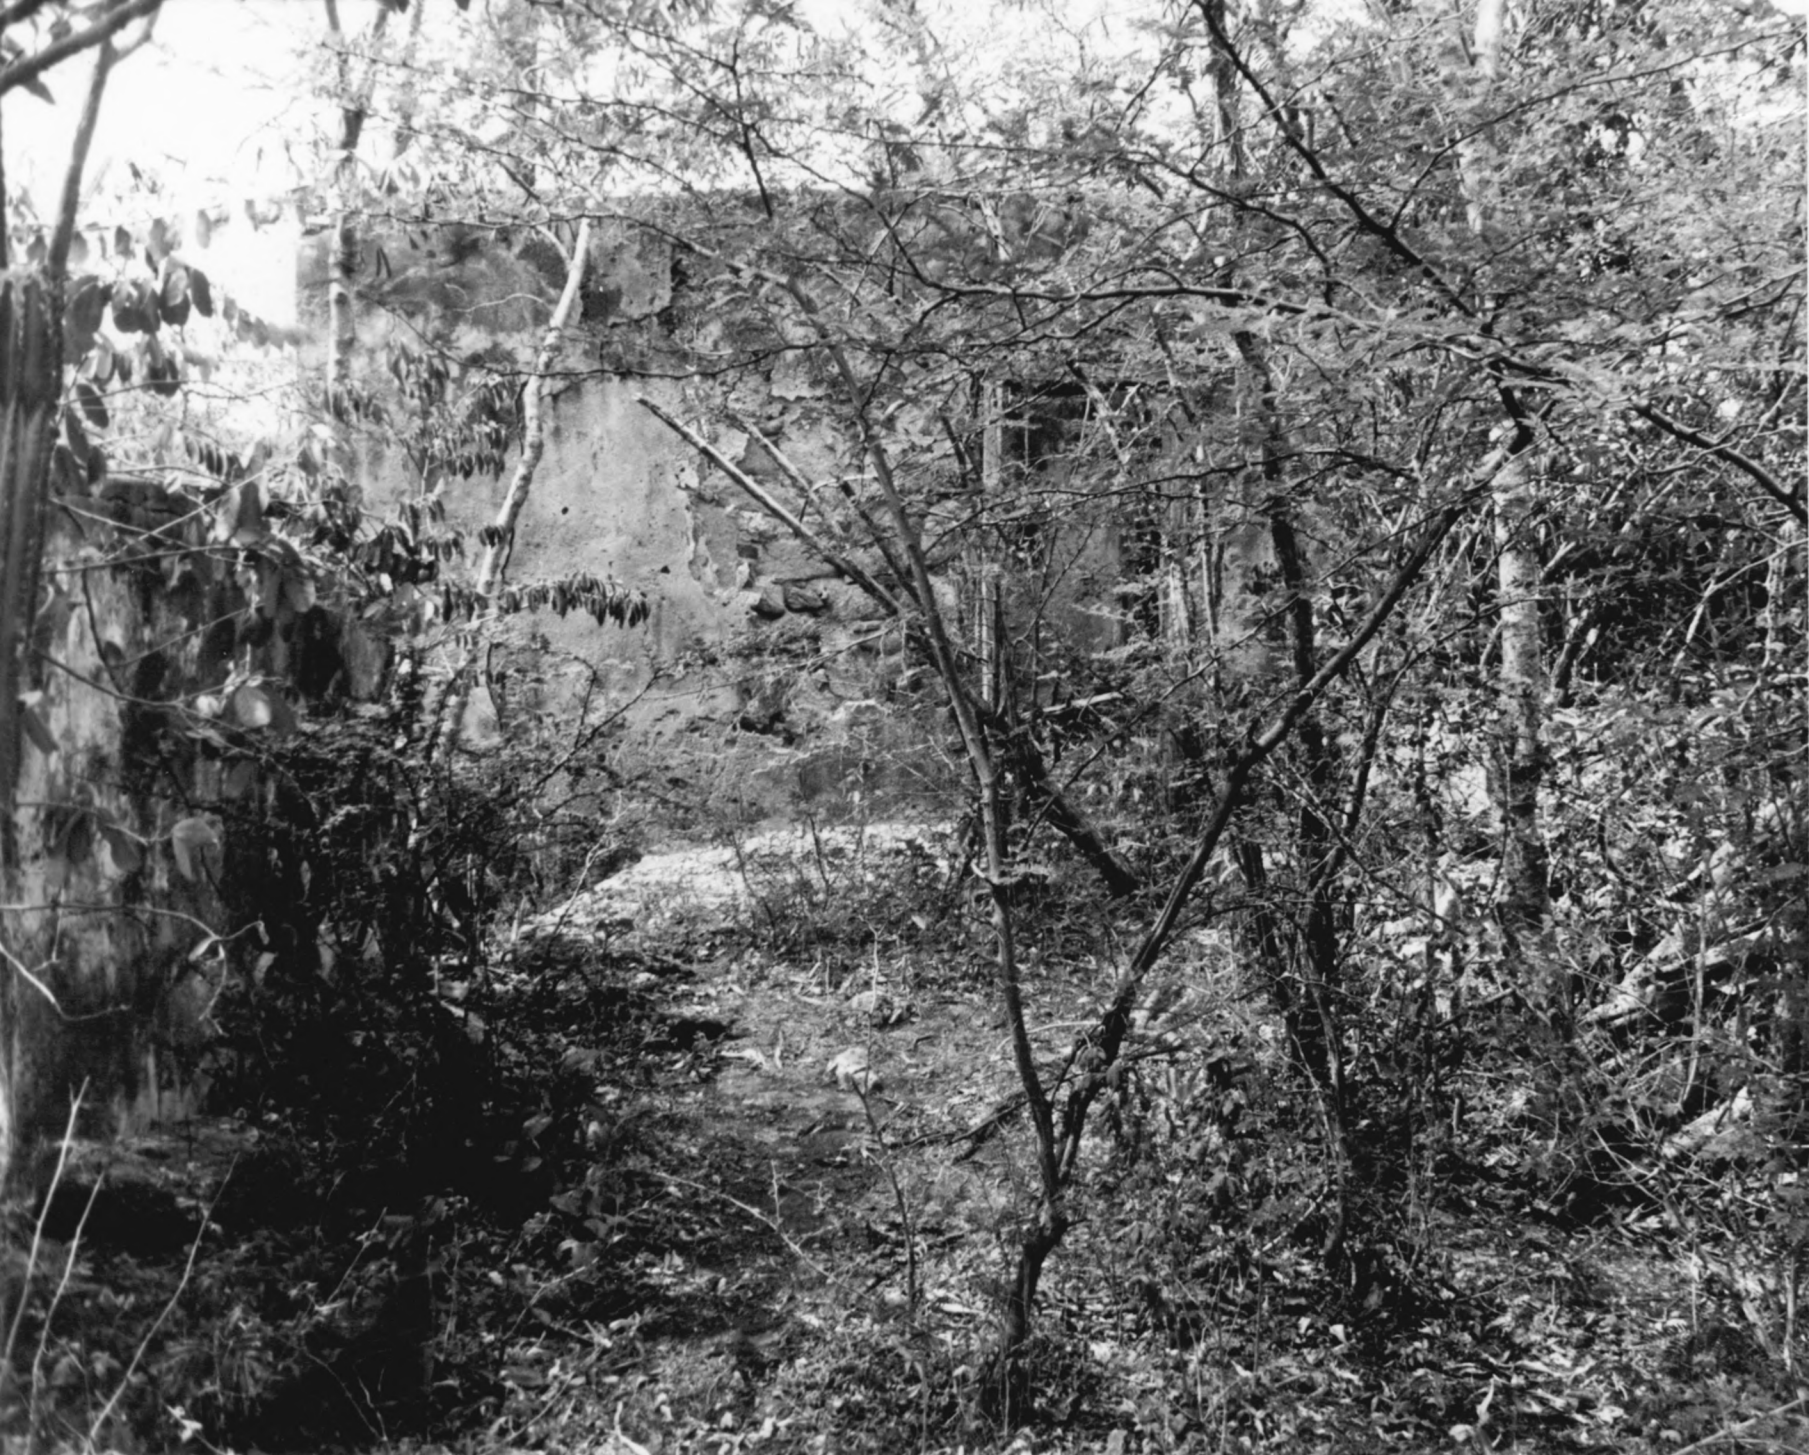
Plantation House H-37, 1 north side of building with a section of Cistern No. 1 showing to the left in the photo.

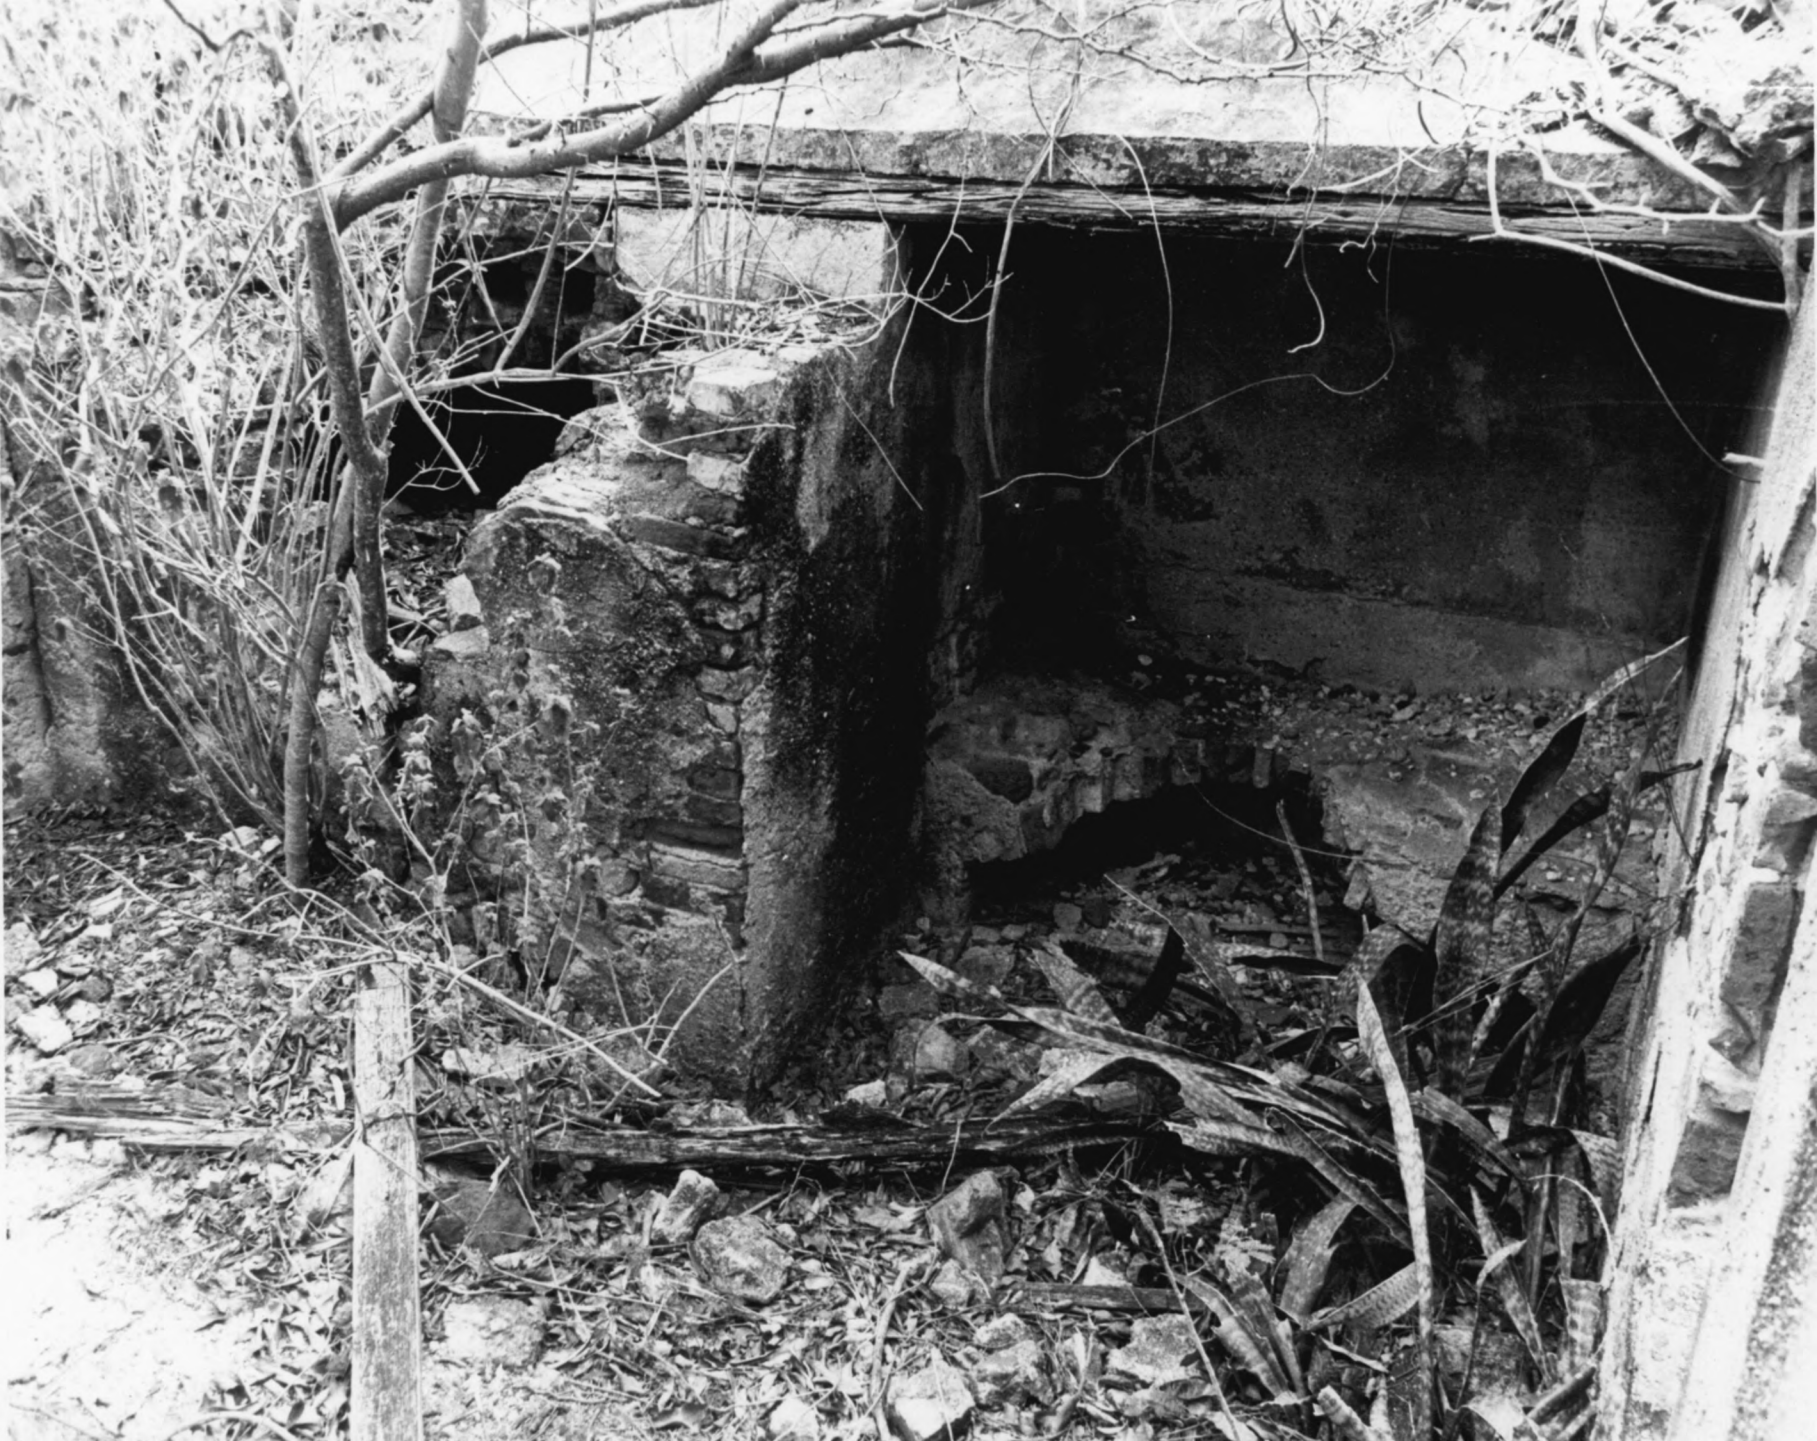
Bake Oven and Cook House

The remains of the bake oven and masonry cooking range  
in the cook house of the Plantation House viewed from  
the west, H-37,1

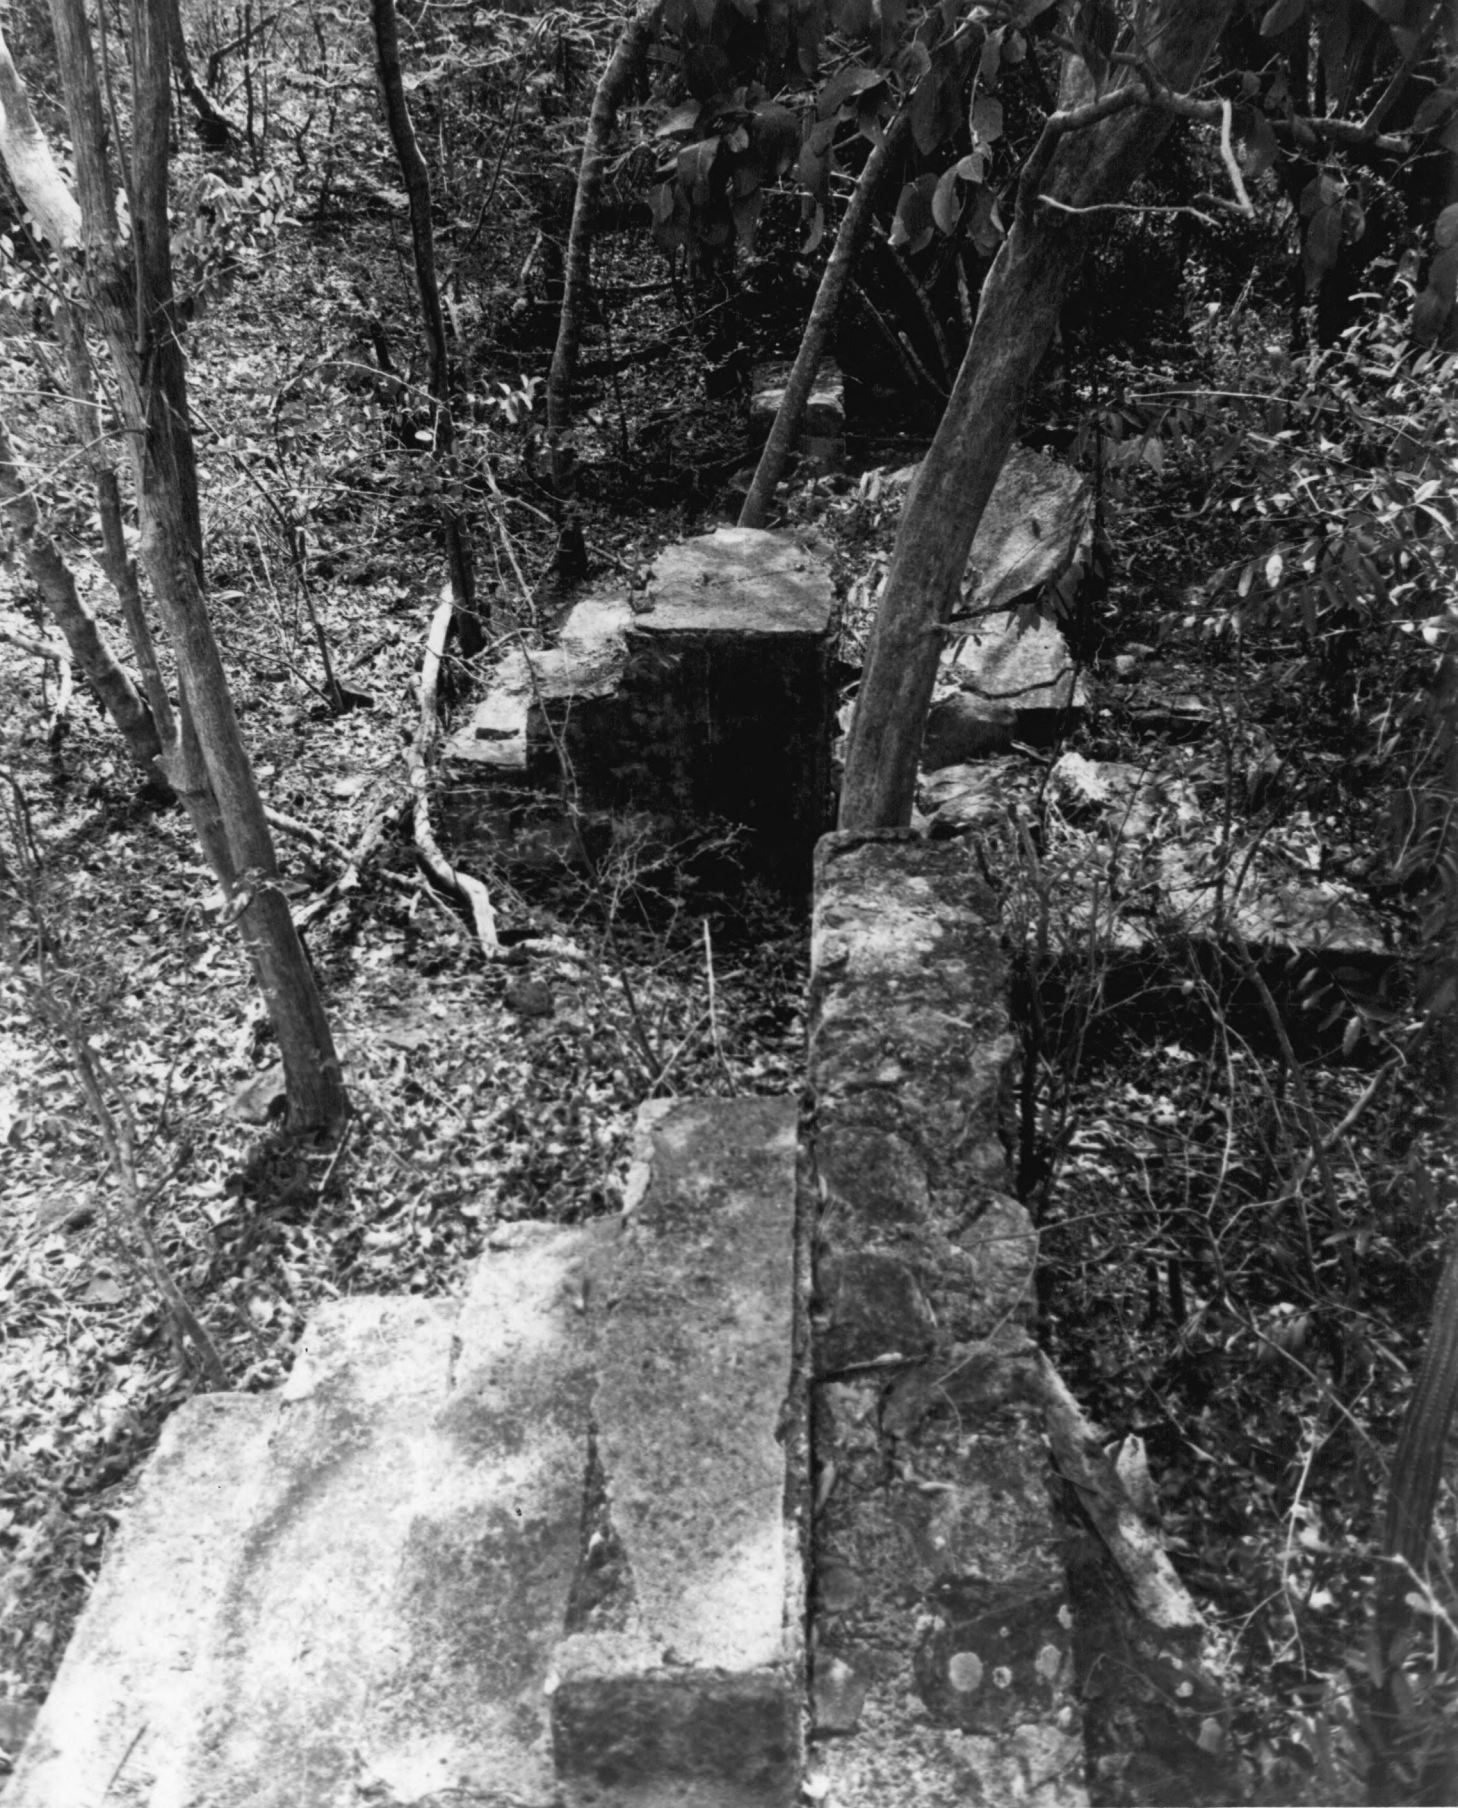
Physical Description: The masonry footings and lower walls of a wood frame barracks like building 12'x40' is located south and west of quarters No. 1. Two sets of steps on the northwest side lead up to the floor level of its former interior. Only the plastered rubble steps footings and lower walls remain. In the 1905 photograph the building had a low hipped roof.

West wall of Quarters No. 2 (H-37,7) viewed from the south.

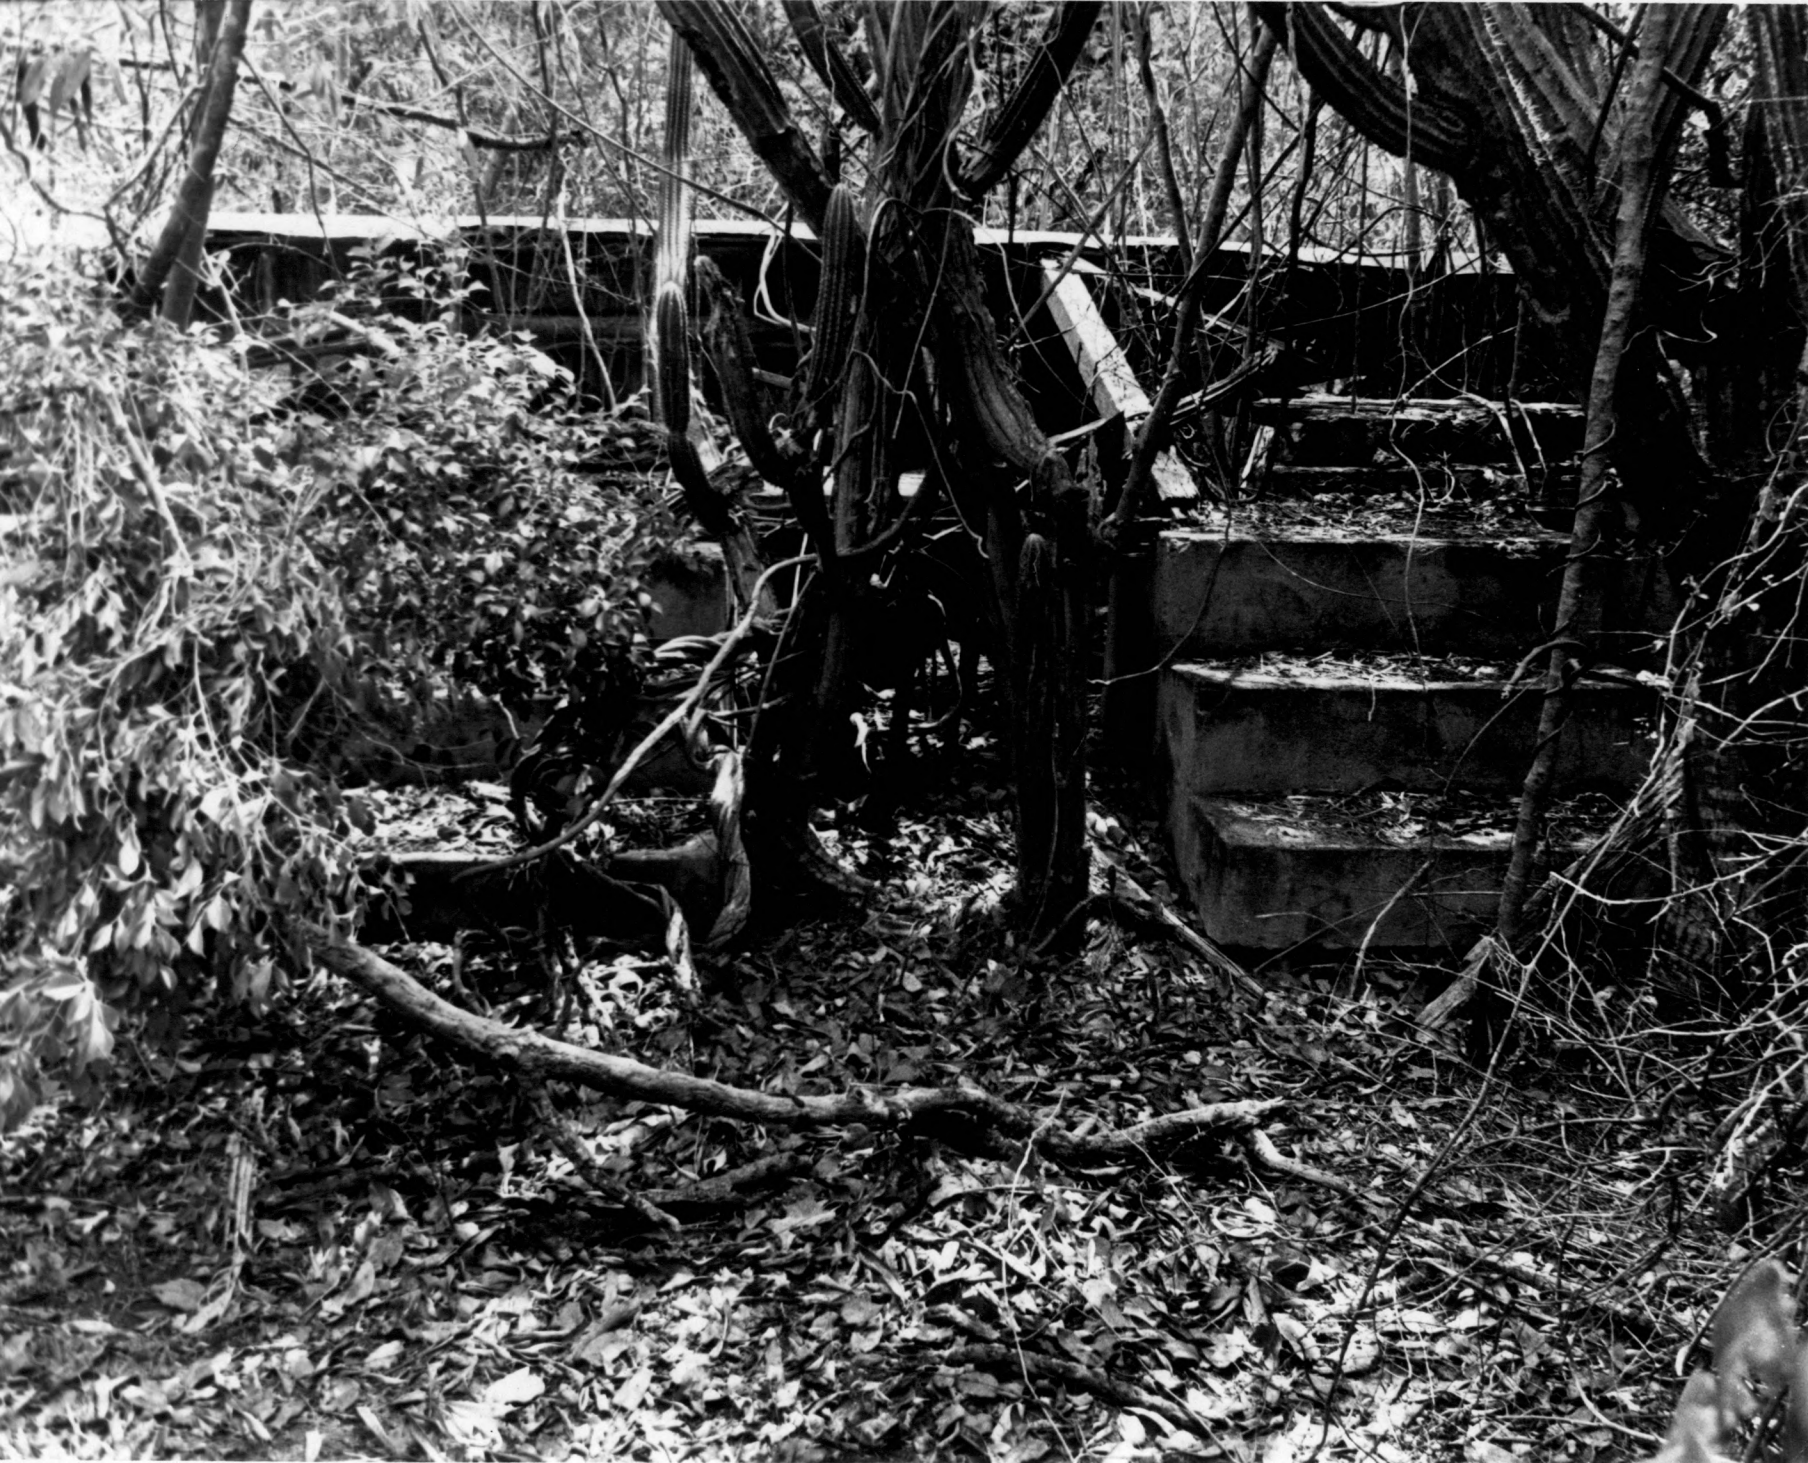
Quarters #4

Quarters No. 4, H-37,9 viewed from the southwest, note the remains of the collapsed wood superstructure.
