## DENNIS BAY HISTORIC DISTRICT

REGION Southeast PARK/AREA NAME Virgin Islands Nat'l Park CODE NO. 5360

STRUCTURE NAME Horsemill No. 1, Dennis Bay STRUCTURE NO. H-24.1

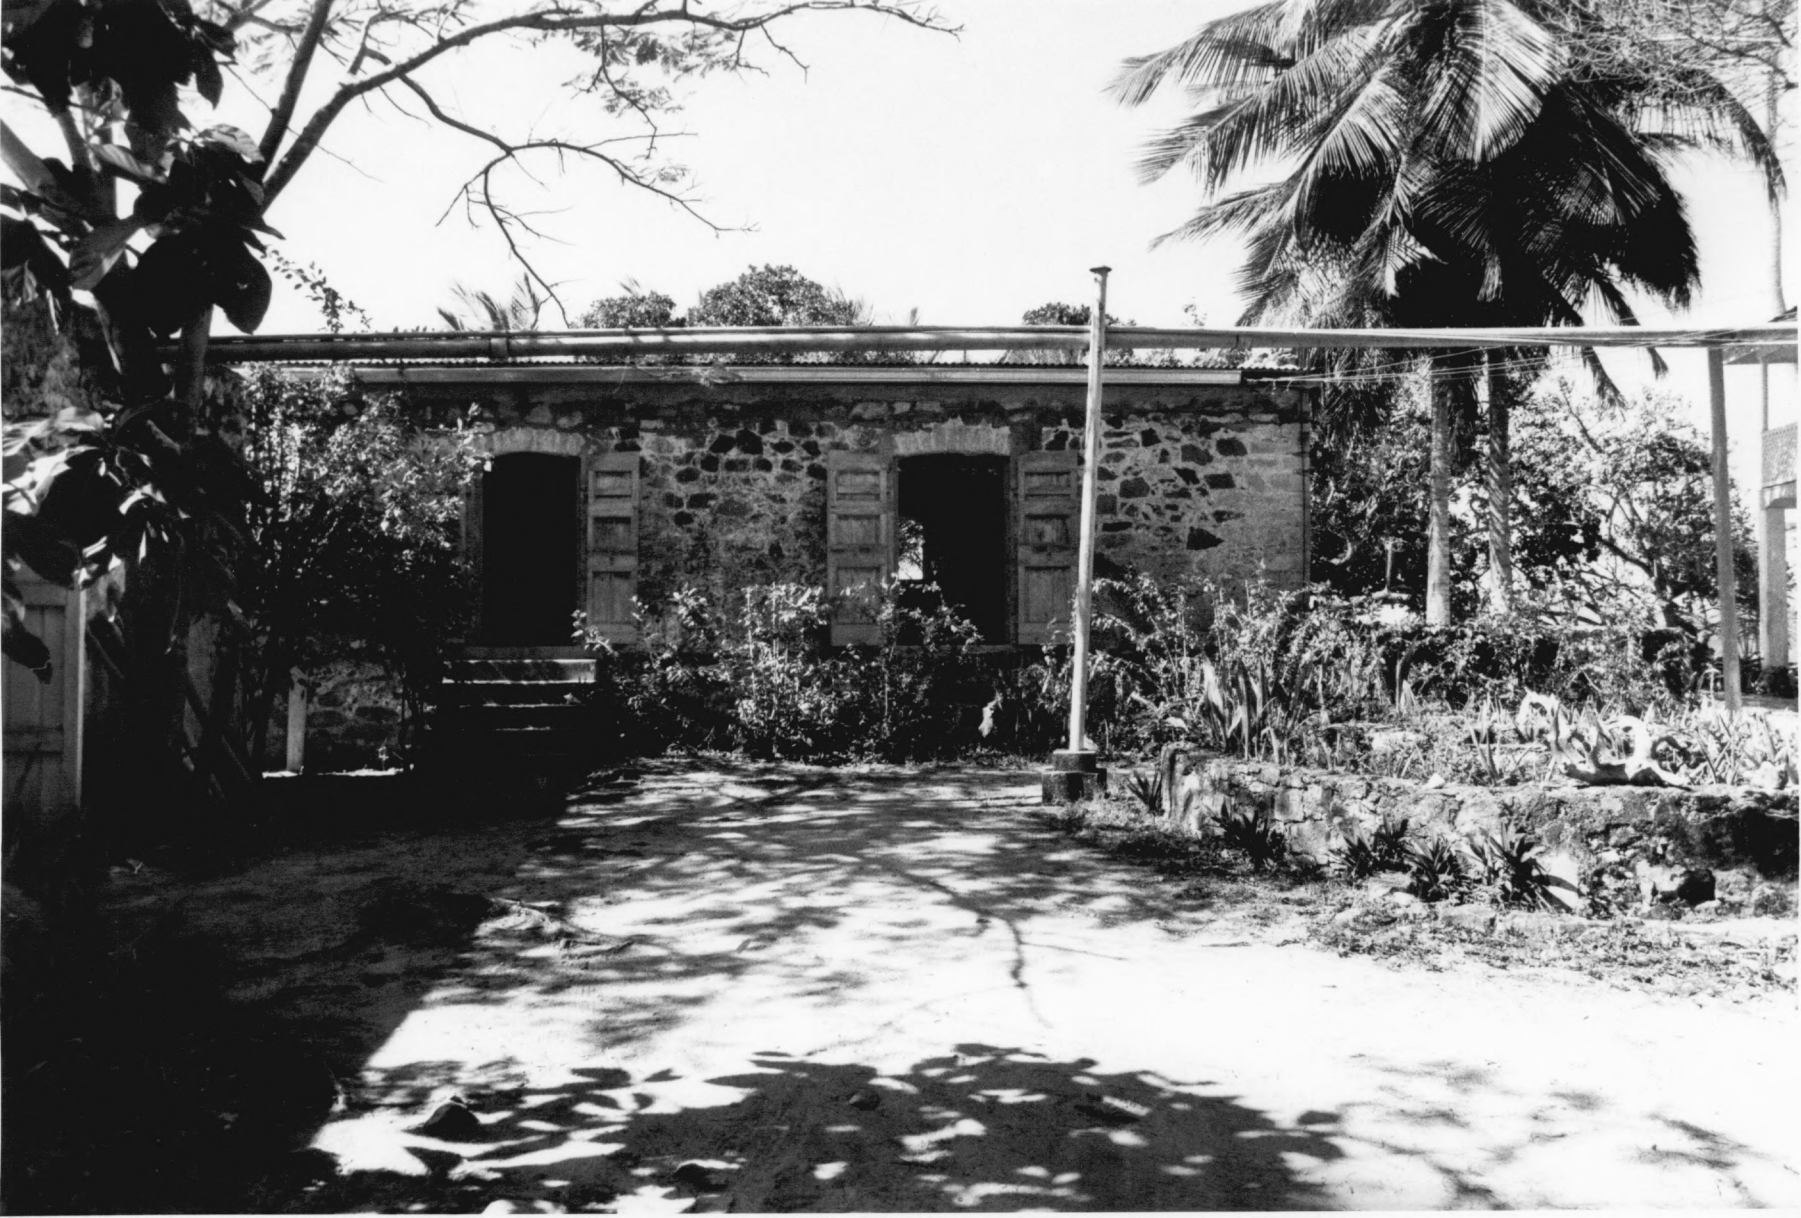
**Factory**

The factory is a rectangular rubble masonry structure 30'x40' located south and 6' from horsemill No. 1. The walls stand to a full one story height. Although the building apparently has retained its original door and window openings, shutters and doors are new. The interior has been divided and remodelled to serve residential purposes and new concrete floors have been laid throughout at a level approximately 3' above surrounding grade. The building is covered with a corrugated metal shed roof on wood beams. An open porch with a floor level 2'6" above grade and with a shed roof supported on wood posts has been constructed against the west end of the building for its full width. Except for the walls, which are in good condition, and the original door, window and gutter openings there are no indication of the building 18th century character and the alterations which are approximately 20 years old tend to obscure its original functions. Lat. 18°21'15" Long. 64°46'04"

**Factory (H-24, 2) viewed from the east.**

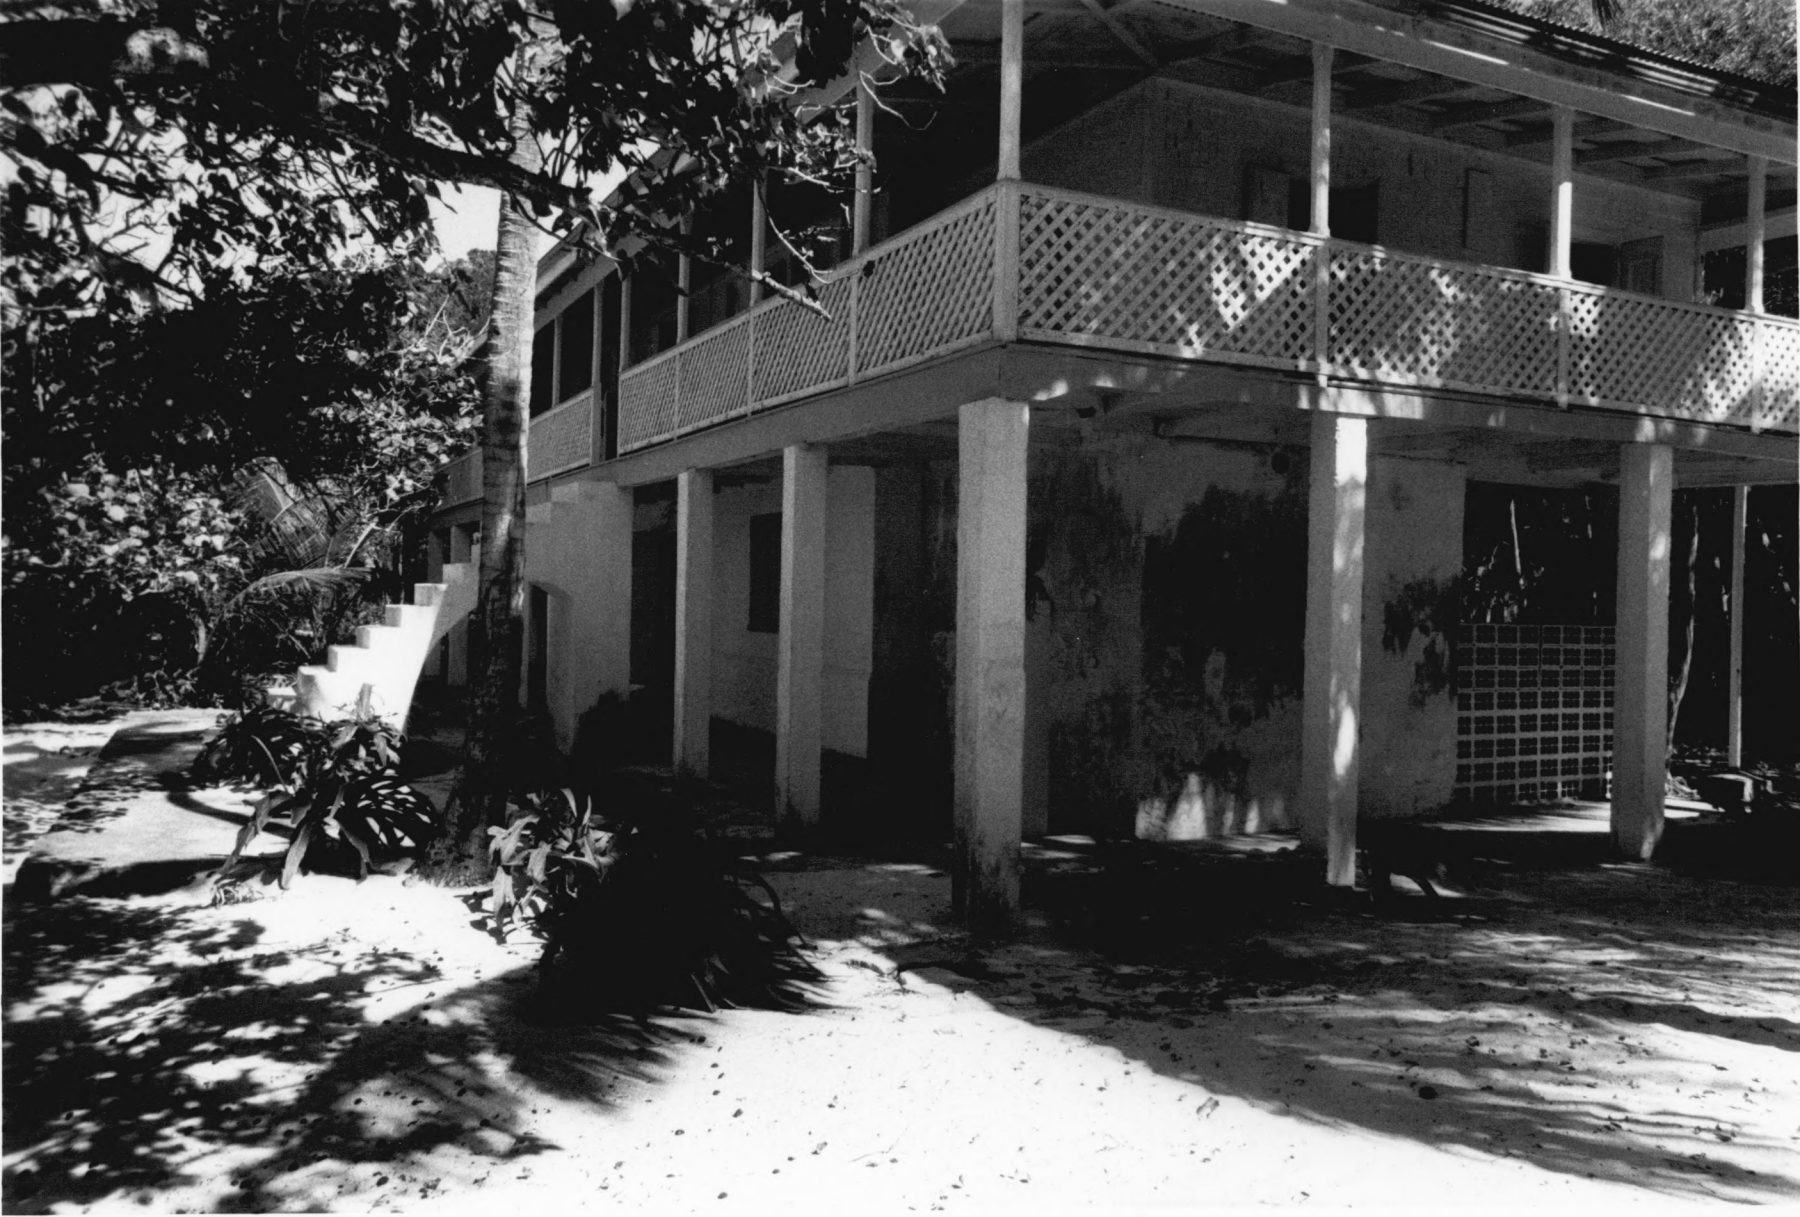
# Plantation House

The building is in good condition and is in use as a residence.

The date of its construction is not known, presumably early 19th century appearance then can be assumed to be much the same as it is now except north and west gallery. The additions and changes were made, reportedly the 1930s.

**Plantation House (H-24, 4) viewed from the northwest.**

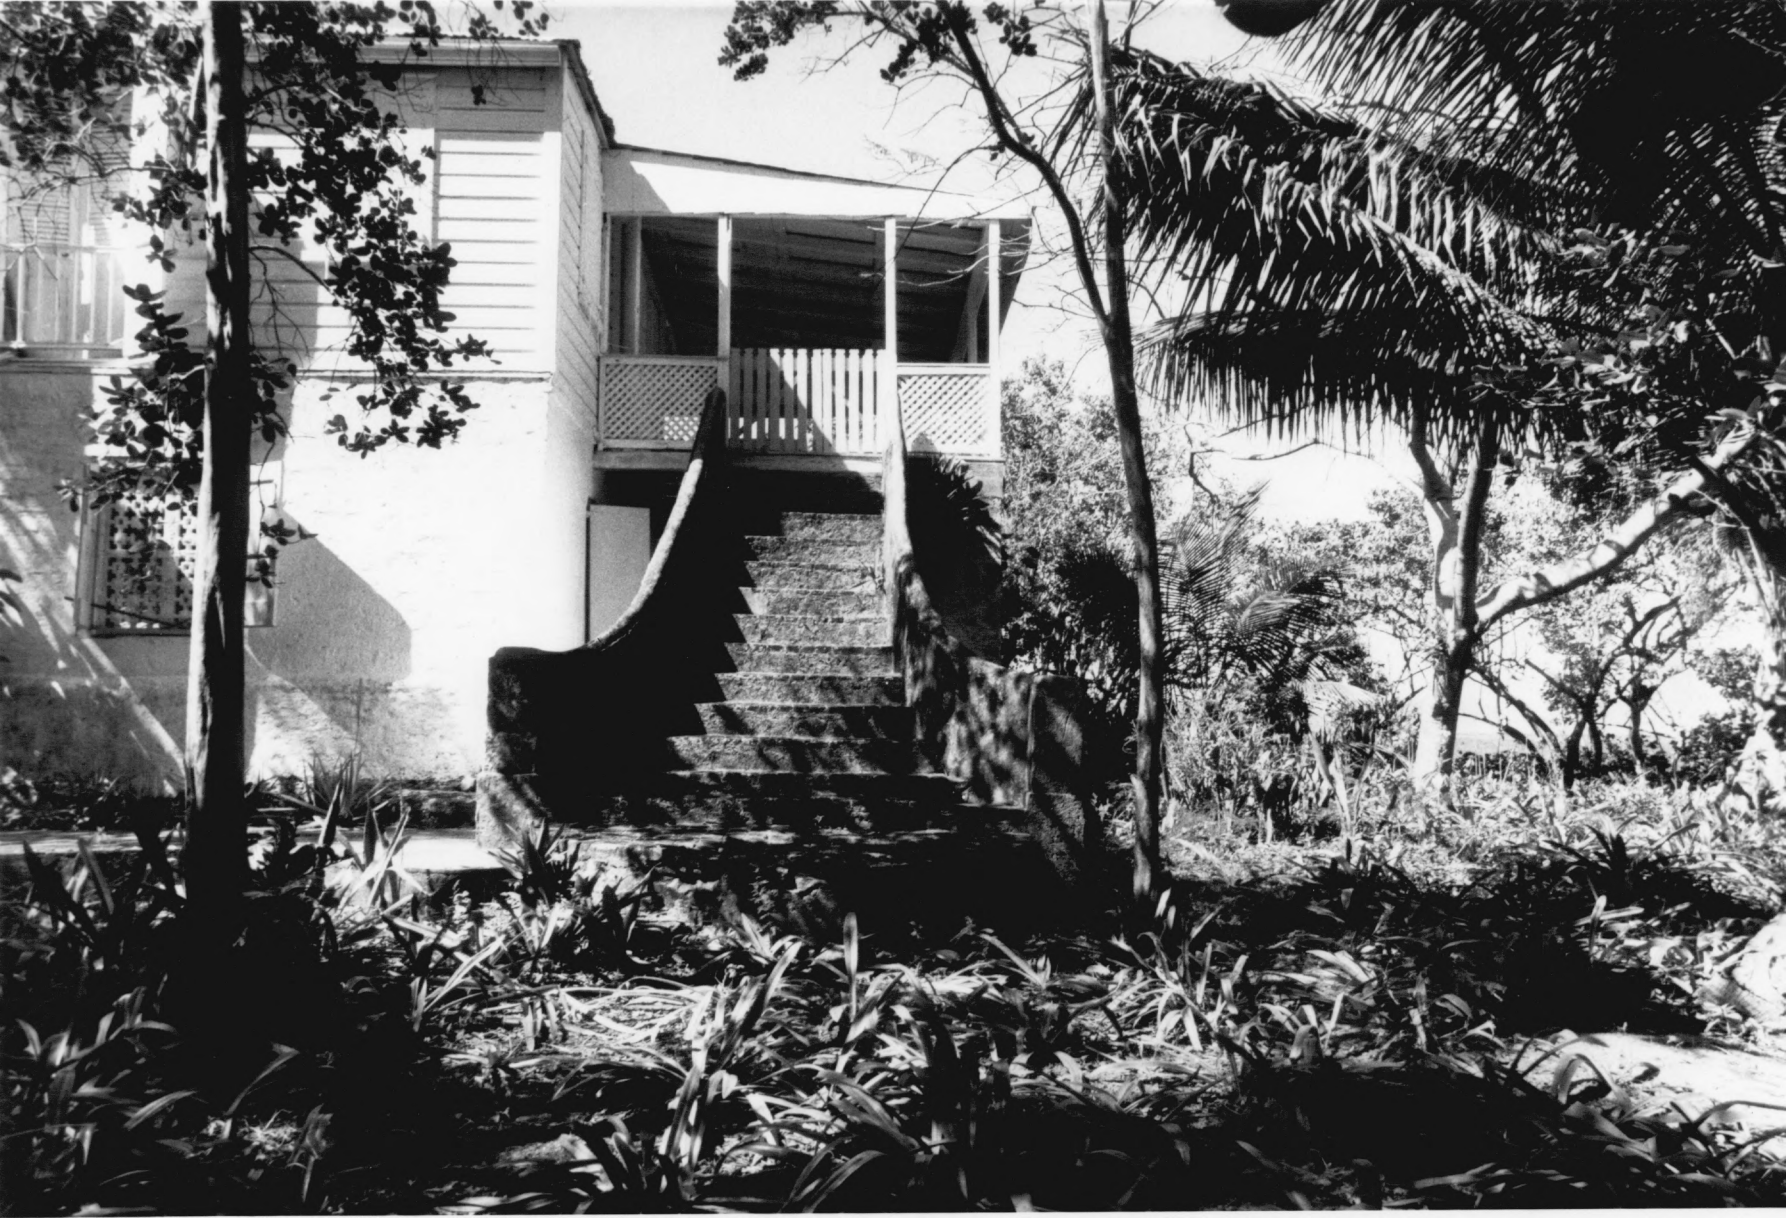
# Plantation House

**Plantation House (H-24, 4) viewed from the south showing the original staircase to second story.**

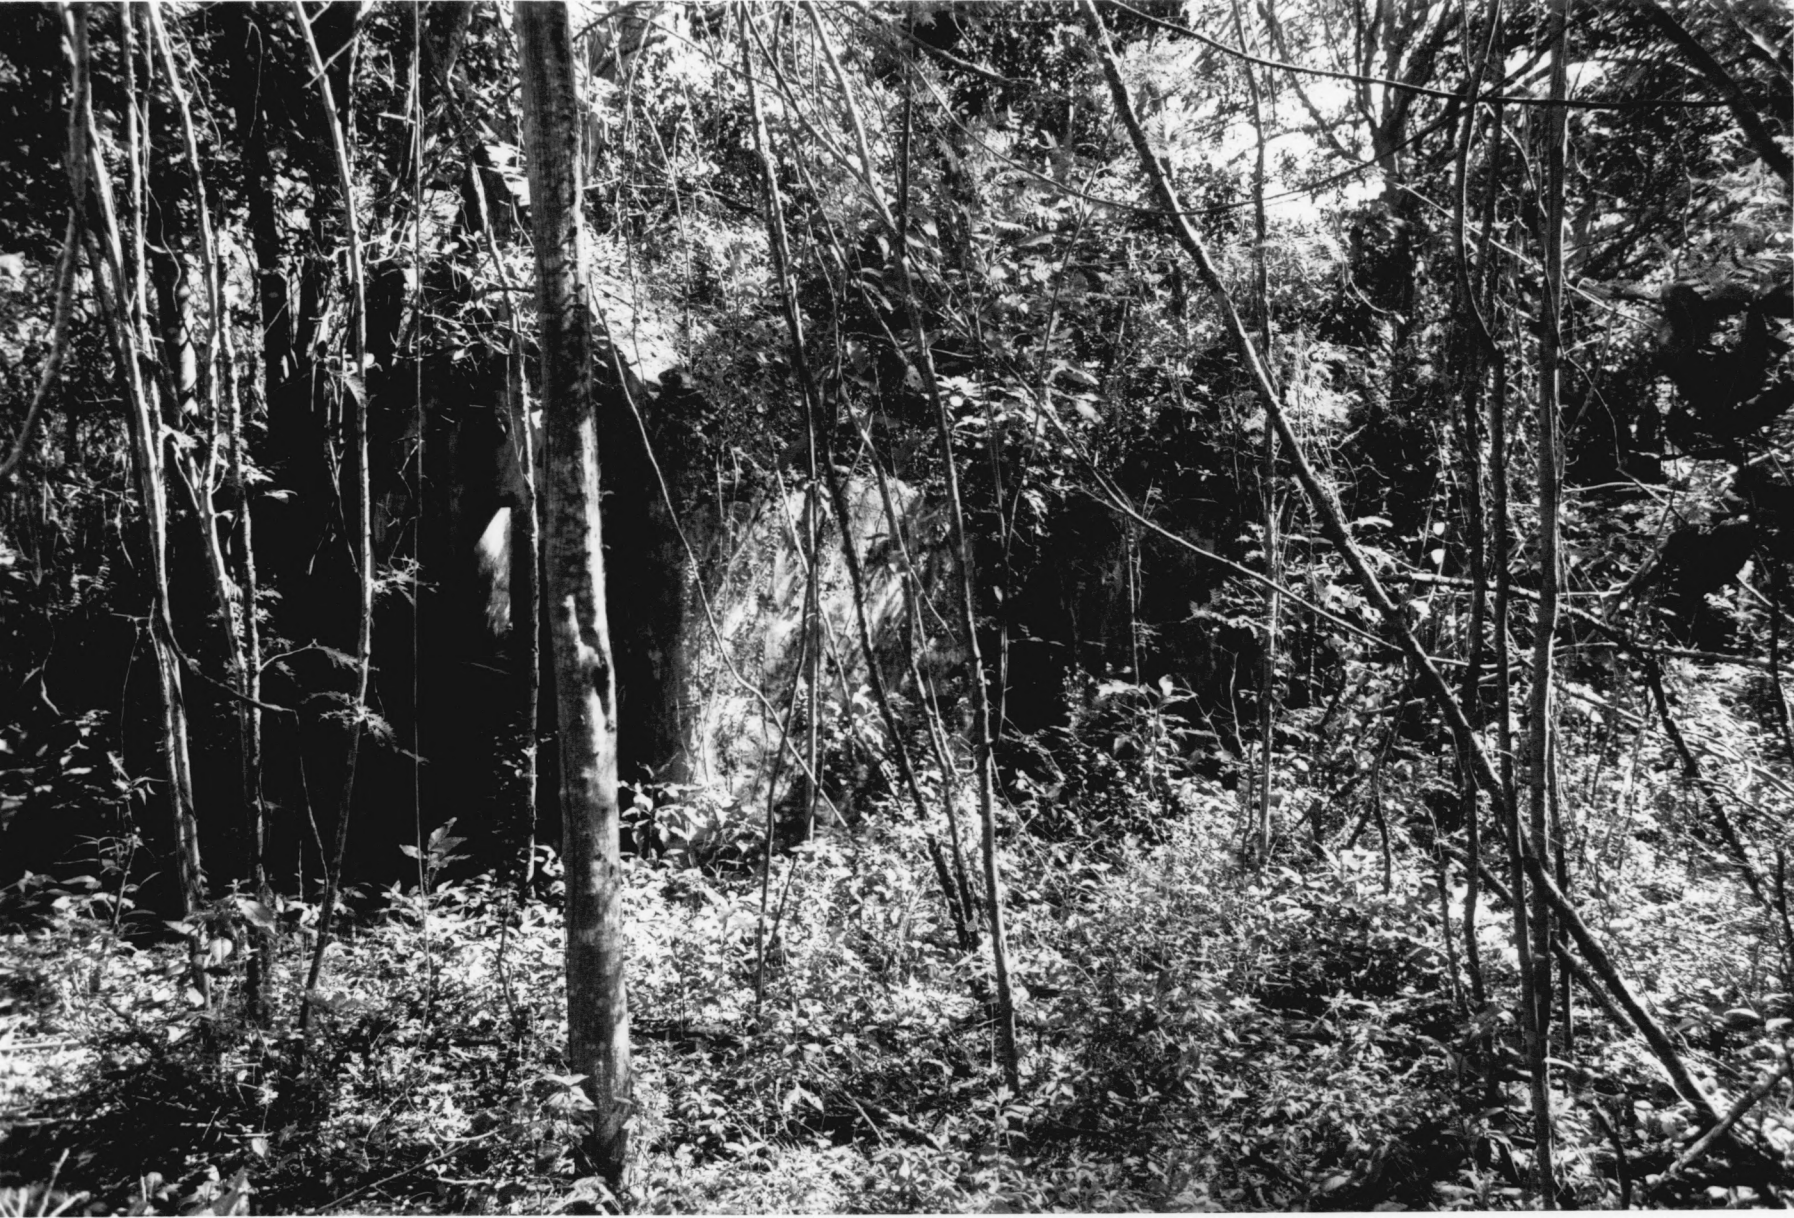
# Slave Cabin

**Slave cabin (24-13) viewed from the northwest.**

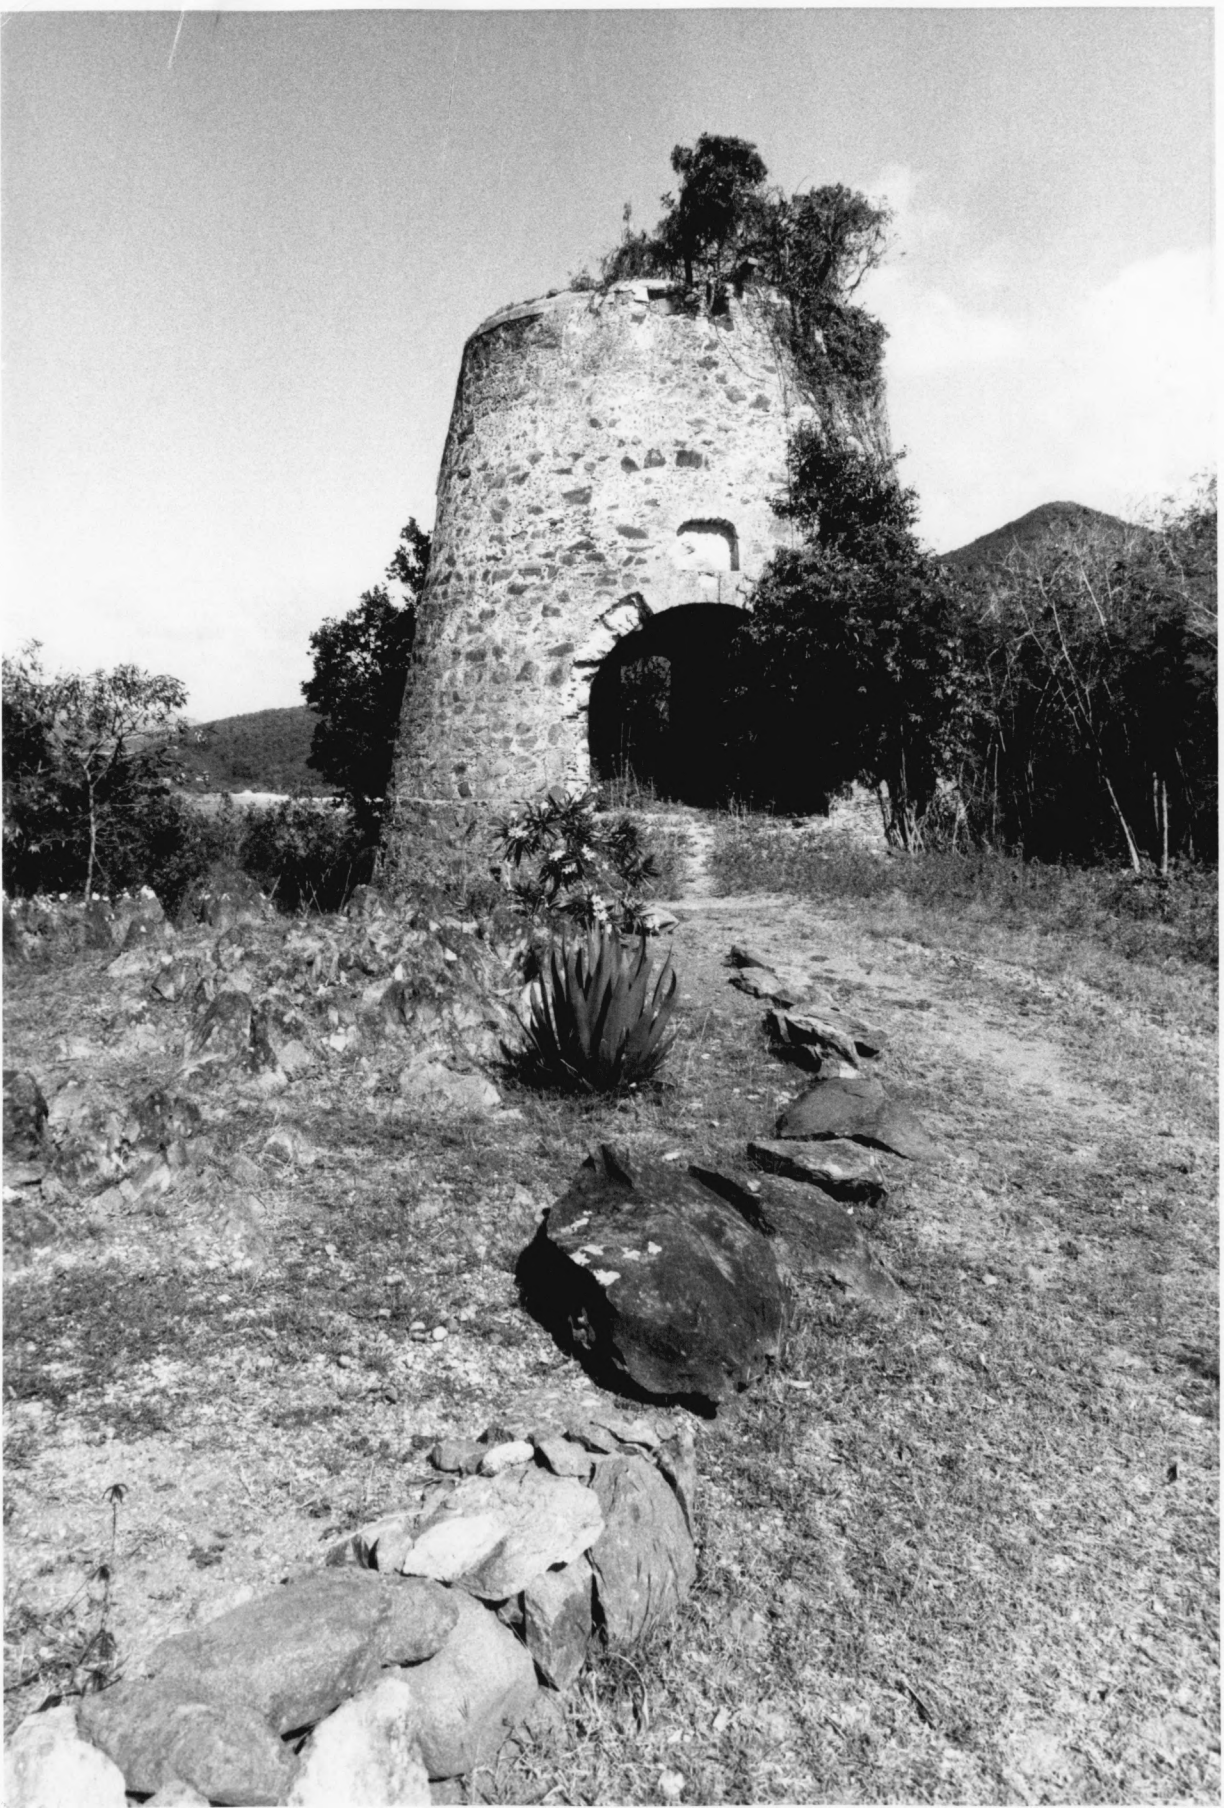
# Mill Tower

Physical Description: A windmill tower is located on the high point of the ridge 250 yds west of the factory. It is a truncated cone circular in plan with a height of 24 - 29'. The floor level of the interior is 4' above the surrounding grade. At floor level the interior diameter is 18' decreasing to 13' at the crown of the tower. The tapered walls have a thickness of 4' at floor level and of 2' at the crown. The entrance to the tower is on the west side. It is a 8½ foot wide archway that is reached by an earth fill ramp. The tall and narrow exchange slit for replacing the interior works faces north. the cane juice gutter led out through an opening towards the south and between it and the entry is the bagasse discharge opening. A fifth opening is opposite the entrance faces east. All openings in the walls have semicircular arches. The entrance has a projecting surround and above the key-stone a shallow niche that probably at one time contained a date stone or the builder's name. The walls still reveal the traces of the interior framing. The interior towards the northeast has a fireplace raised 2' above the floor with a flue spiralling up through the heavy wall and disgorging at the crown above the entrance. There are no remains of the interior works or of the movable wood superstructure that carried the sails. The masonry is in a fair condition only.

The mill tower post dates 1800 and is assumed to have been constructed about 1830.

Dennis Bay Mill Tower H-24, 17 viewed from the east.
