NATIONAL REGISTER OF HISTORIC PLACES  
INVENTORY -- NOMINATION FORM

Lameshur Plantation

#### Lameshur Plantation H-22

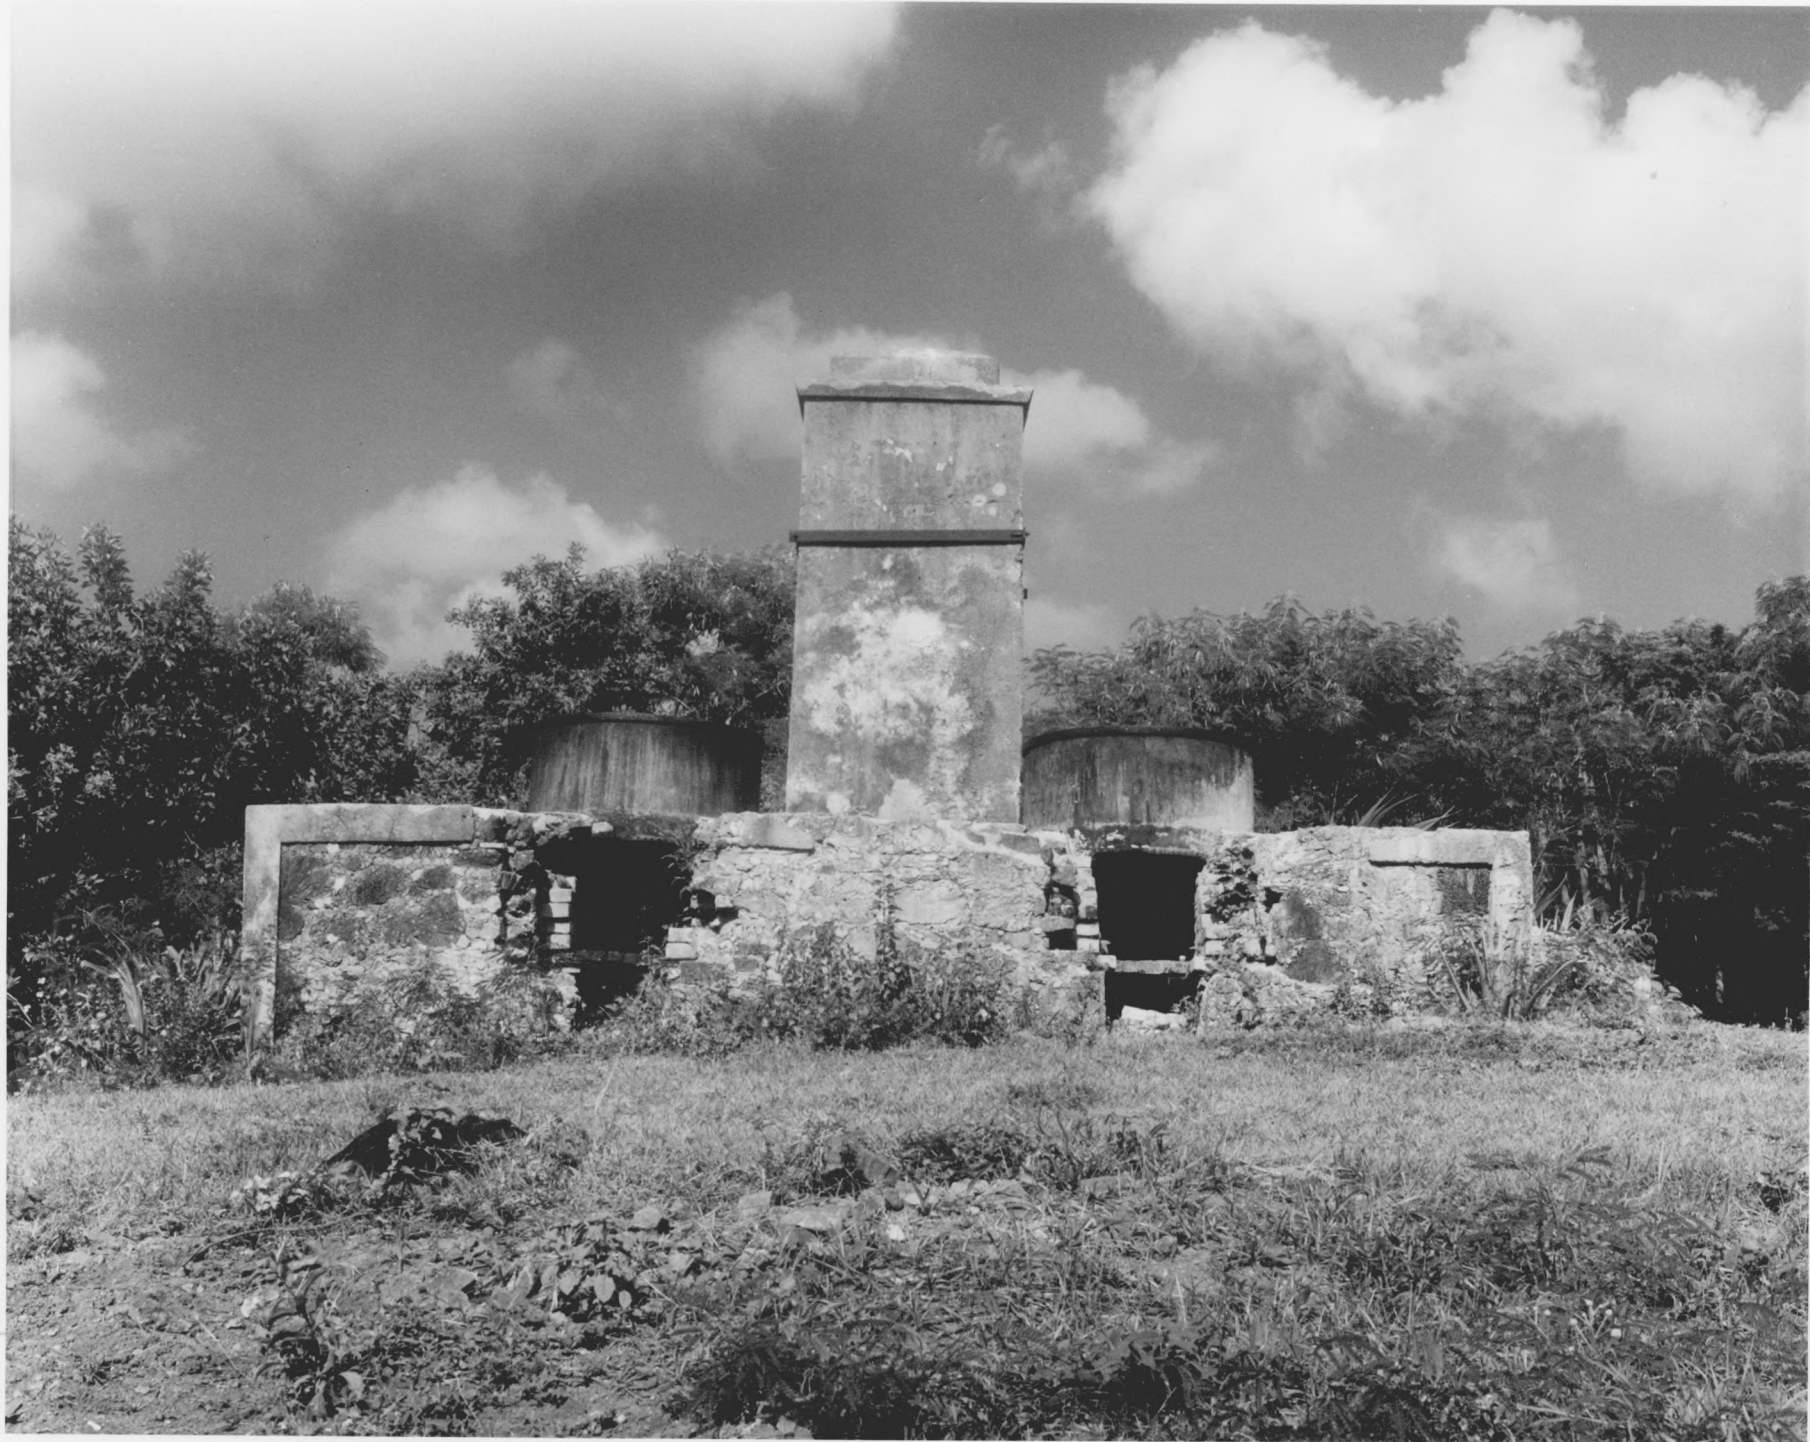
PHOTO NO.  
1 of 8

DESCRIBE VIEW, DIRECTION, ETC. IF DISTRICT. GIVE BUILDING NAME & STREET  
Bay Oil Still viewed from the east.

A fairly well preserved Bay Oil Still is located 17 feet north of the Plantation House (H-22, 3). It is a plastered brick and rubble masonry structure 9 by 20 feet raised from 3 to 5 feet above the sloping grade and with a 14 foot high 4 feet square chimney centered on the west long side. The two large circular straight sided pots of the still are in place while firing doors on the east face of the still have deteriorated and the masonry around them failed.

The structure probably dates from around the turn of the century.

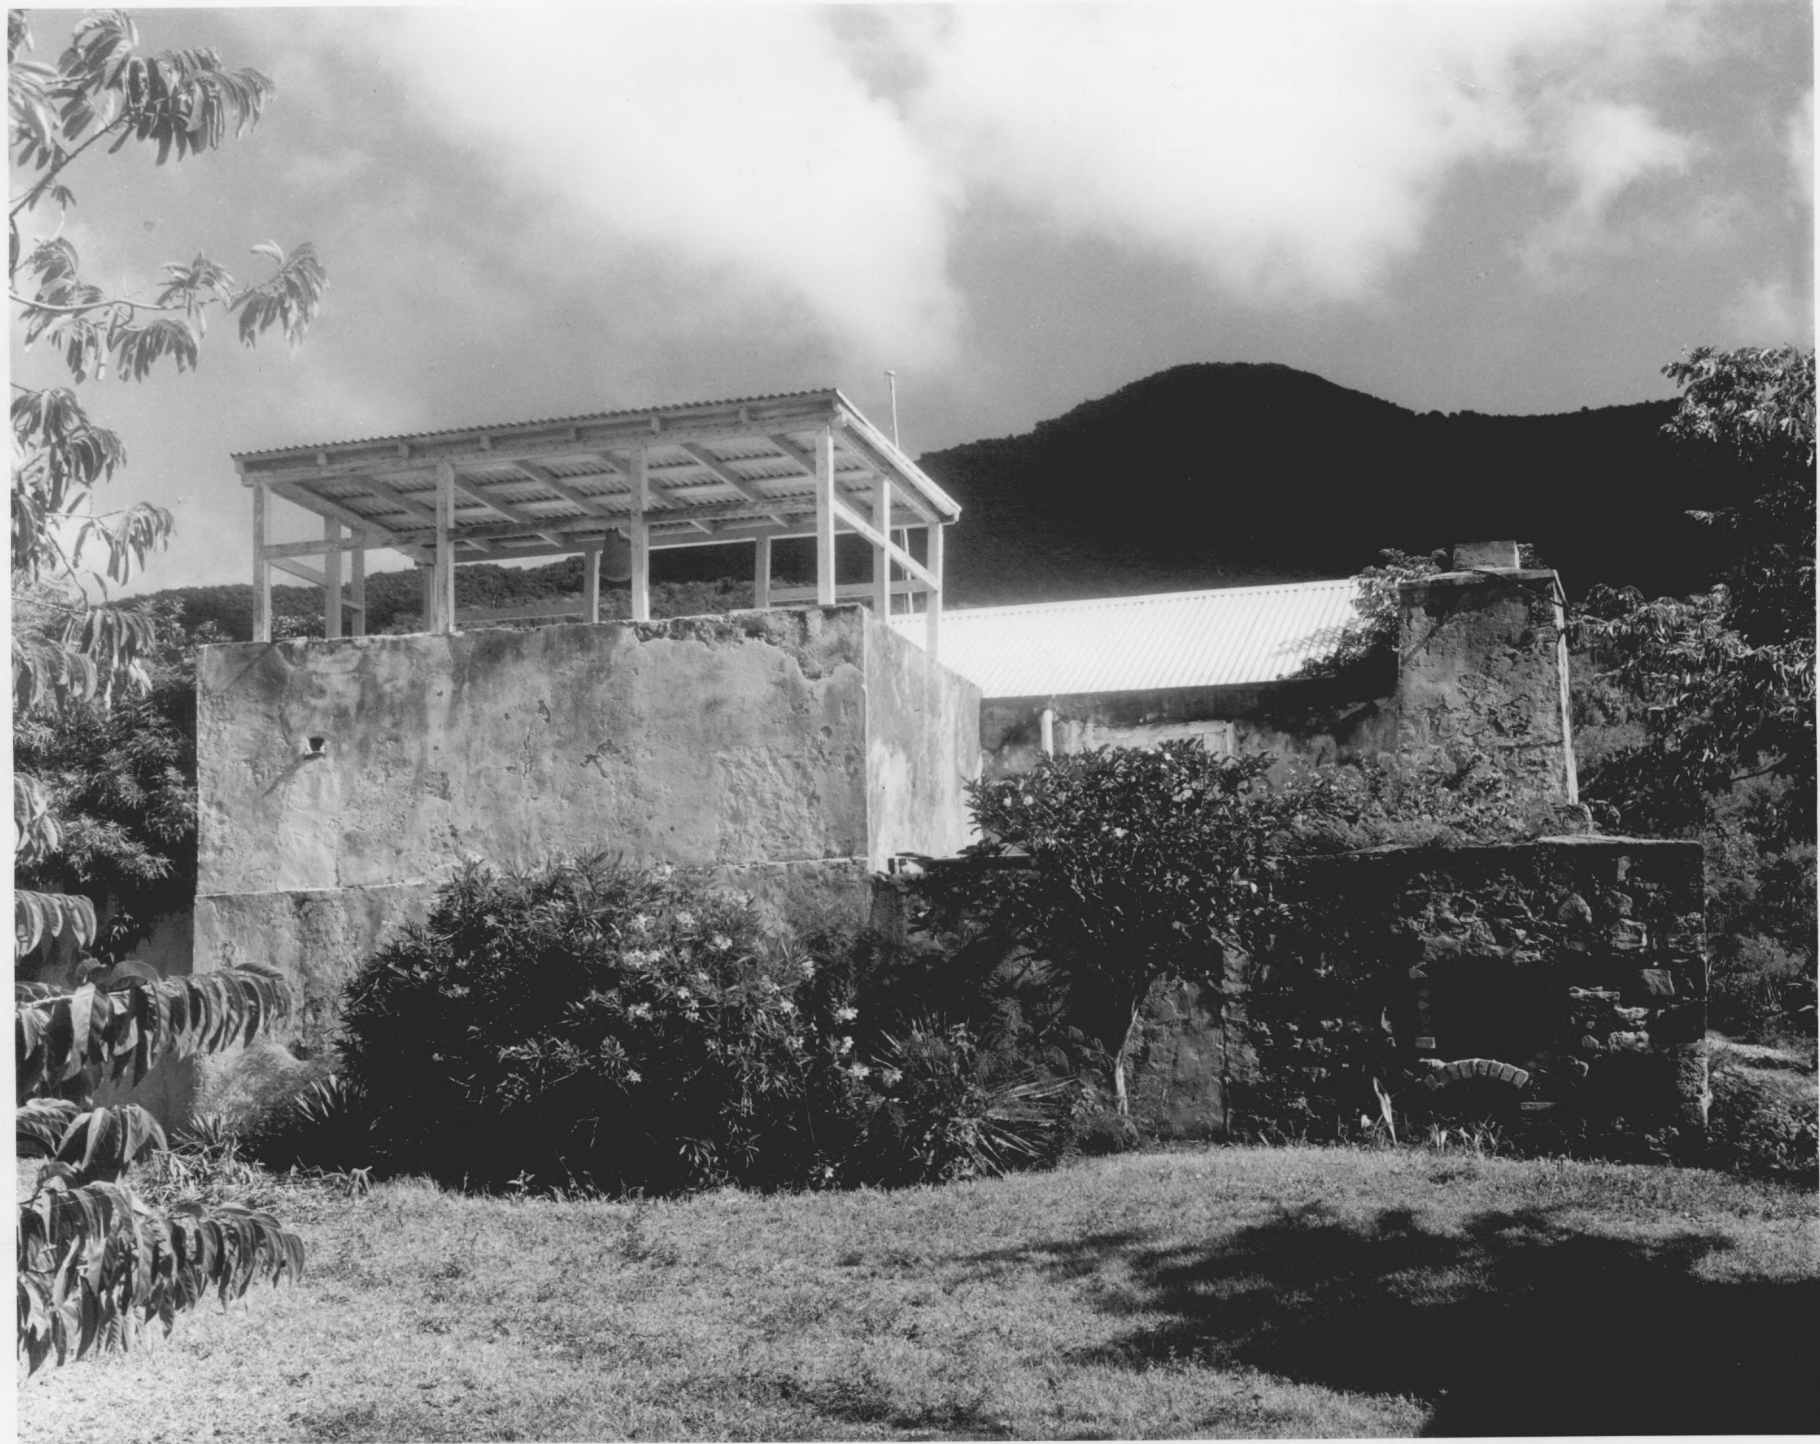
2 of 36

Old Plantation House viewed from the south with  
Bay Oil Still to the right.

The main body of the building is a rectangle 31 by 17 feet covered by a low gable roof. A six foot wide masonry staircase that wraps around the southwest corner of the building provides access to a 16 by 11 foot terrace at near roof level on the south side of the building. The terrace is supported on heavy rubble masonry walls and a vaulted chambre on the ground floor level. A shed roof on wood posts anchored into the masonry railings of the terrace provides shade and protection against rain.

An eight by eleven foot cistern is built against the east wall of the terrace and the main body of the building and a still nine and a half by 12 feet adjoins the east side of the cistern giving the plantation house the overall dimensions of 44 x 28 feet. The walls of both the cistern and the still are 6 feet high or about half as high as the walls of the main body of the building except for the chimney of the still built against the southeast corner of the main body and rising 3 feet above its walls. Access to the single room interior of the main body is by two doors in respectively the east and west gable ends and ventilation is provided by one window in the south wall over the cistern and three windows in the north wall.

Both the still and the cistern are additions to the original structure which seems to have been preserved in the main body and in the masonry staircase. In its original form the plantation house appears to have had a masonry ground floor (the main body) supporting a wood second floor that contained the residence proper and was reached by the very substantial and pretentious staircase.

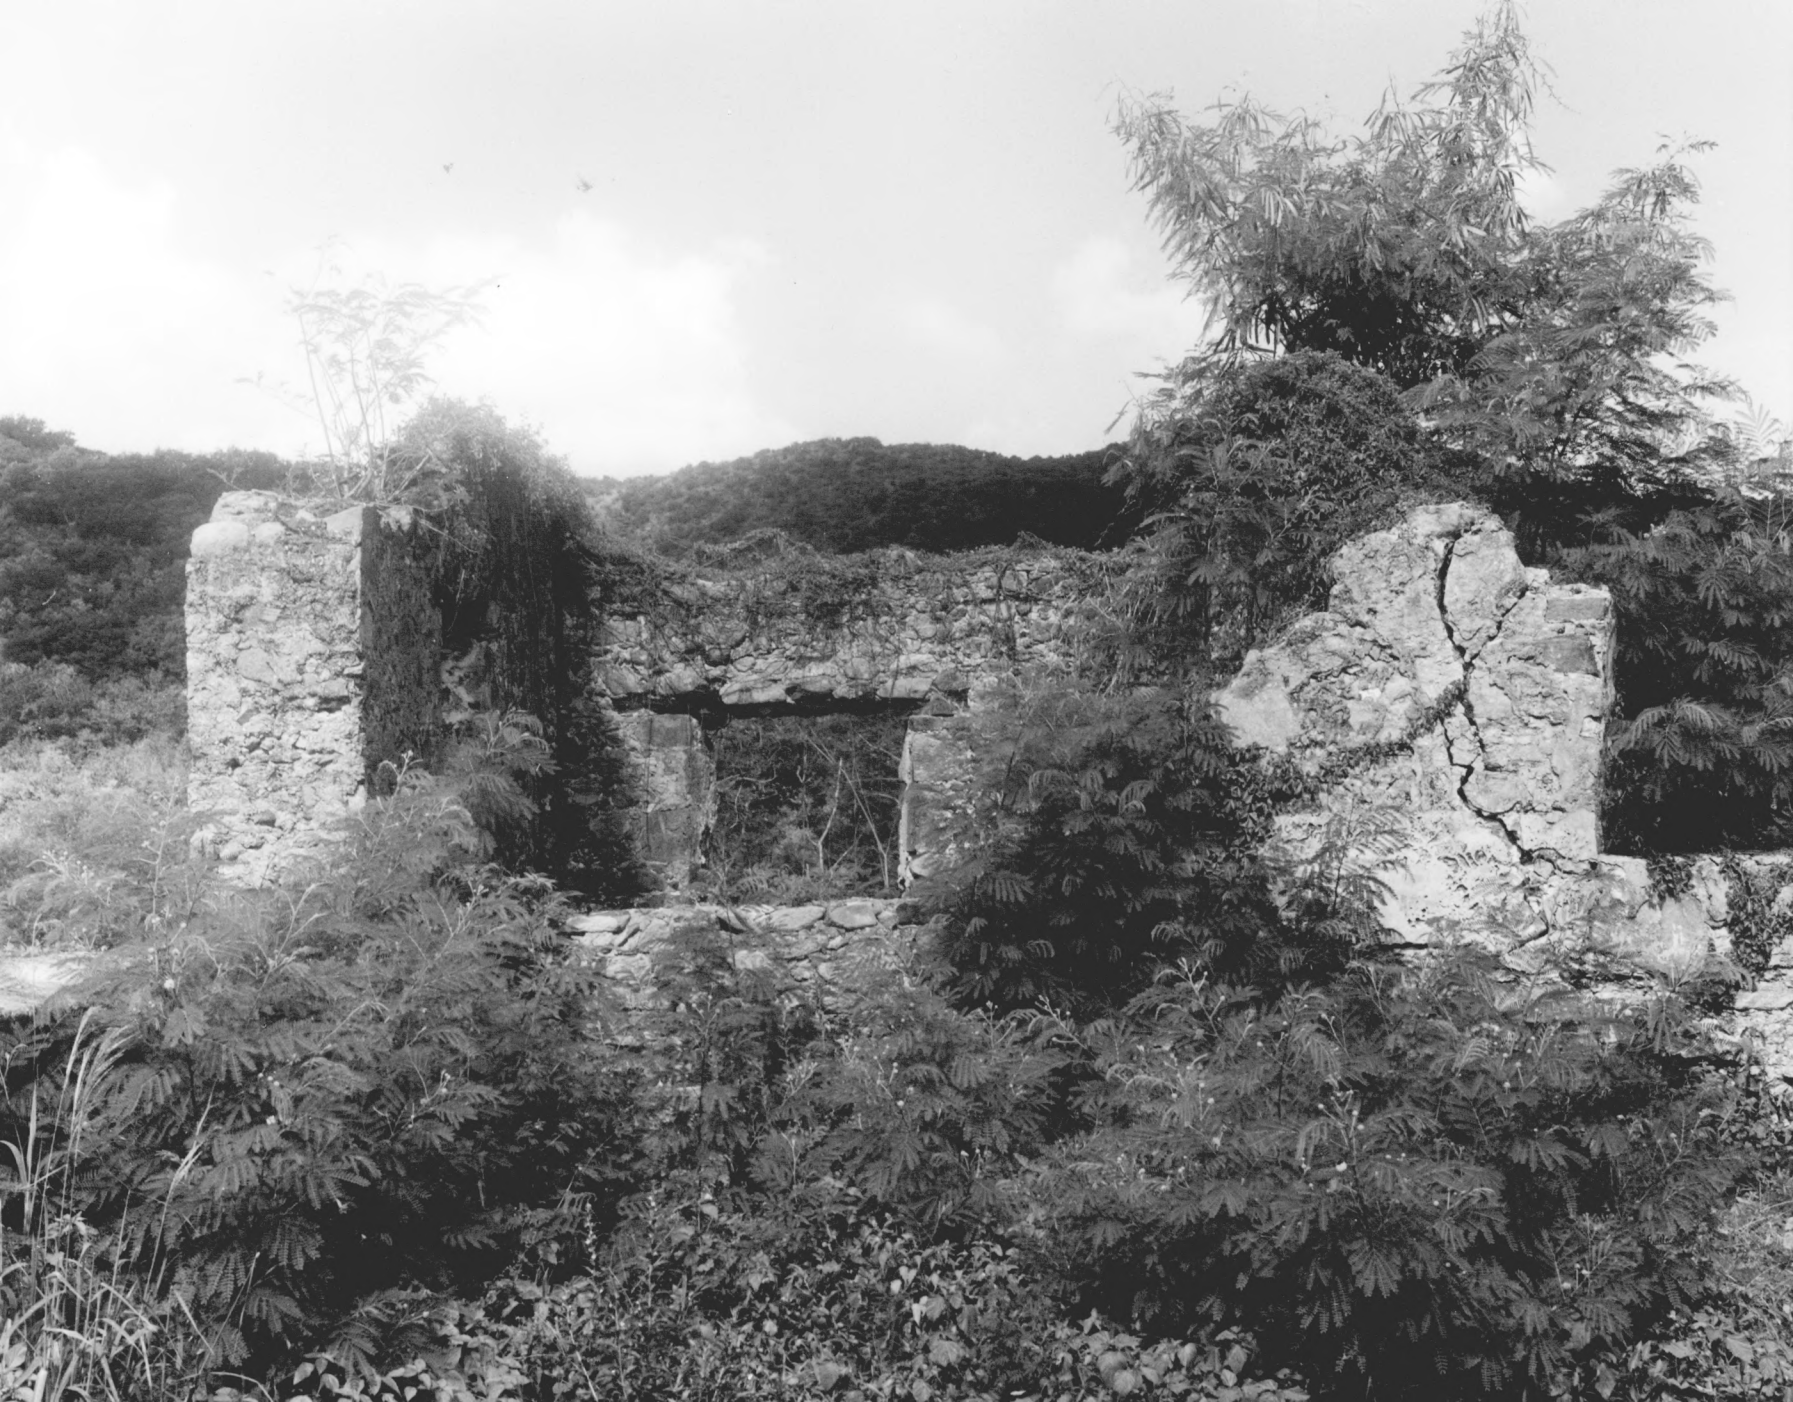
3 of 3

Storage wing of factory viewed from the east.

trench at a lower level terminated in a storage and curing room at the southwest corner of the building. The storage and curing room was converted into a cistern 13 feet square at a slightly lower level than the firing trench. The trench was roofed and the remains of the four 2 feet square piers that supported the roof are still apparent as are the remains of the footings of the flue and chimney at the northwest corner of the factory. At an unknown date after the discontinuance of the sugar production and after the collapse or demolition of the factory the south and north wall of the boiling house were extended eastward 15 feet and connected by a 4 foot high rubble masonry wall with a gate in the added east wall 8 feet from the northeast corner to form a cattle pen. The added east wall was extended 12 feet north to connect with a freestanding cistern 9 x 16 feet. Subsequently a wood shed 19 x 11 feet was erected against the old wall of the factory between it and the horsemill.

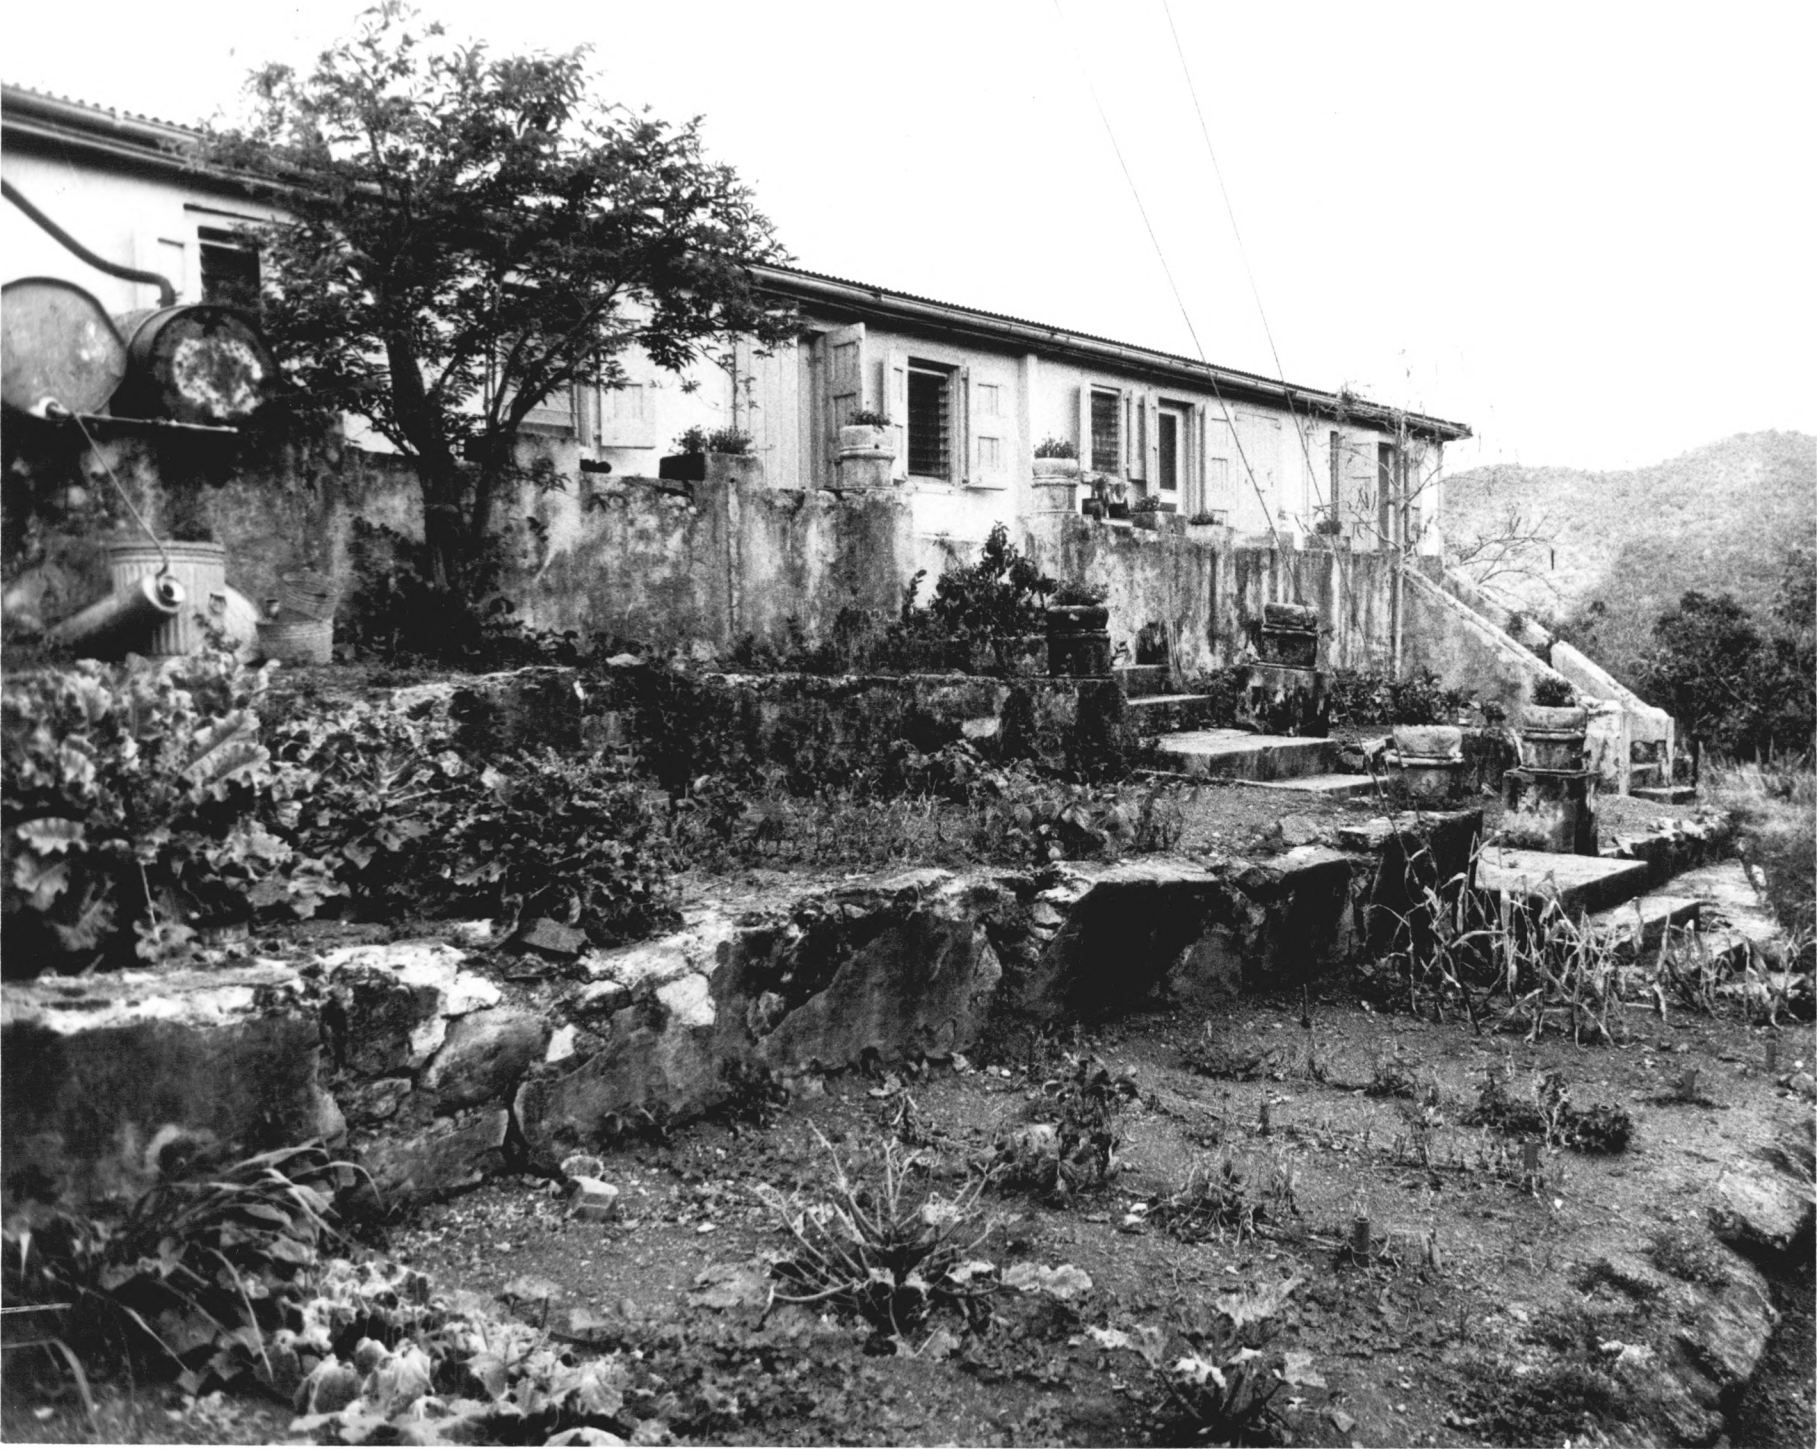
PHOTO NO. 4 of 6

Great House H-22, 10 northside of Great House viewed from  
the southwest.

Lameshur Plantation Great House and its associated service buildings are located on a spur of the hillside 300 yards northeast of the factory. The Great House is a rectangular one story masonry structure 32 by 61 feet oriented east-west with a wing extending 13 feet south and 10 feet west of the main body of the building and connecting it with an above grade masonry covered cistern 11 by 21 feet on the sloping ground southwest of the building. The northern two-thirds of the main body of the great house has a hipped roof that on the south side continues into a shed roof. The wing to the south and west is covered with a shed roof sloping west. The roofing throughout is corrugated metal. The front of the building faces south and overlooks Lameshur Bay. Steps lead up to an enclosed porch that occupies the center half of the south side of the house and is embellished by four squat columns faintly reminiscent of ~~mayan~~ forebearers supporting the shed roof above it.

A 7 foot wide paved terrace runs along the northside of the building. Two masonry staircases lead from the terrace down to the lower grades north of the Great House.

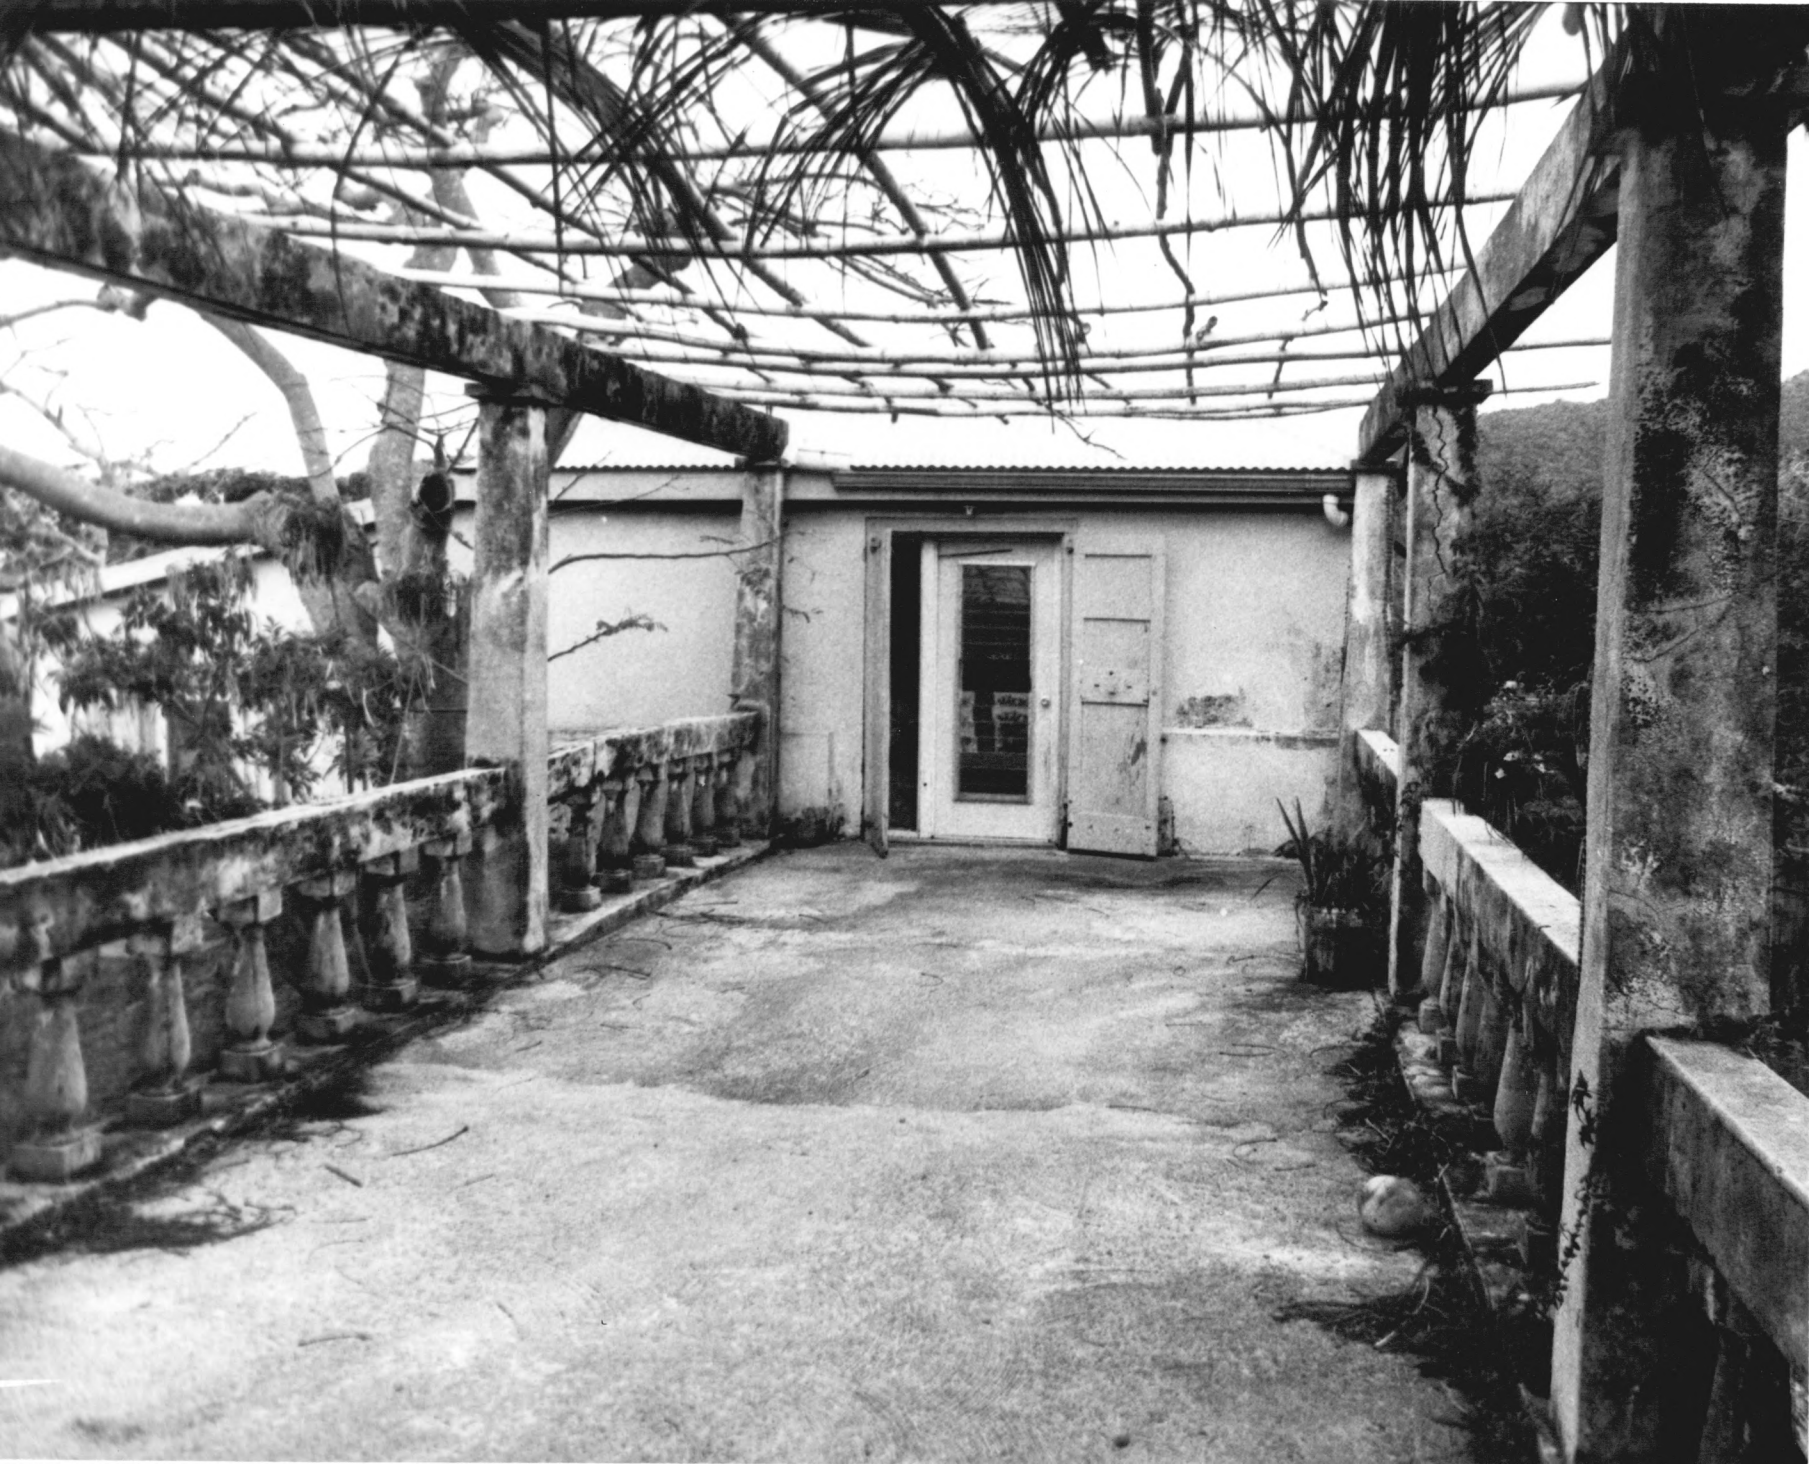
PHOTO NO. 5 of 6

East side of Great House H-22, 10 showing part of terrace  
and pergola.

A 12 by 29 foot paved terrace extends east from the building and is defined by cast concrete balustrades. The terrace is covered by a pergola supported on square concrete posts. At its east end where the level of the terrace is 4 feet above the grade a masonry staircase leads down to the access road that from the Lameshur-Bordeaux trail west and north of the Great House branches off to pass east and south of the building.

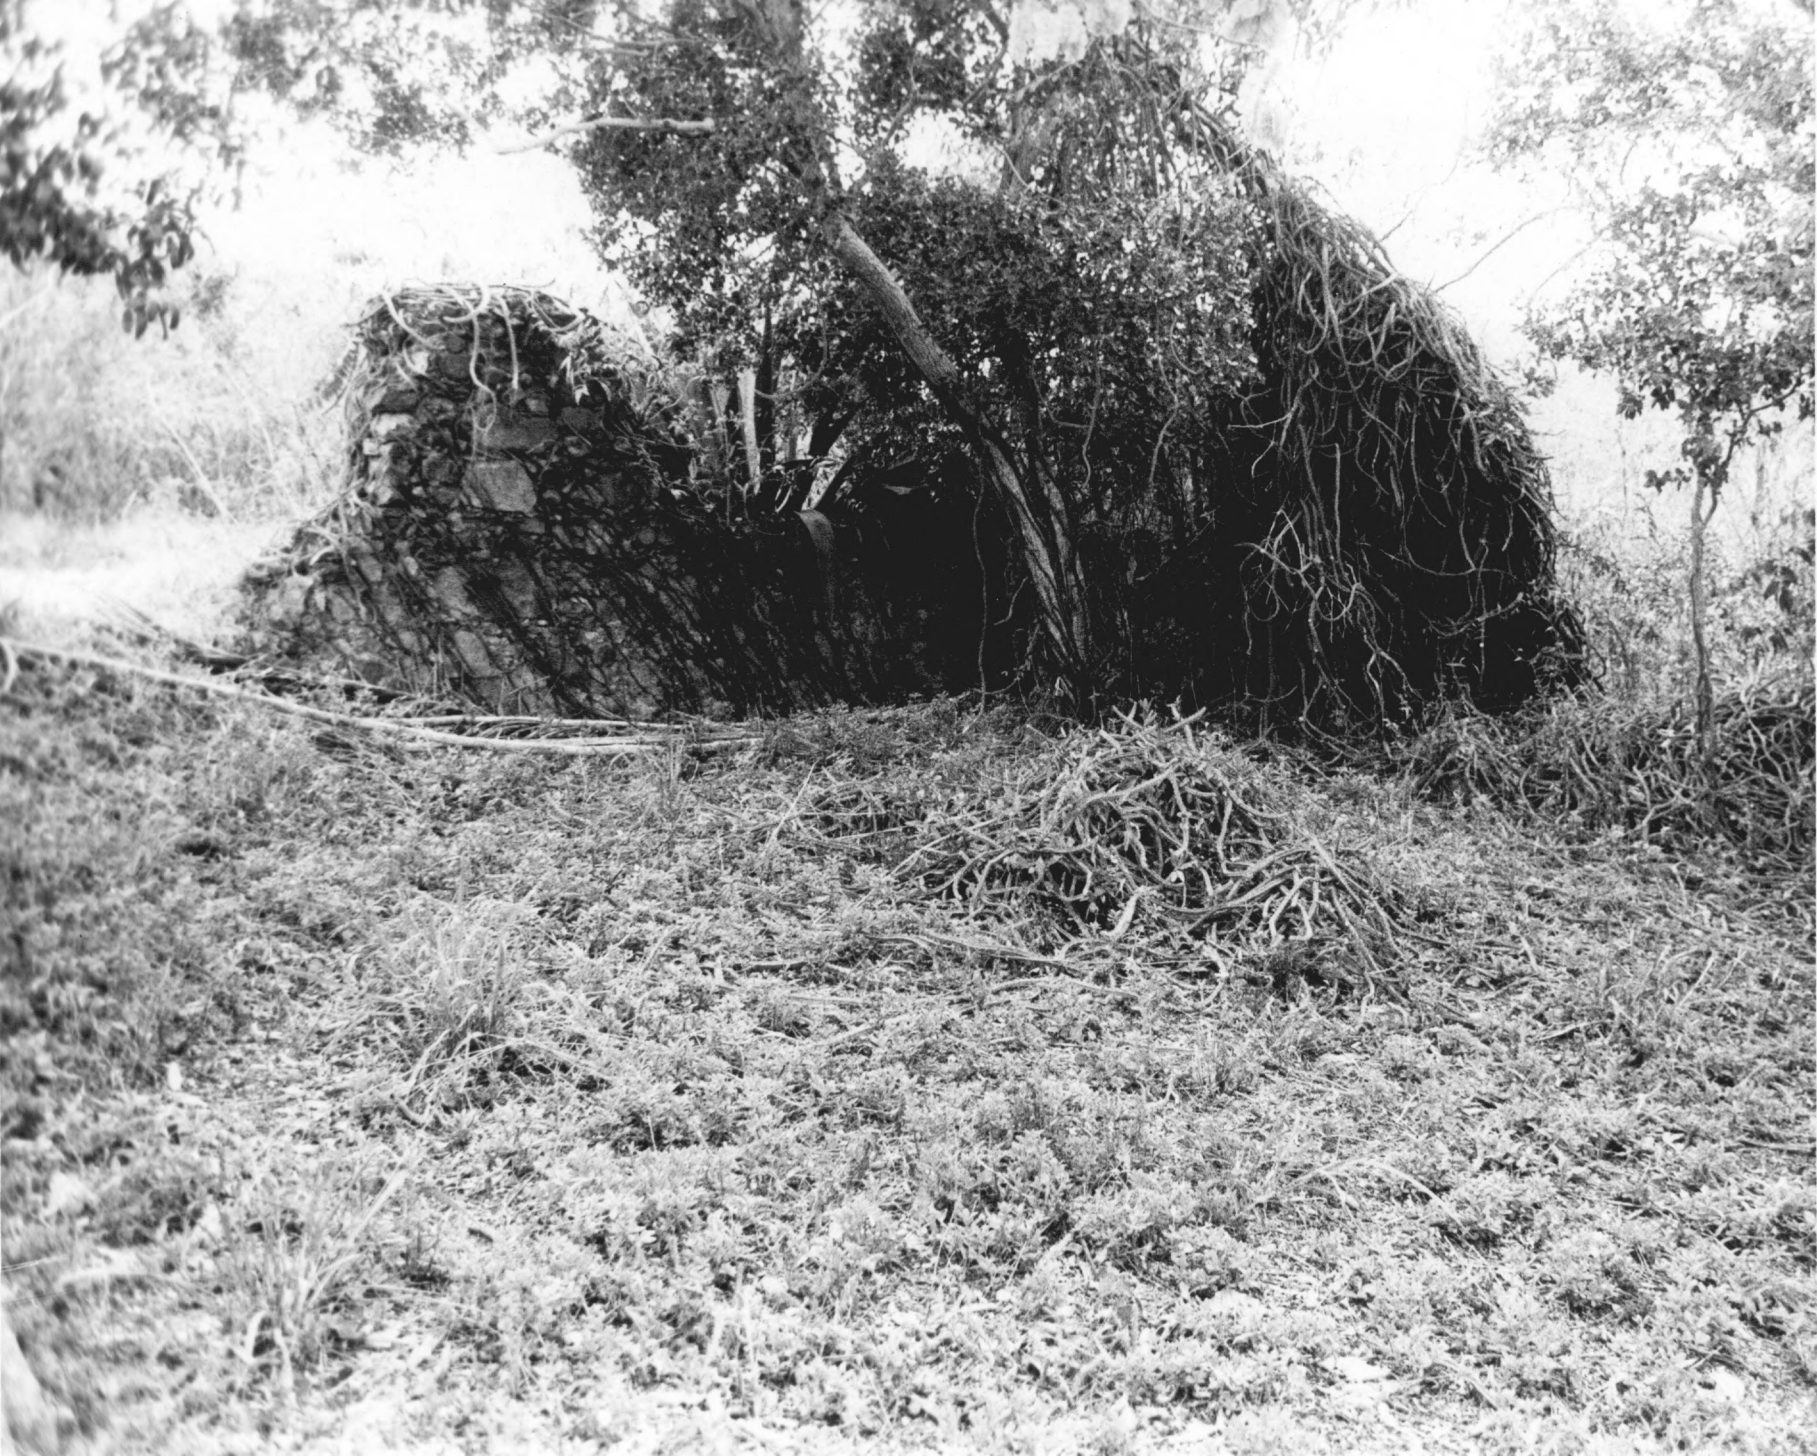
PHOTO NO. 6 of 6

Cook House H-22, 11 viewed from the southwest.

The ruins of a cook house is located approximately 40 feet east of the Great House. The rubble masonry walls of the north and east side of the building stand 6 feet above grade while the south and west walls have collapsed.
