ATTACHMENT A

COMPARISON OF  
GERAGHTY AND MILLER'S AND CDM FPC'S  
INTERPRETATION OF FRACTURE TRACES  
IN THE IMMEDIATE VICINITY  
OF THE TUTU WELL FIELD SITE

Tutu Well Field Site  
Work Assignment C02048

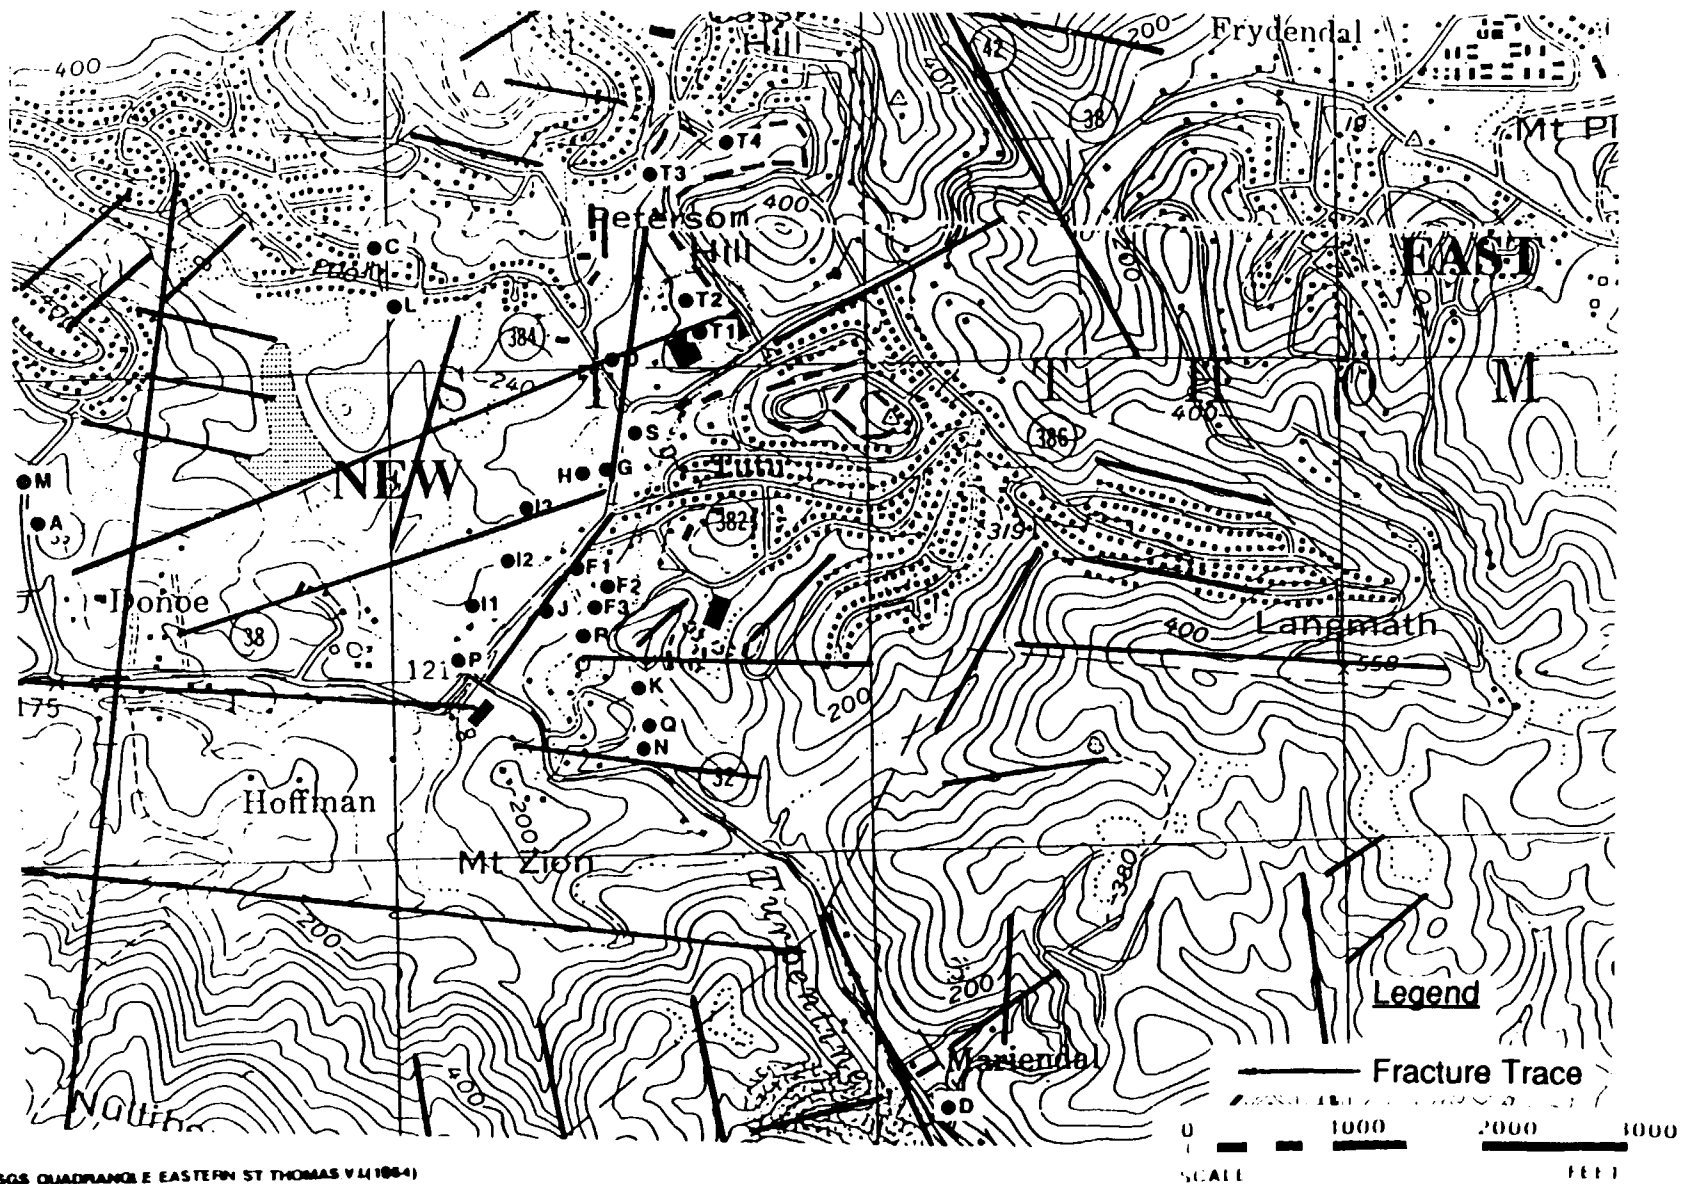
Figure 1

Geraghty and Miller Interpretation of  
Fracture Traces in Technical Memorandum I  
April 10, 1992

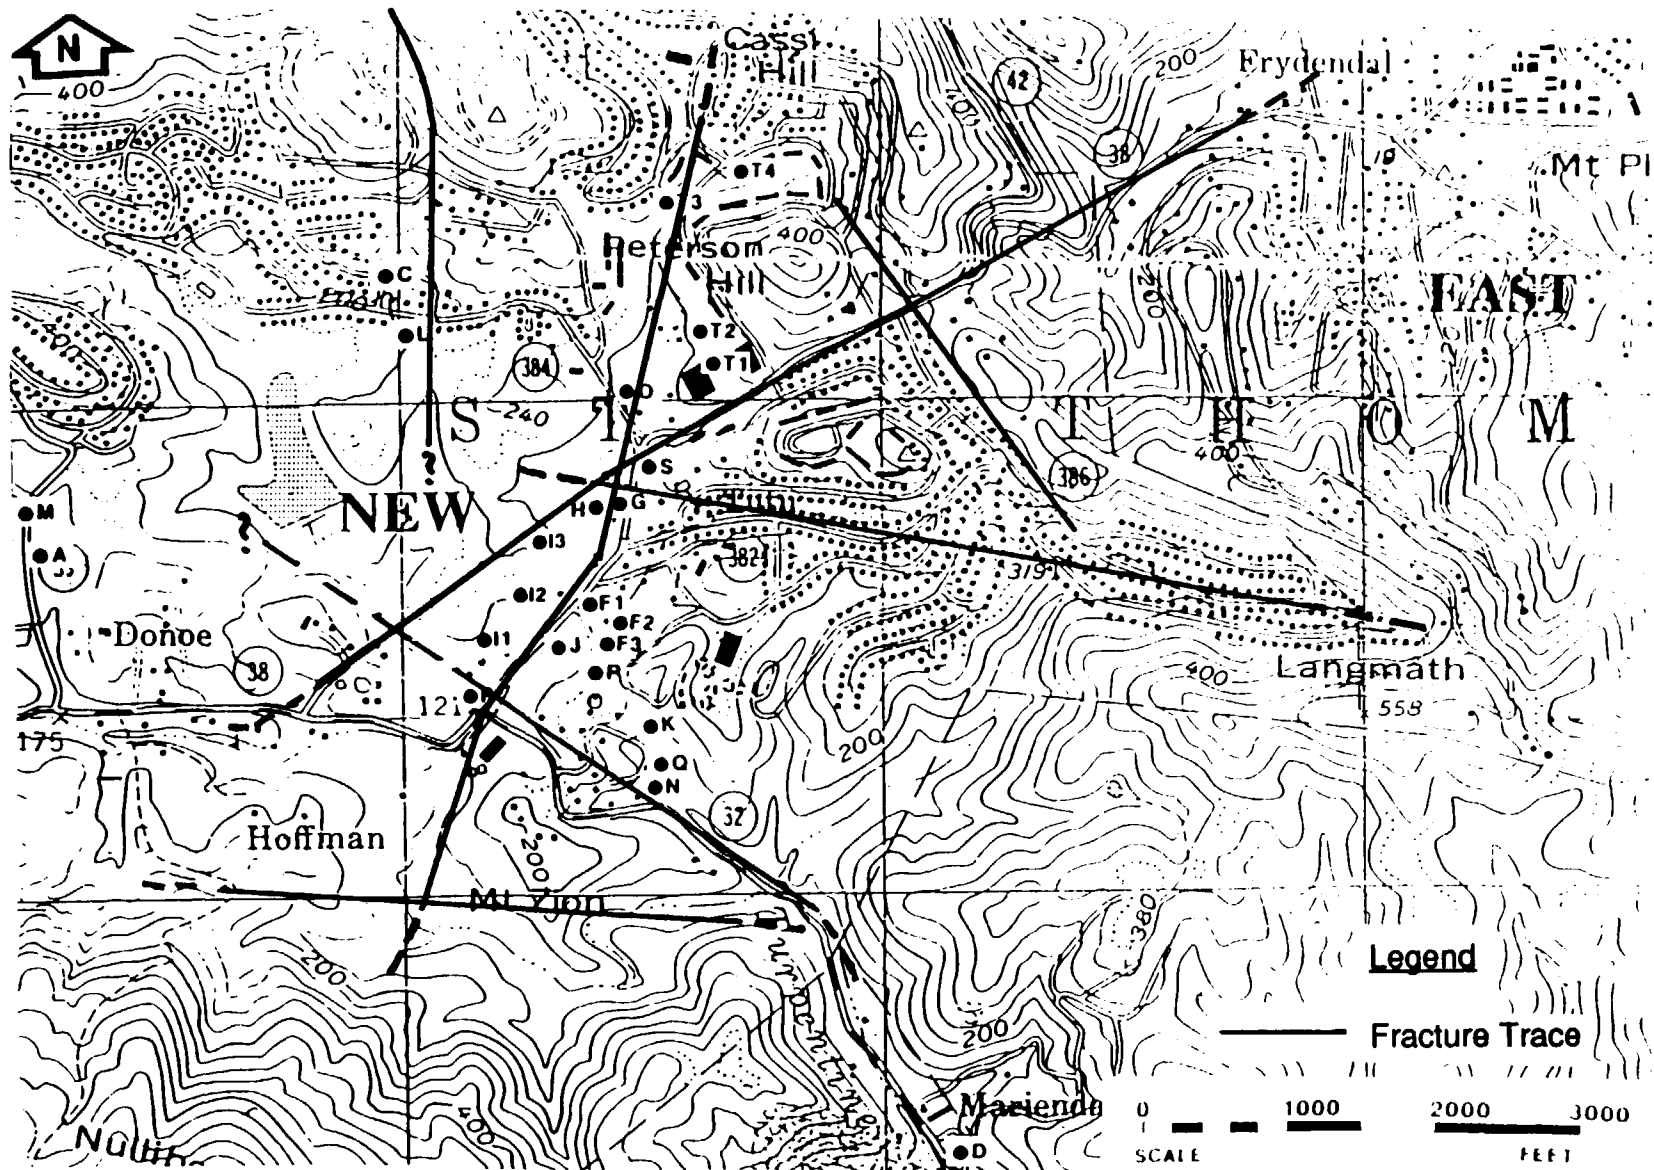
Figure 2

CDM FPC Interpretation of  
Fracture Traces in the Area of the Site
