DATE: Preliminary Assessment, Removal Site Evaluation, and Funding  
SUBJECT: Authorization Request for a CERCLA Removal Action at the Virgin  
Island Chemical Company, Inc. Site, St. Croix, U.S. Virgin  
Islands - ACTION MEMORANDUM  
FROM: Douglas R. Kodama, On-Scene Coordinator *Douglas R. Kodama*  
Response and Prevention Branch  
TO: William J. Muszynski, P.E.  
Acting Regional Administrator  
THRU: *John S. Amico* Stephen D. Luftig, Director  
Emergency and Remedial Response Division

I. EXECUTIVE SUMMARY

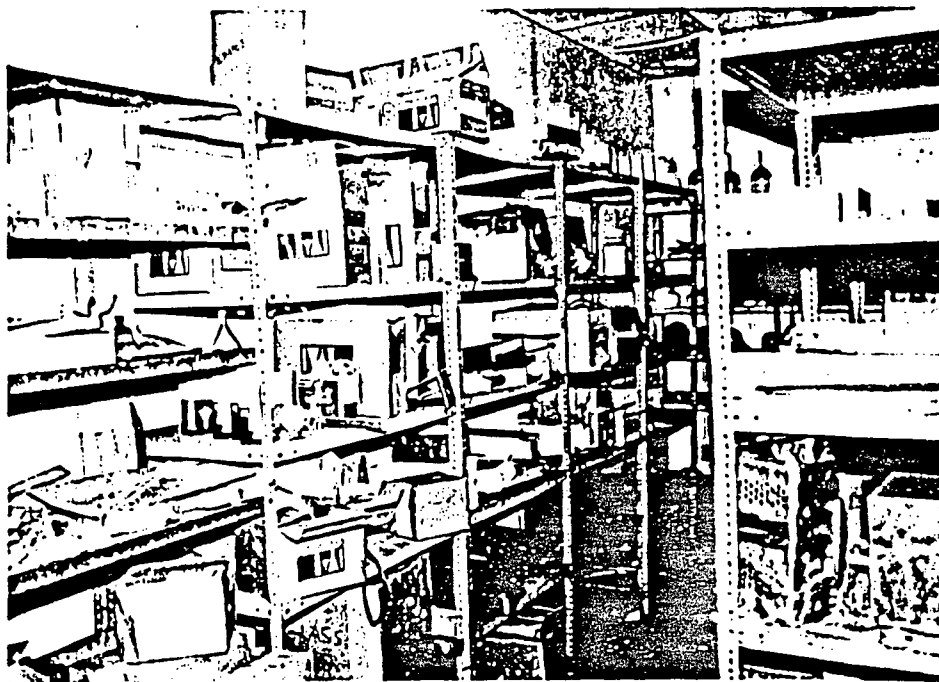
Photo #8. Area 18 chemical and glassware storage

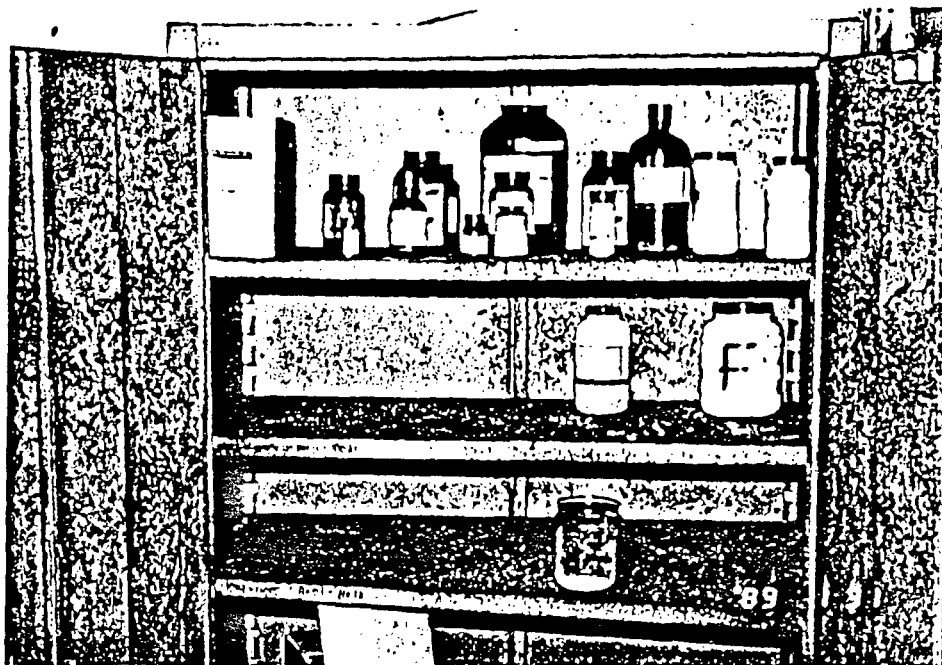
Incompatible materials are stored in close proximity in the laboratories and the warehouse. In addition, the potential for adverse reactions is real and will continue to increase as the chemicals age in a hot and humid climate and are subject to persistent winds laden with saline moisture from the Caribbean Sea and rain water from the leaking warehouse roof. At least three examples of reactions taking place are evident in the drum storage area. These consist of one bulging drum and two drums in which an unknown crystalline material has exerted enough pressure to push open the drum lids and dispersed this material to the surrounding floor (photo #16). An unknown lab reagent has leaked its contents within one of the reagent storage closets (photo #10 and #11).

Photo #9. Incompatible storage of lab reagents

- 4) Segregate materials by hazard class, and separate incompatible materials. Relocate and stage all overpacked containers in an area of the warehouse where they will not be impacted by rain water from the leaking roof. If dry warehouse space is limited, overpacked drums will be placed on pallets and covered with waterproof tarps.

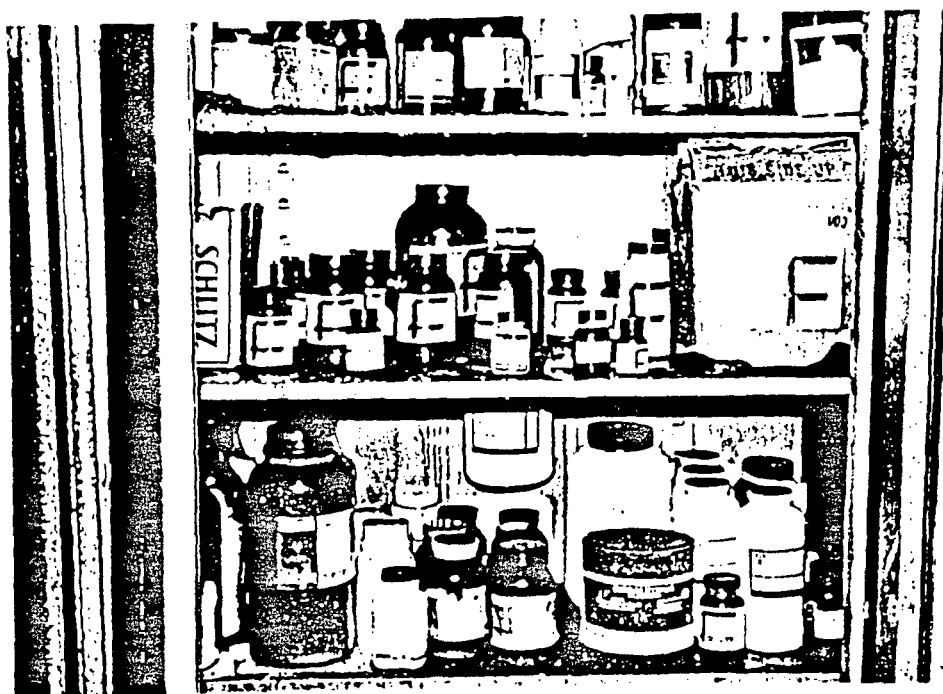
Photo #10. Incompatible and leaking storage of lab reagents

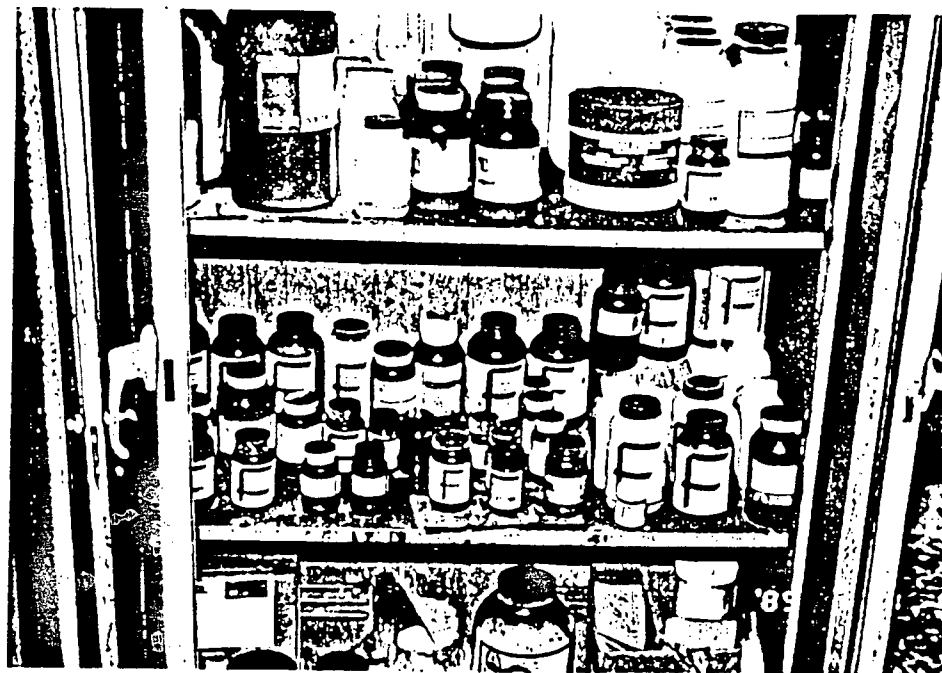
Photo #11. Incompatible and leaking storage of lab reagents

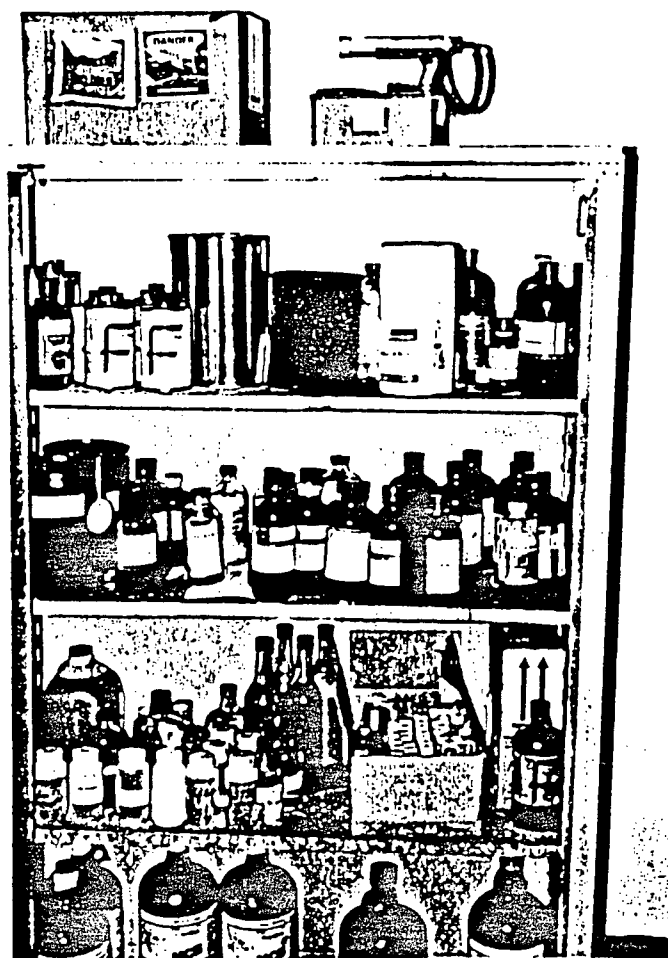
Photo #12. Incompatible storage of lab reagents

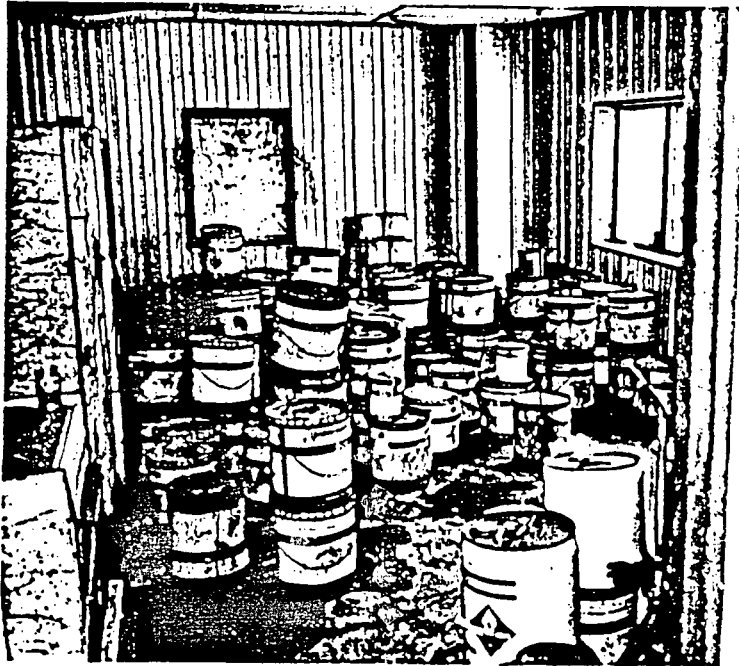
Photo #13. Paint cans in area 1

VIChem has indicated that it would not object to or obstruct EPA's performance of the removal action described herein. EPA will also seek VIAG's and SCSK's agreement to not operate or have personnel (or dogs) on-site during working hours of the removal action or if conditions at the site (stability) warrant evacuating the site of non-essential personnel. It may be desirable to have SCSK maintain site security during interim periods when EPA has temporarily demobilized for analytical and transportation/disposal coordination. The dog kennel is a very effective deterrent for potential trespassers or vandals. Further, EPA will seek to ensure that VIAG properly removes its numerous paint cans and two drums of water treatment chemicals at the site.

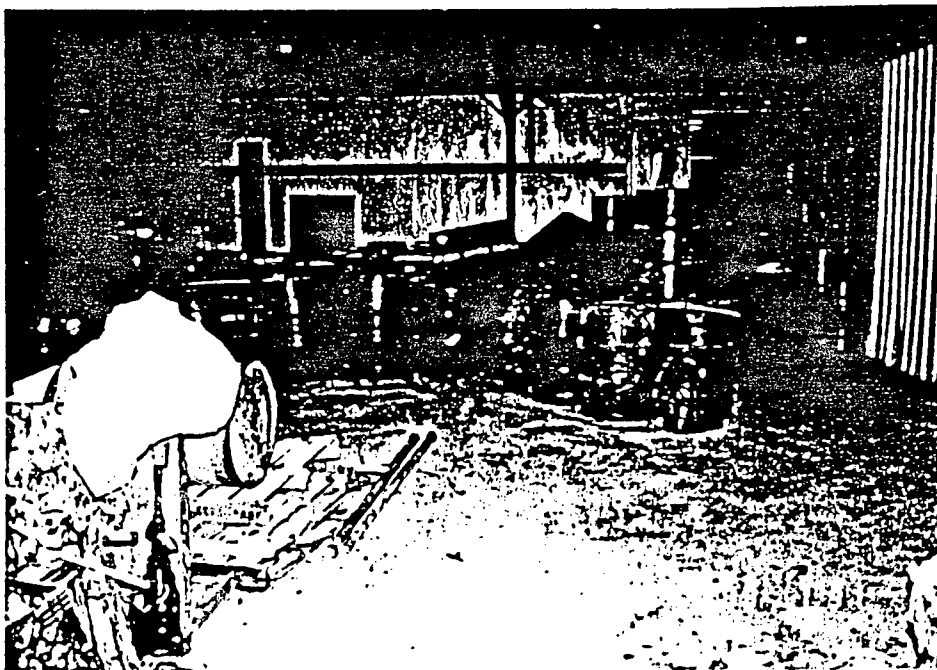
The deterioration of these containers has been accelerated by leaks in the warehouse roof, causing portions of the warehouse floor to be flooded after it rains. The accumulation of rain water on the floor allows spilled materials to mix and is eventually discharged to the ground east of the warehouse near the septic tank.

Photo #15. Drums in area 4; note water on the floor

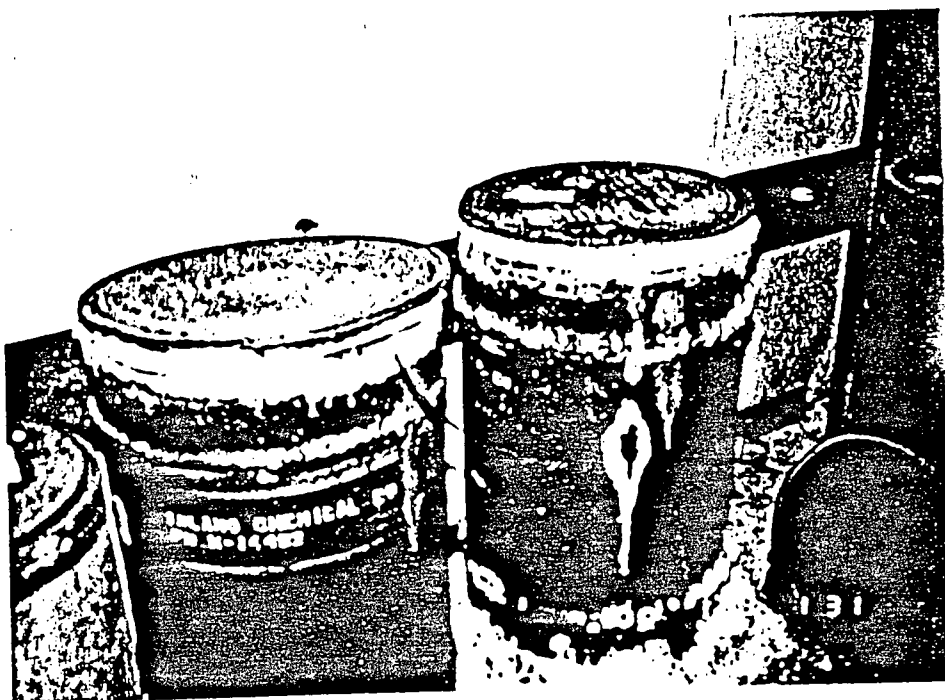
containers include a cylinder of chlorine, one cylinder of hydrogen chloride, one unlabeled bulging drum, two drums with unknown contents in which a reaction has taken place causing the lids to come off and dispersing a white crystalline material, one drum of sulfamic acid which is broken and is leaking its contents.

Photo #16. Drum contents undergoing a reaction

- 1) Stabilize, detonate/treat, or recycle air-reactive, water-reactive and shock-sensitive materials, and the deteriorated cylinders.
- 2) Sample and overpack or transfer to new drums all other containerized materials.

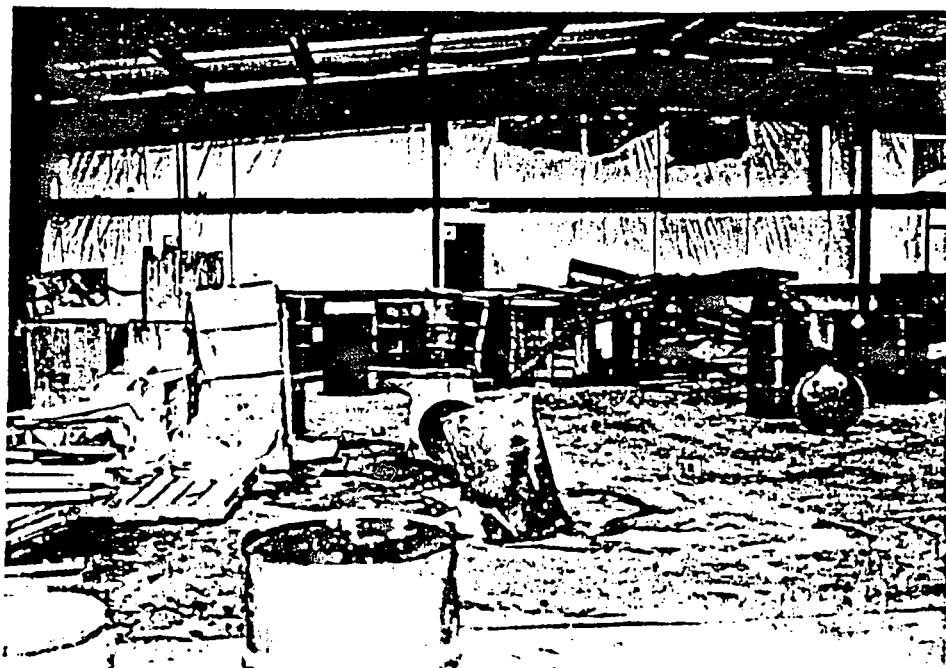
Photo #17. Virgin Island Chemical Company  
Drums and debris in area 5

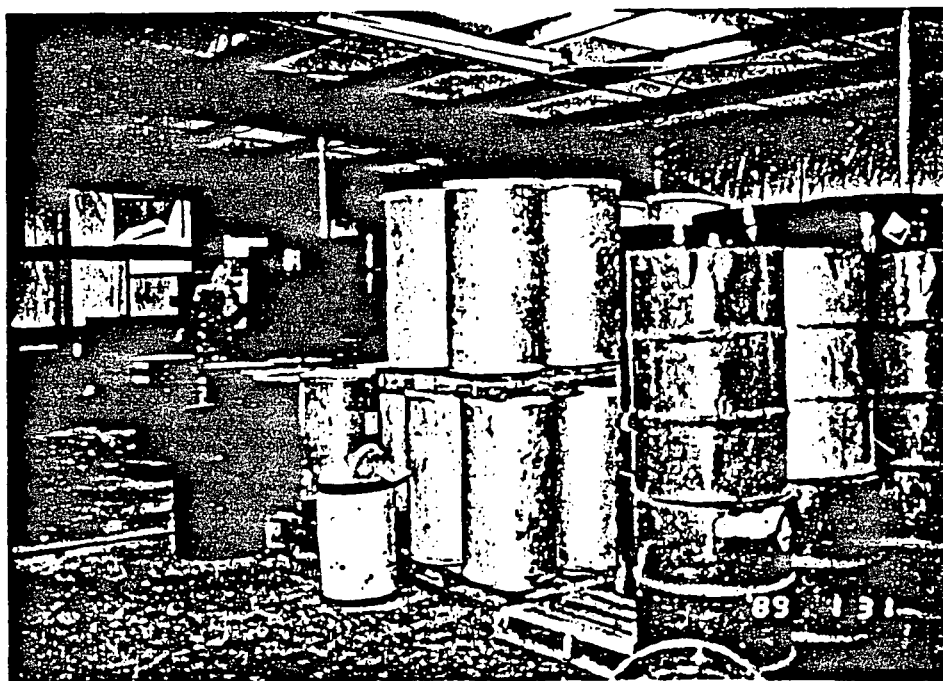
Photo #18. Drums in area 5

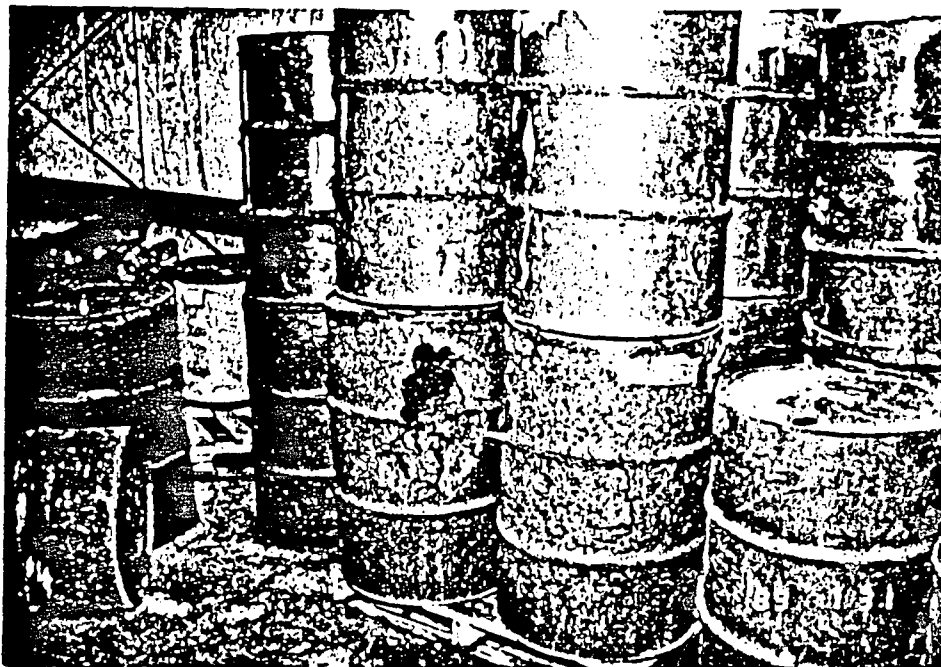
The majority of the remaining drums contain flammable, poisonous, combustible or corrosive materials. Although some of these drums are in poor condition, they have not yet been severely impacted by rain water from the leaking roof.

Photo #19. Deteriorating drums in area 6

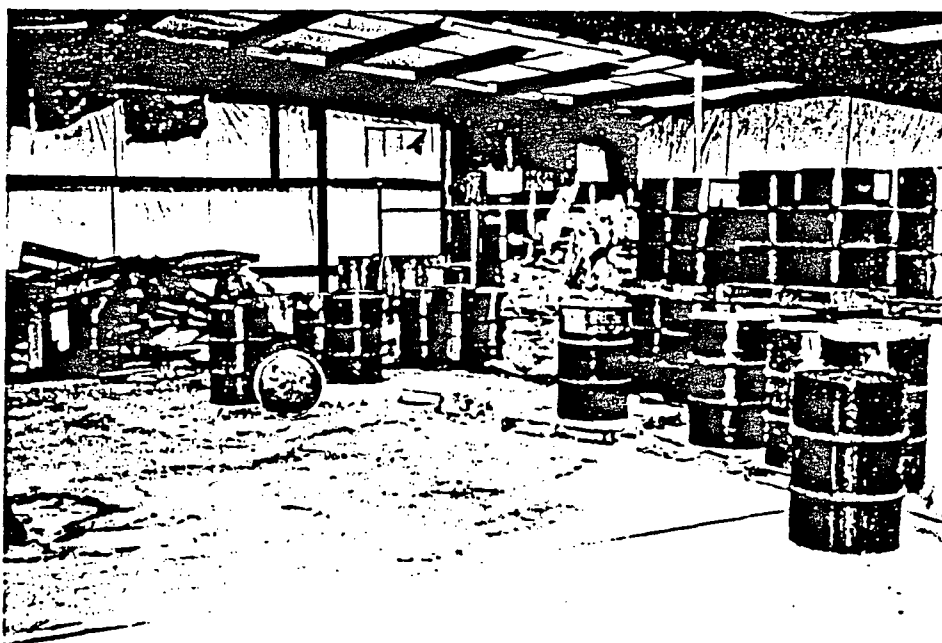
The warehouse area of the main building contains several drums which have leaked or are presently leaking. A 55 gallon fiber drum of sulfamic acid has been extremely deteriorated by the flooding of the warehouse floor from the leaking roof (photo #17). Two unlabeled drums show signs of an uncontrolled reaction and have dispersed some of their contents to the surrounding warehouse floor (photo #16). Bags of tartaric acid have deteriorated and released some of the acid to the floor as well (photo #21). Several unlabeled drums are in such poor condition that any material in them has already been released (photo #19). There may be other releases which have occurred which are not as obvious as those presented in the photodocumentation. Air monitoring in the warehouse area during the initial entry in January 1989 revealed minor elevated readings on the organic vapor analyzer (1 to 2 units above background). No other elevated air monitoring readings were observed.

Photo #20. Drums and floor contamination in area 5

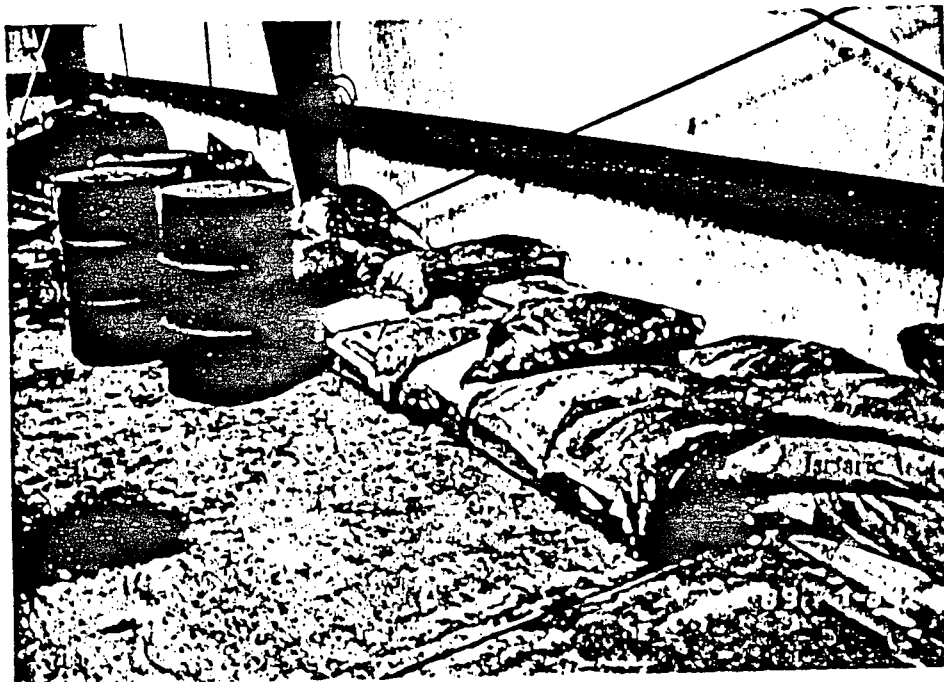
Photo #21. Deteriorating bags in area 6
