APPENDIX B  
RUSTENBERG PLANTATION SOUTH  
HISTORIC DISTRICT

## Appendix B, Historic District

CLASSIFIED STRUCTURE FIELD INVENTORY REPORT  
(Attach 4"x5" B&W Photo)

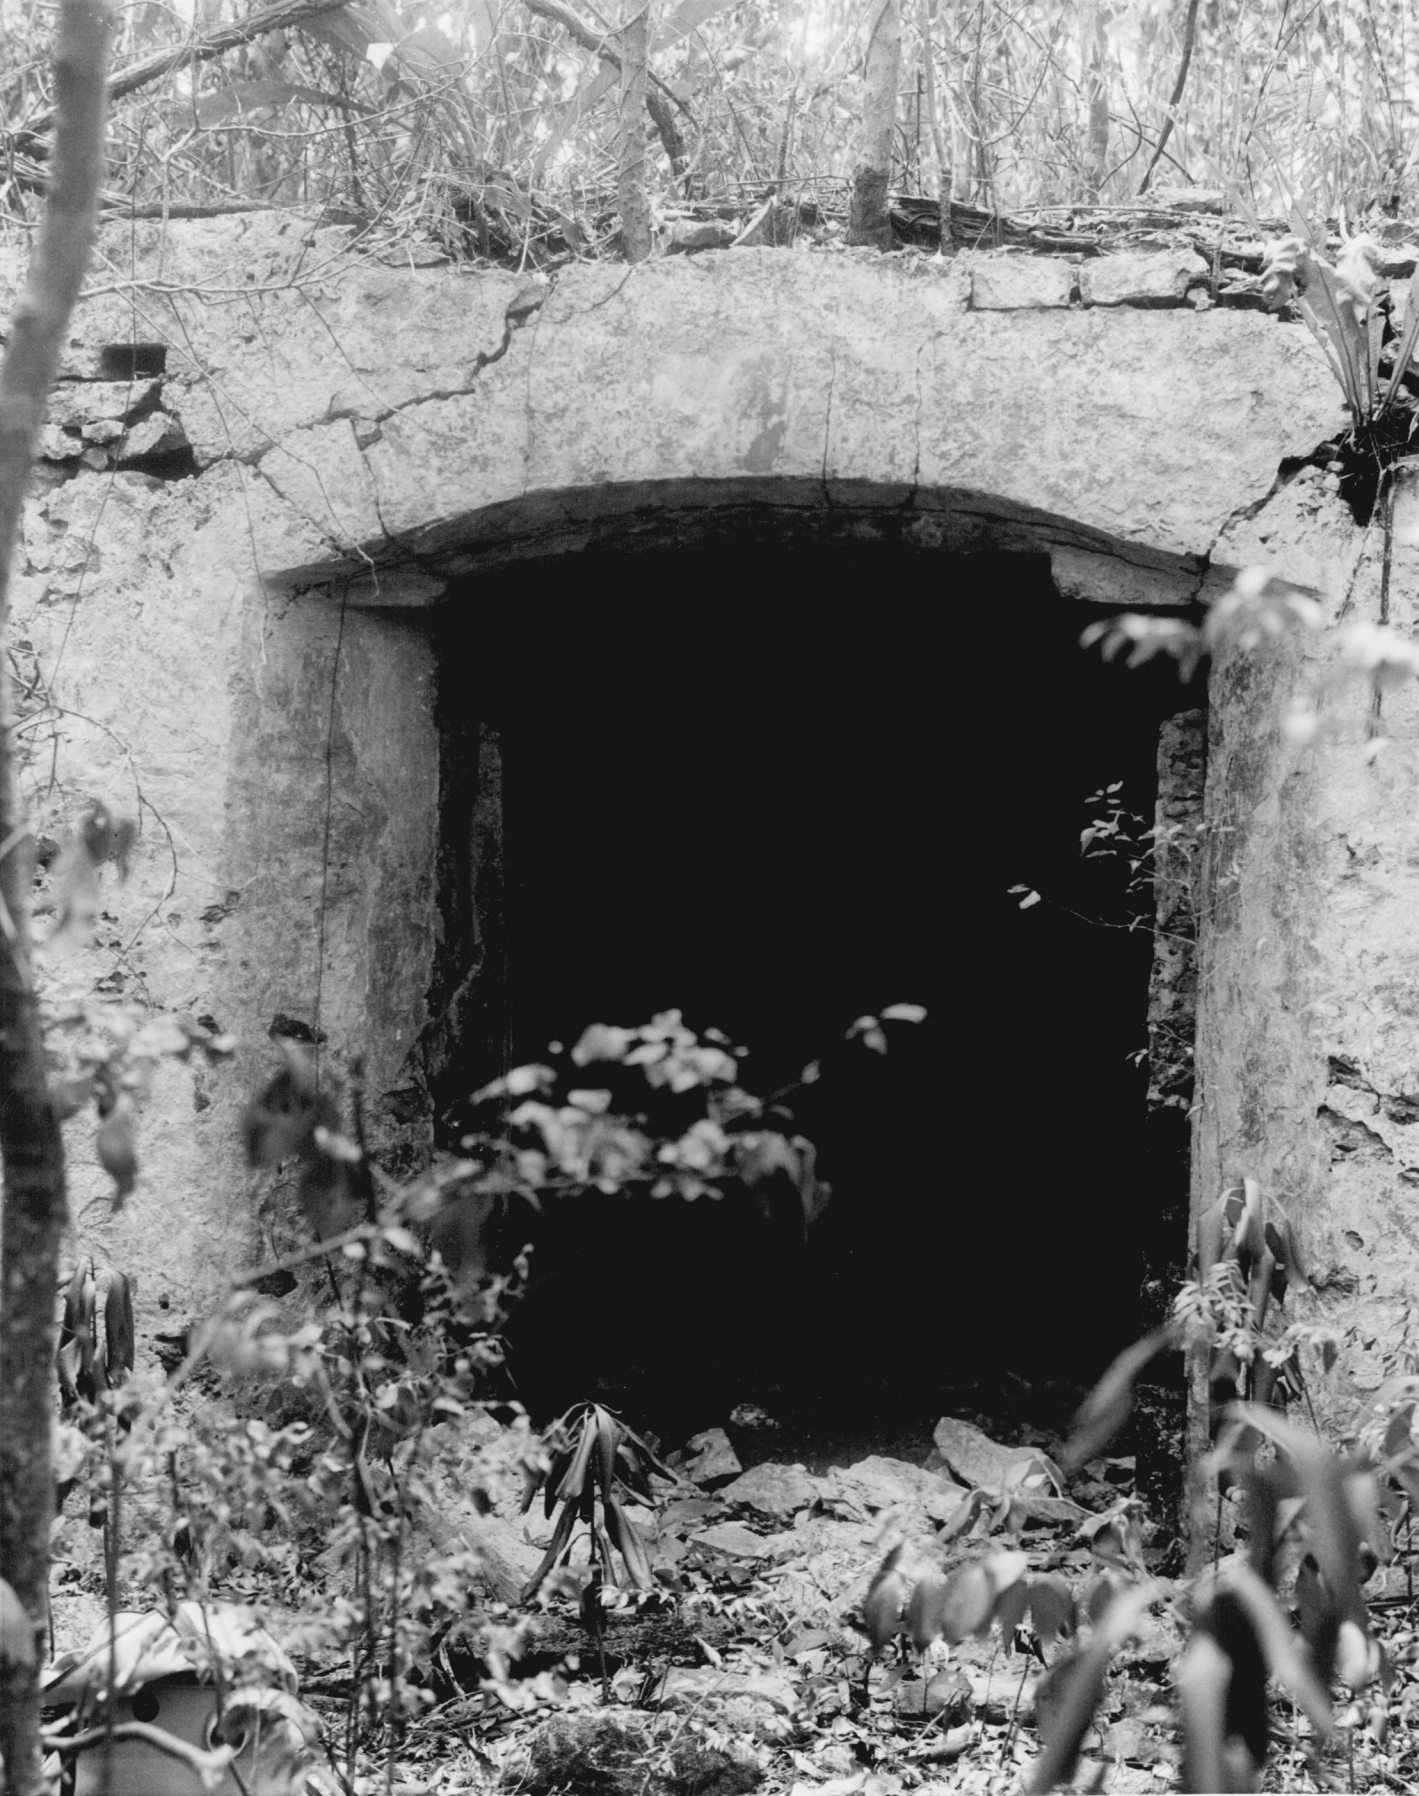
**Vault**

**Entrance to vault under horsemill (H27, 1) viewed from the north.**

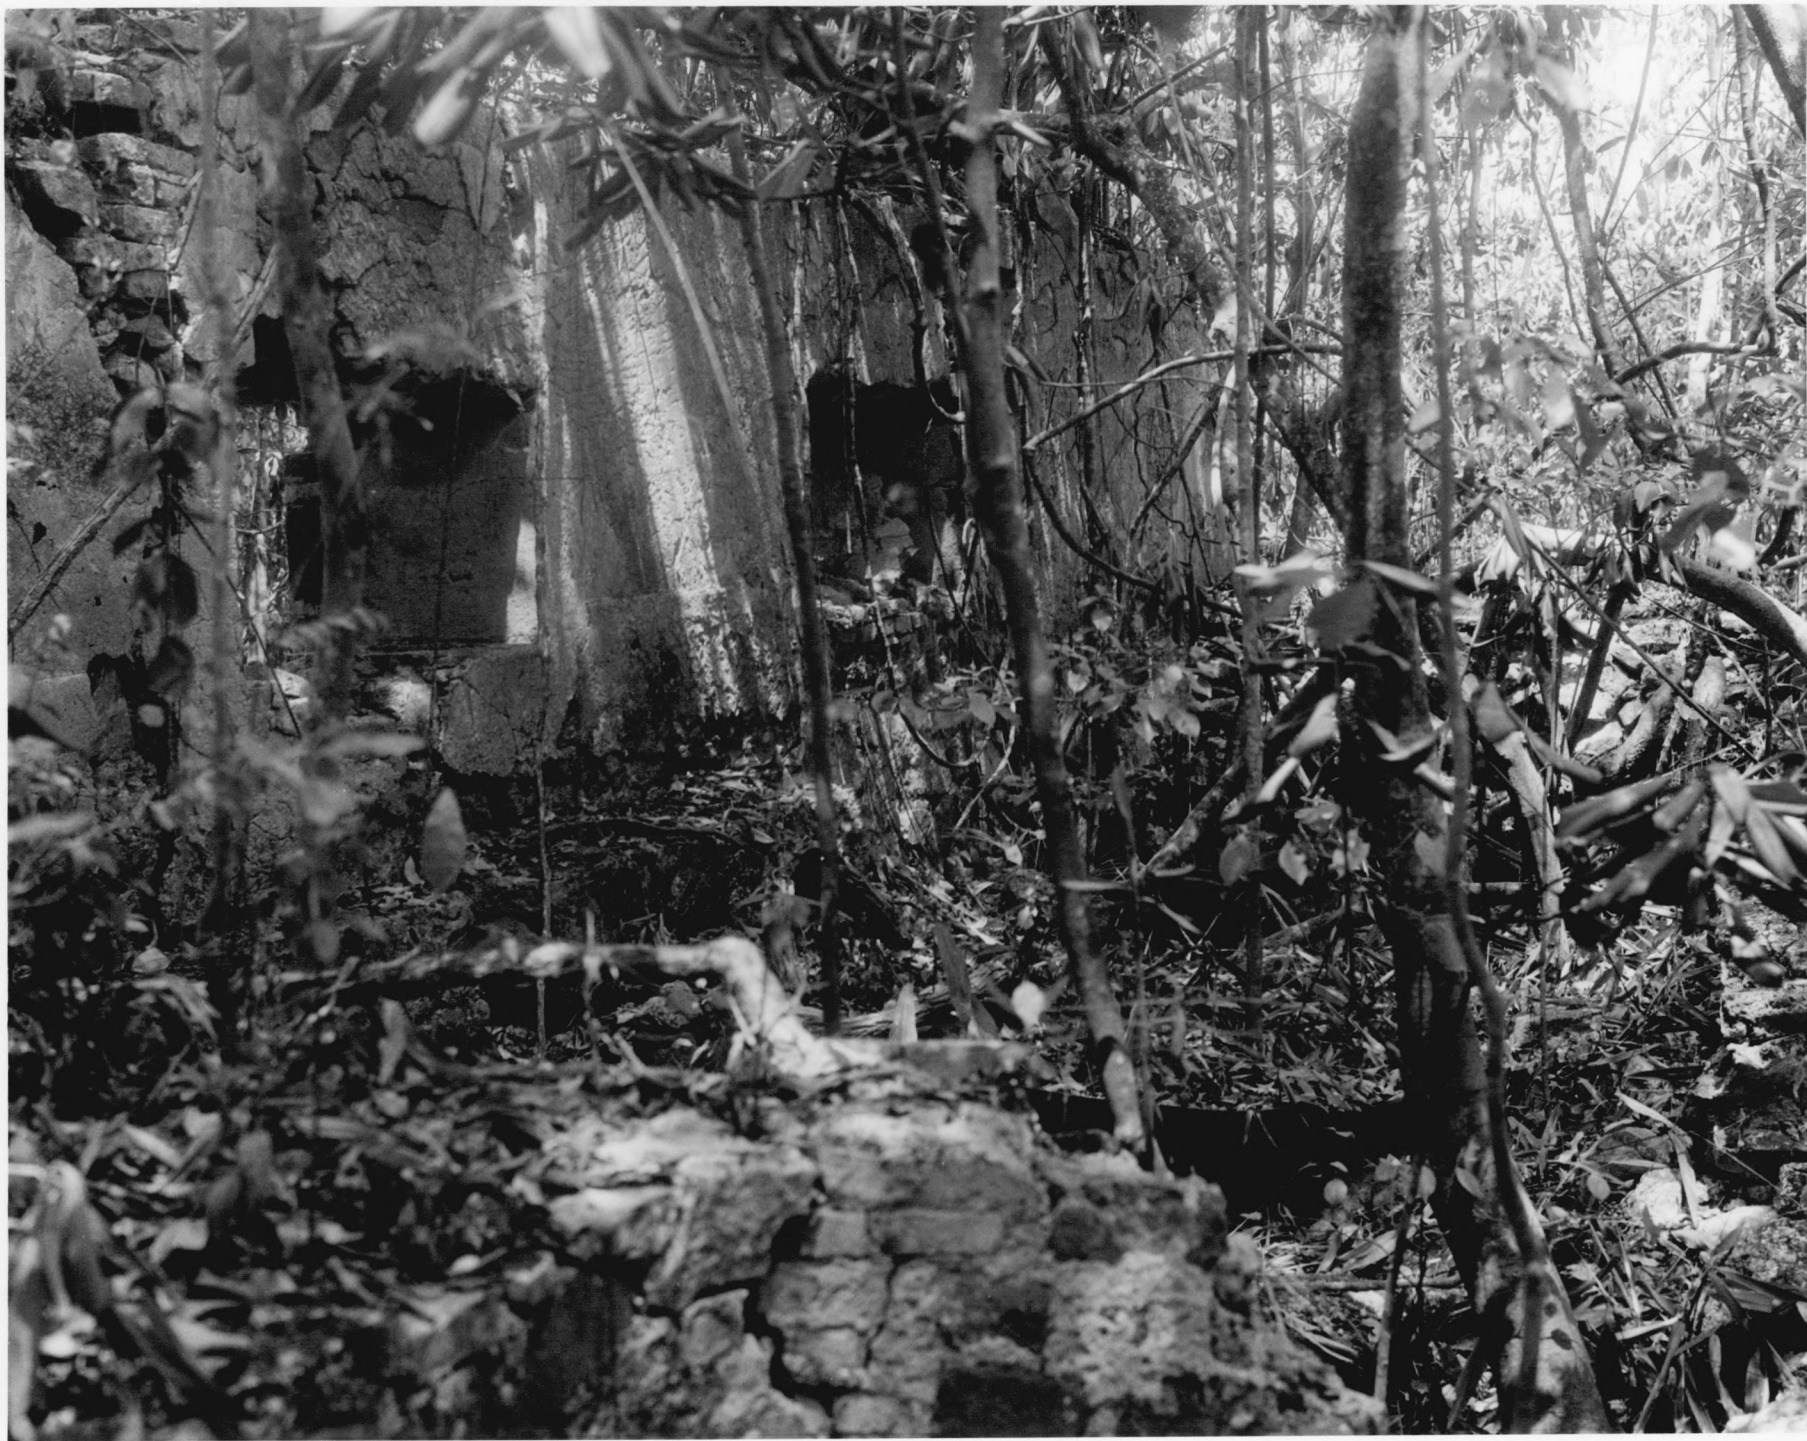
## Boiling Bench

still stand to plate height. It has retained the boiling bench and fragments of two coppers and of its original limestone pavement.

Boiling Bench of factory (H-27, 1) viewed from the southeast.

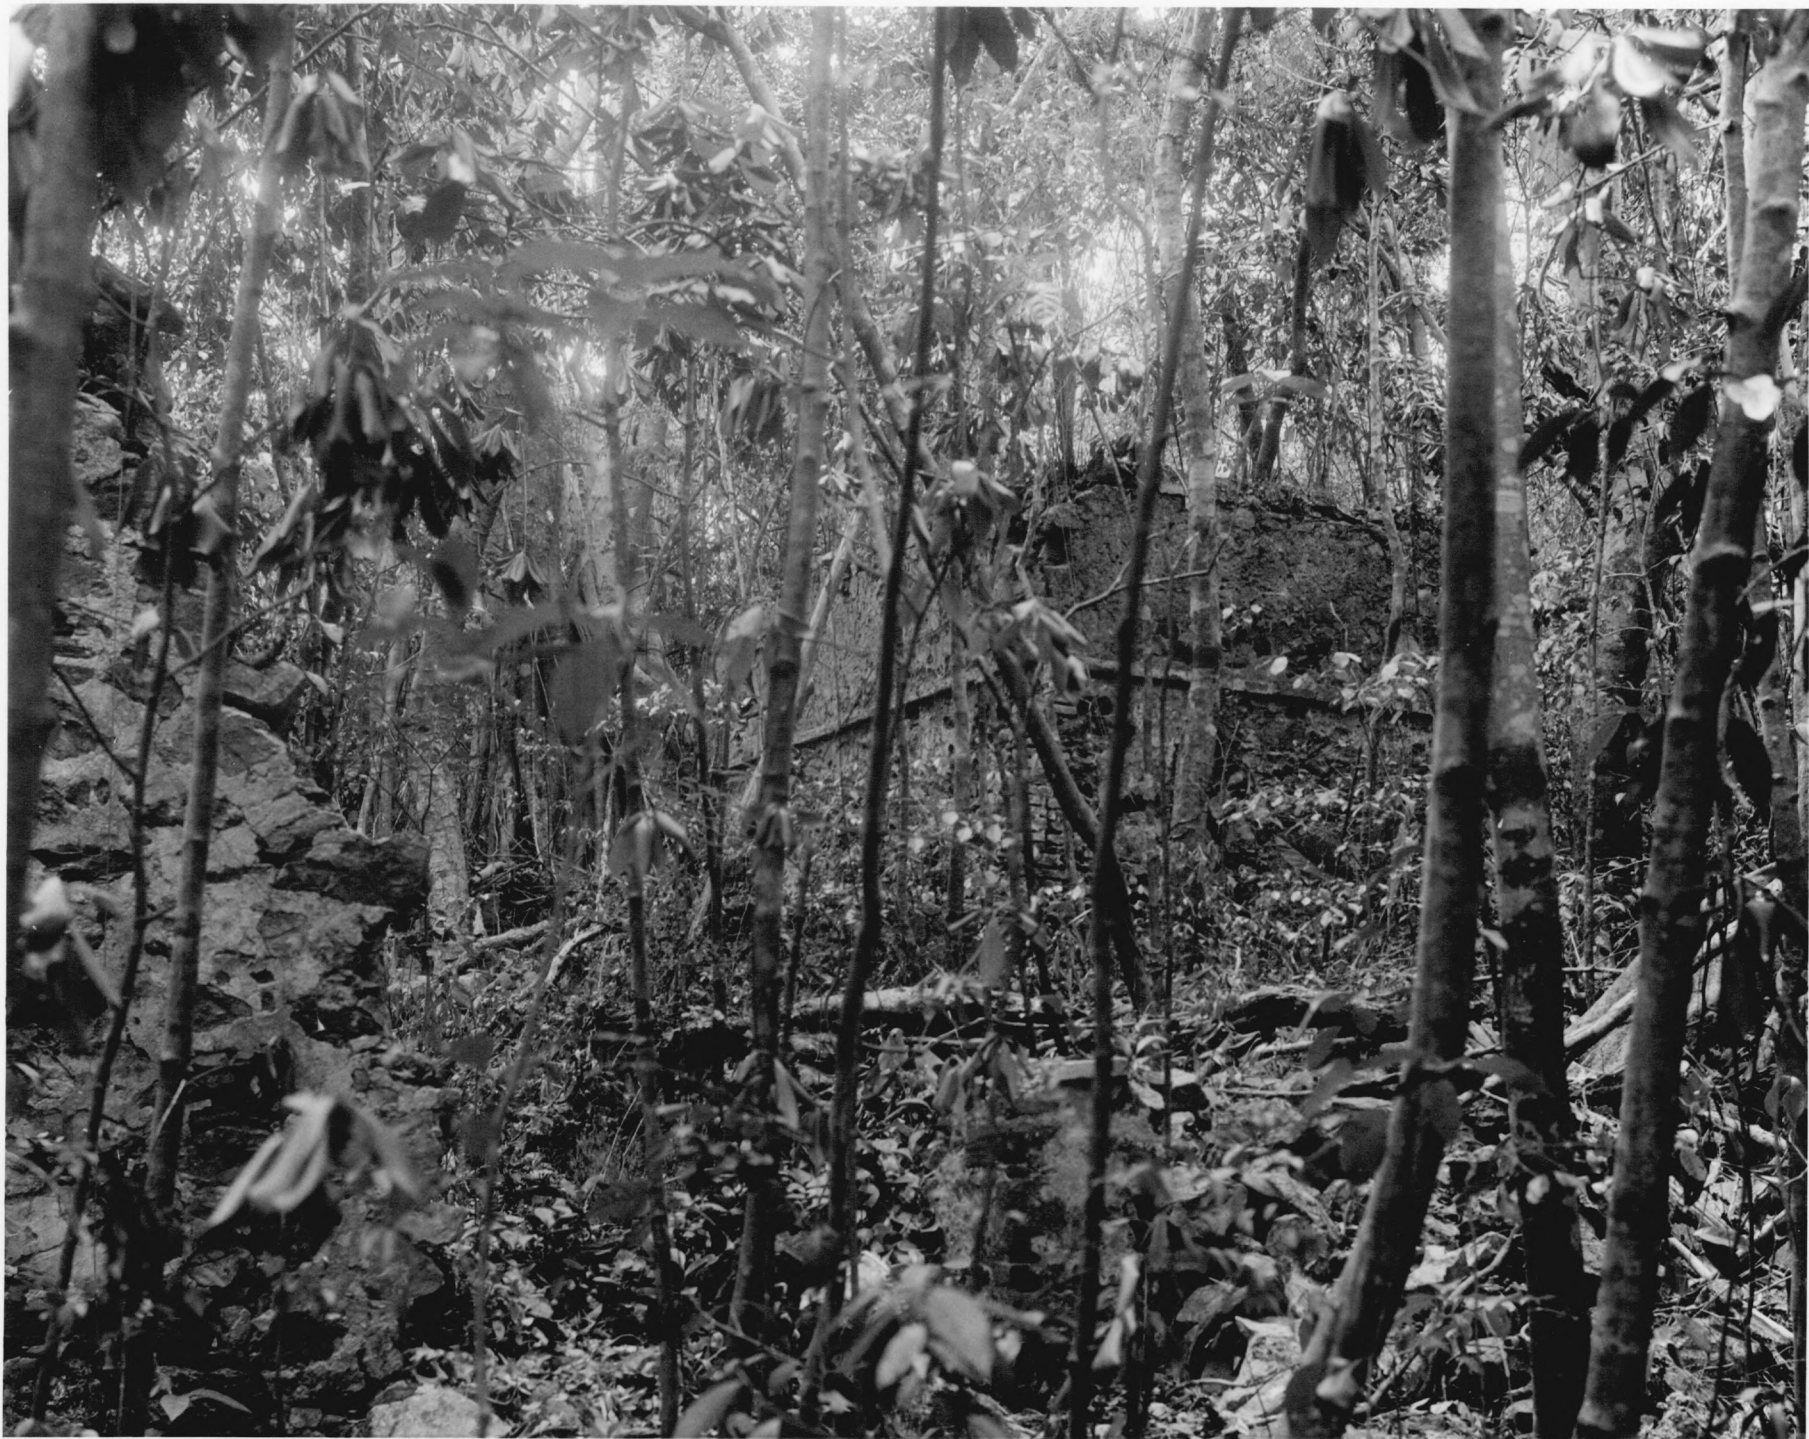
Raised Cistern

The factory is a one and two story masonry structure 52' by 45'. The date of construction is unknown but by plan, type and organization, it can be judged to be early and to predate 1790. A cistern is built against the east side of the factory and on the west side an elevated cistern with drinking troughs 15' by 20' adjoin the factory building. The ruins are in a poor condition although some of the walls

Raised cistern of factory (H-27, 2) viewed from the  
southwest.

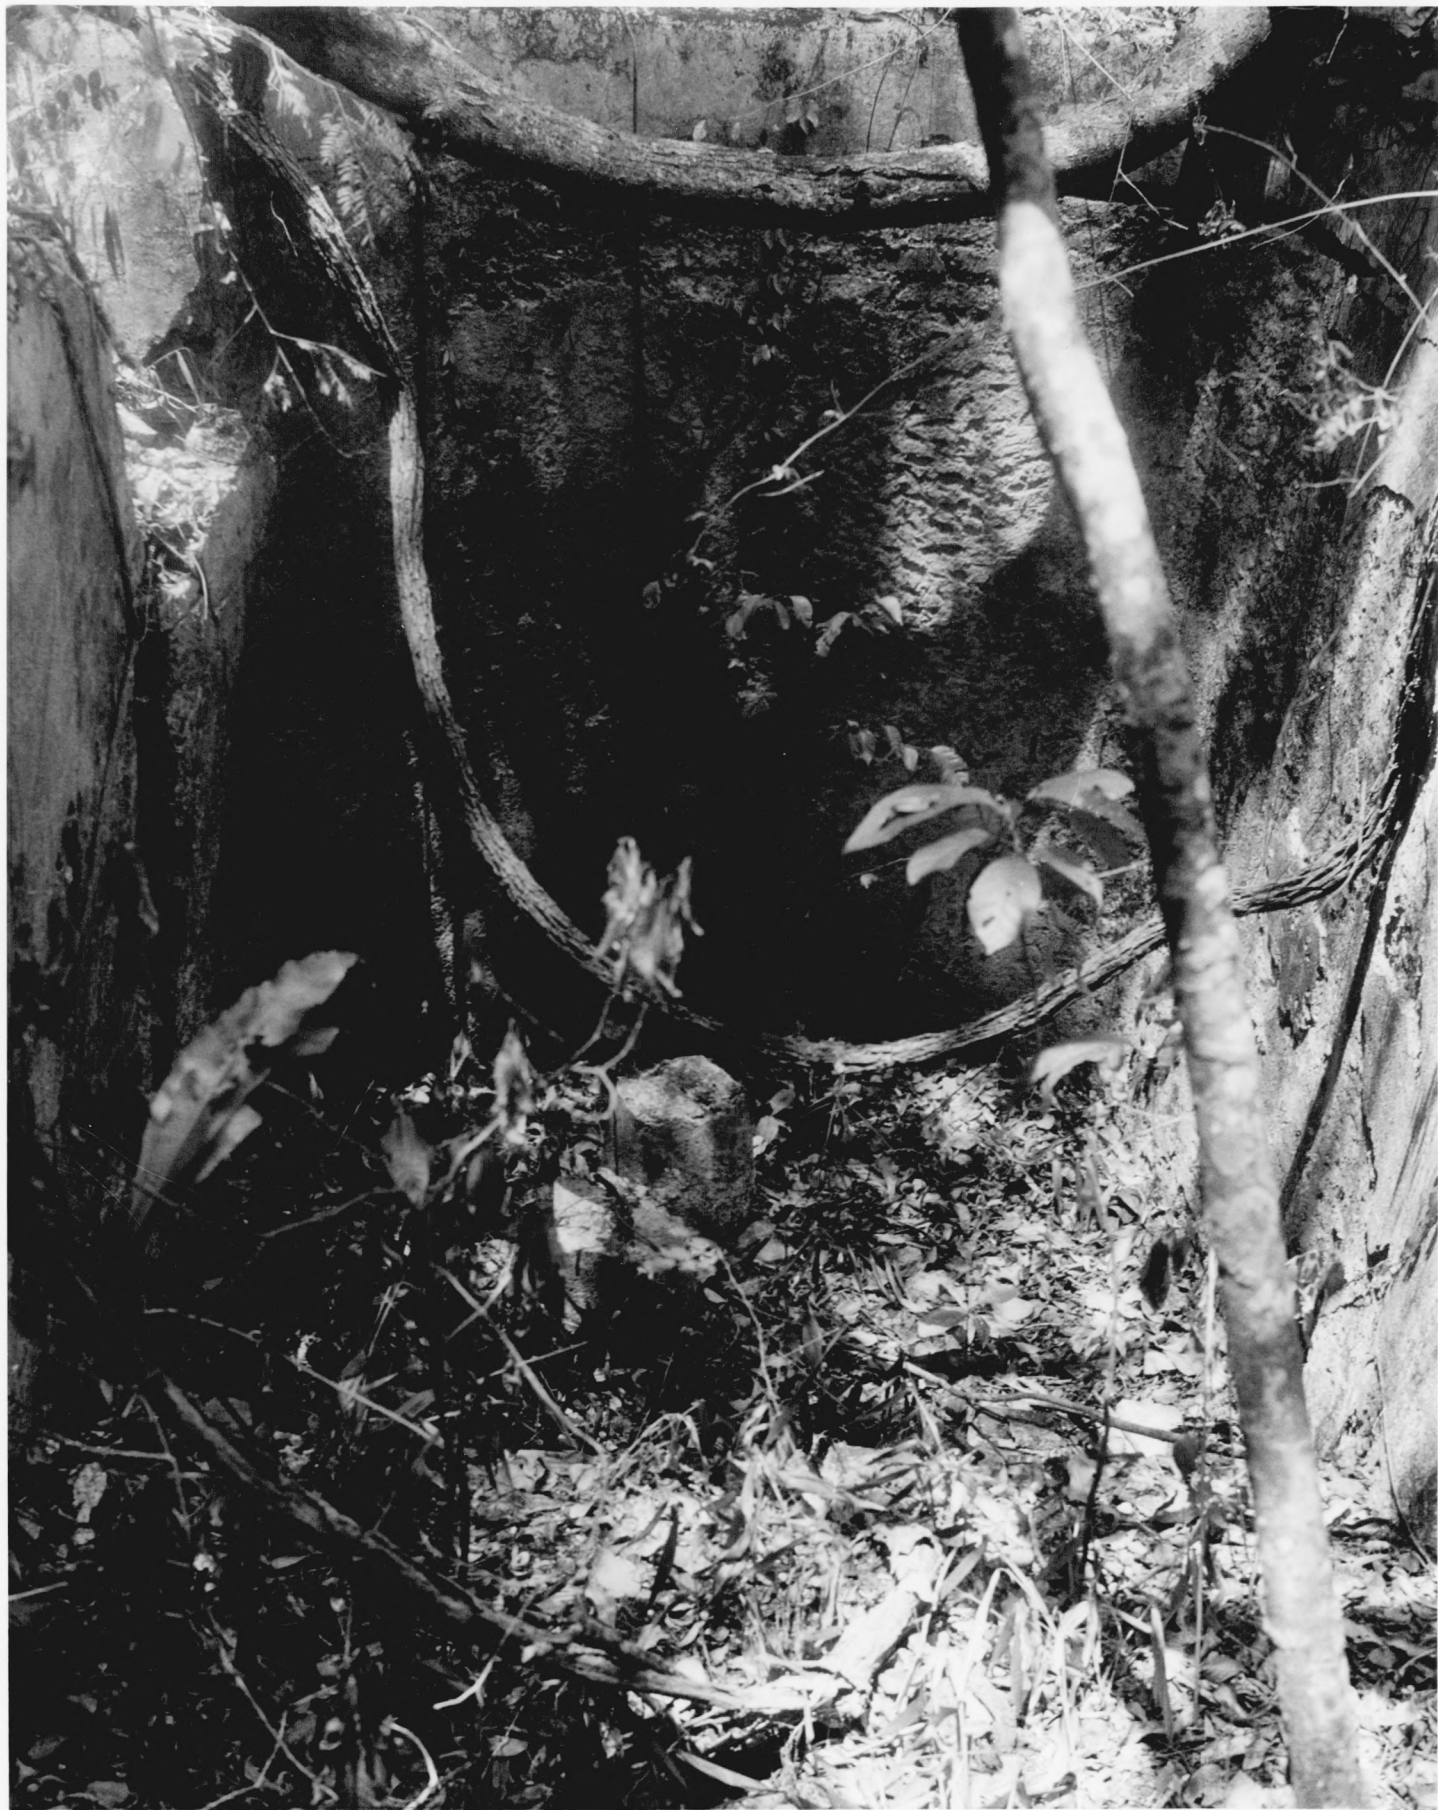
Cistern of Still

The still is an irregular shaped masonry building with overall dimensions of 37' x 30'. The still proper is located on the south side of the building against a raised cooling cistern measuring 24 by 12 feet and extending westward from the center core of the building. A two room storage shed is built against the east and north wall of the cistern. All walls have been preserved to their full height except for

the still furnace and chimney. These have collapsed and have been retained in fragments only. It is approximately 125 feet due west of the factory.

Cistern of still (H-27, 5) viewed from the south.

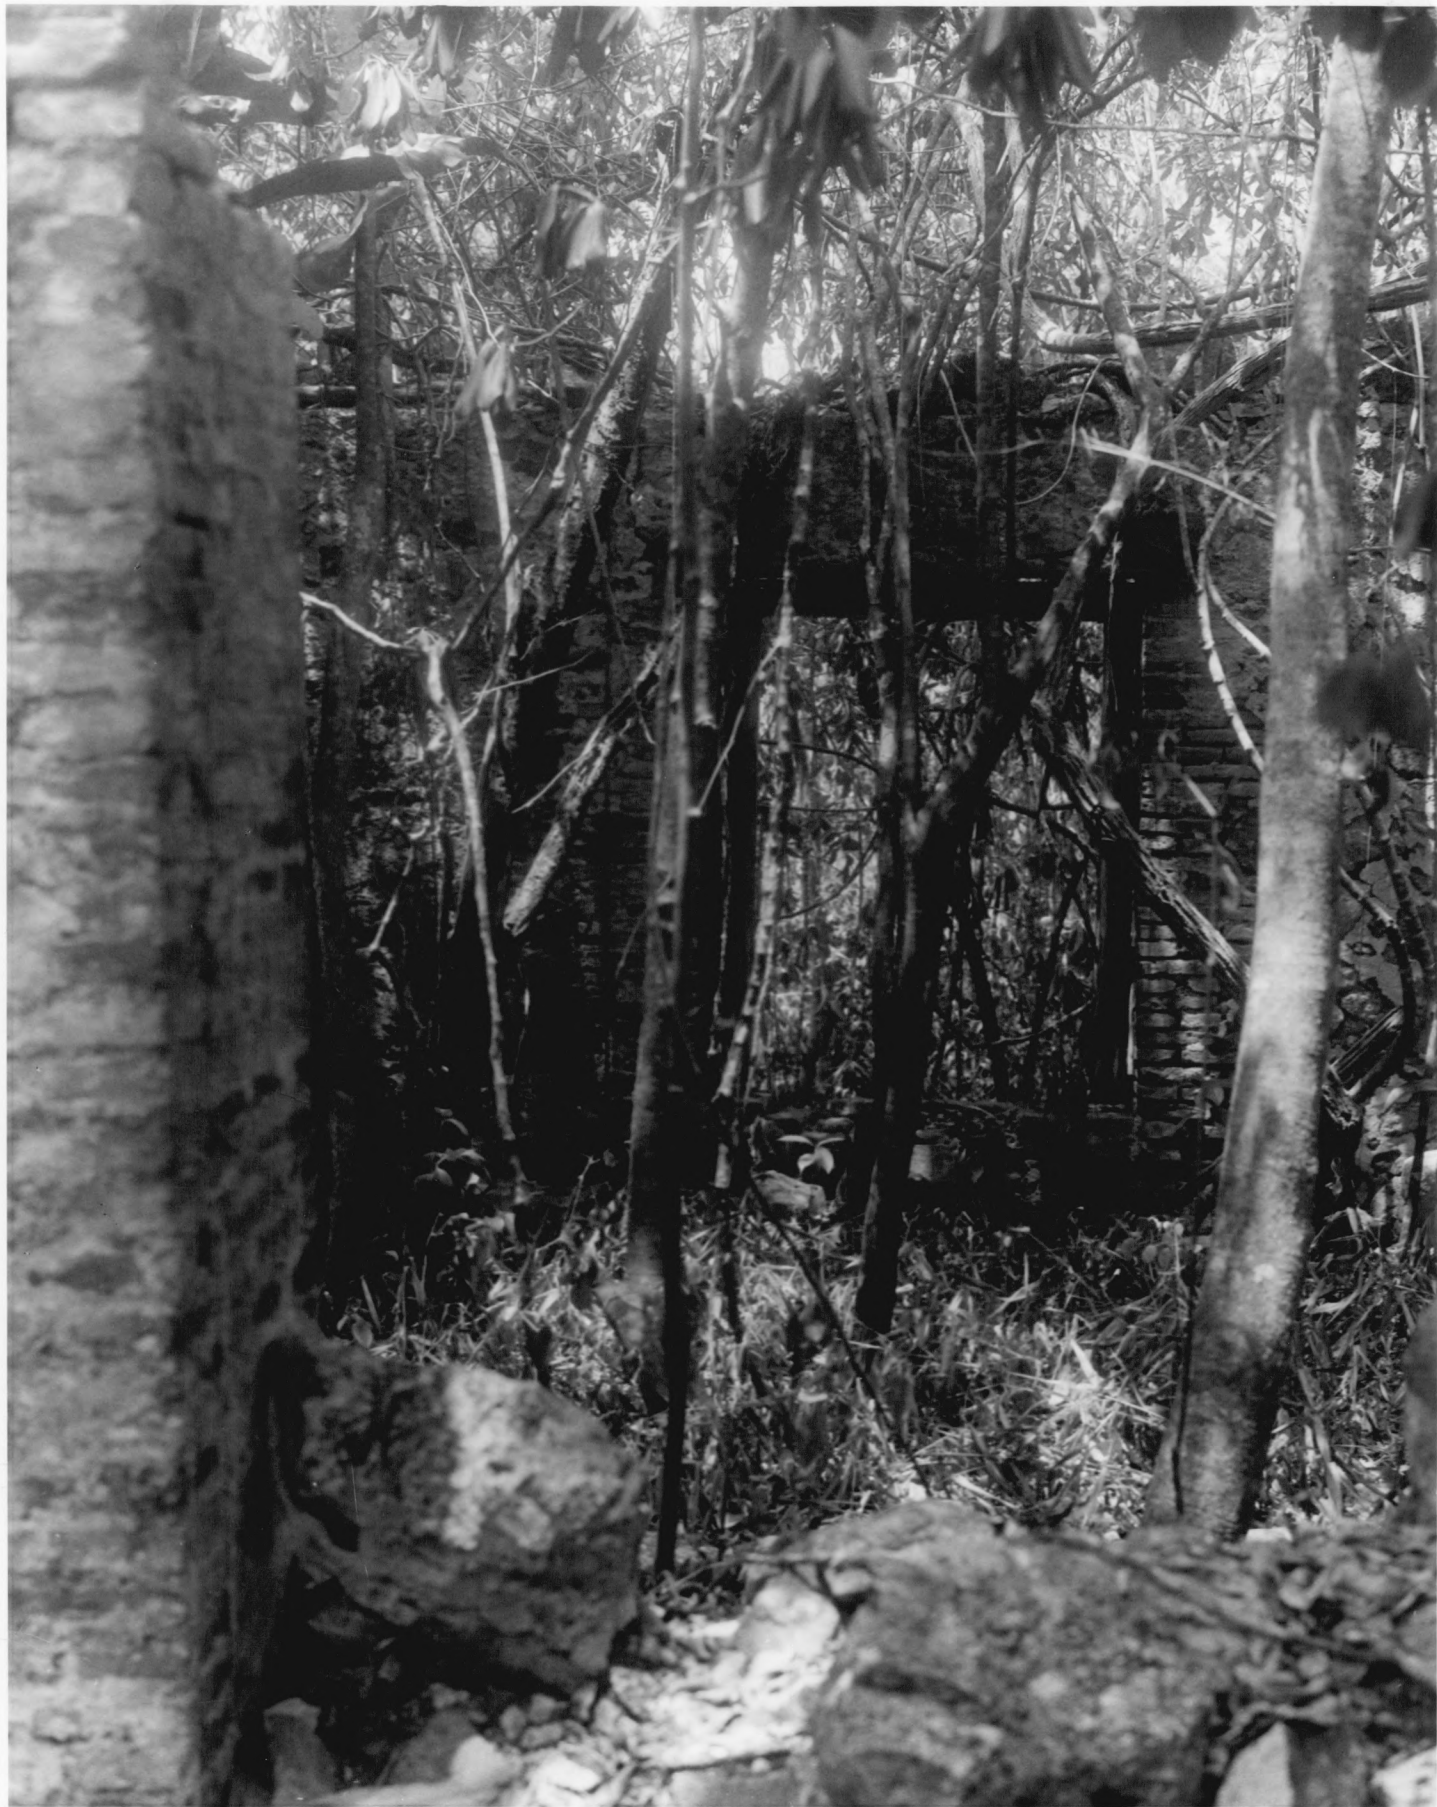
## Warehouse and Residence

The warehouse and residence is a one-story masonry structure 20' x 82' oriented southeast to northwest between the still (H-27, 5) and the bagasse shed (H-27, 3) and extending south of both. A bake oven is built against the southeast wall. The south end of the building was used as a residence or quarters while the north end appears to have served as a warehouse facility. About 50% of the structure stands to plate height. The residential section of the building has two rooms separated by a masonry partition and is divided from the warehouse section by a masonry wall. The structure was evidently build in several stages and the walls are constructed in rubble as well as brick masonry. Lat. 18°20'42" Long. 64°44'59"

Interior of warehouse and residence (H-27, 6) viewed  
from the west.
