## REEF BAY SUGAR FACTORY HISTORIC DISTRICT

## Appendix B, Historic District

CLASSIFIED STRUCTURE FIELD INVENTORY REPORT  
(Attach 4"x5" B&W Photo)

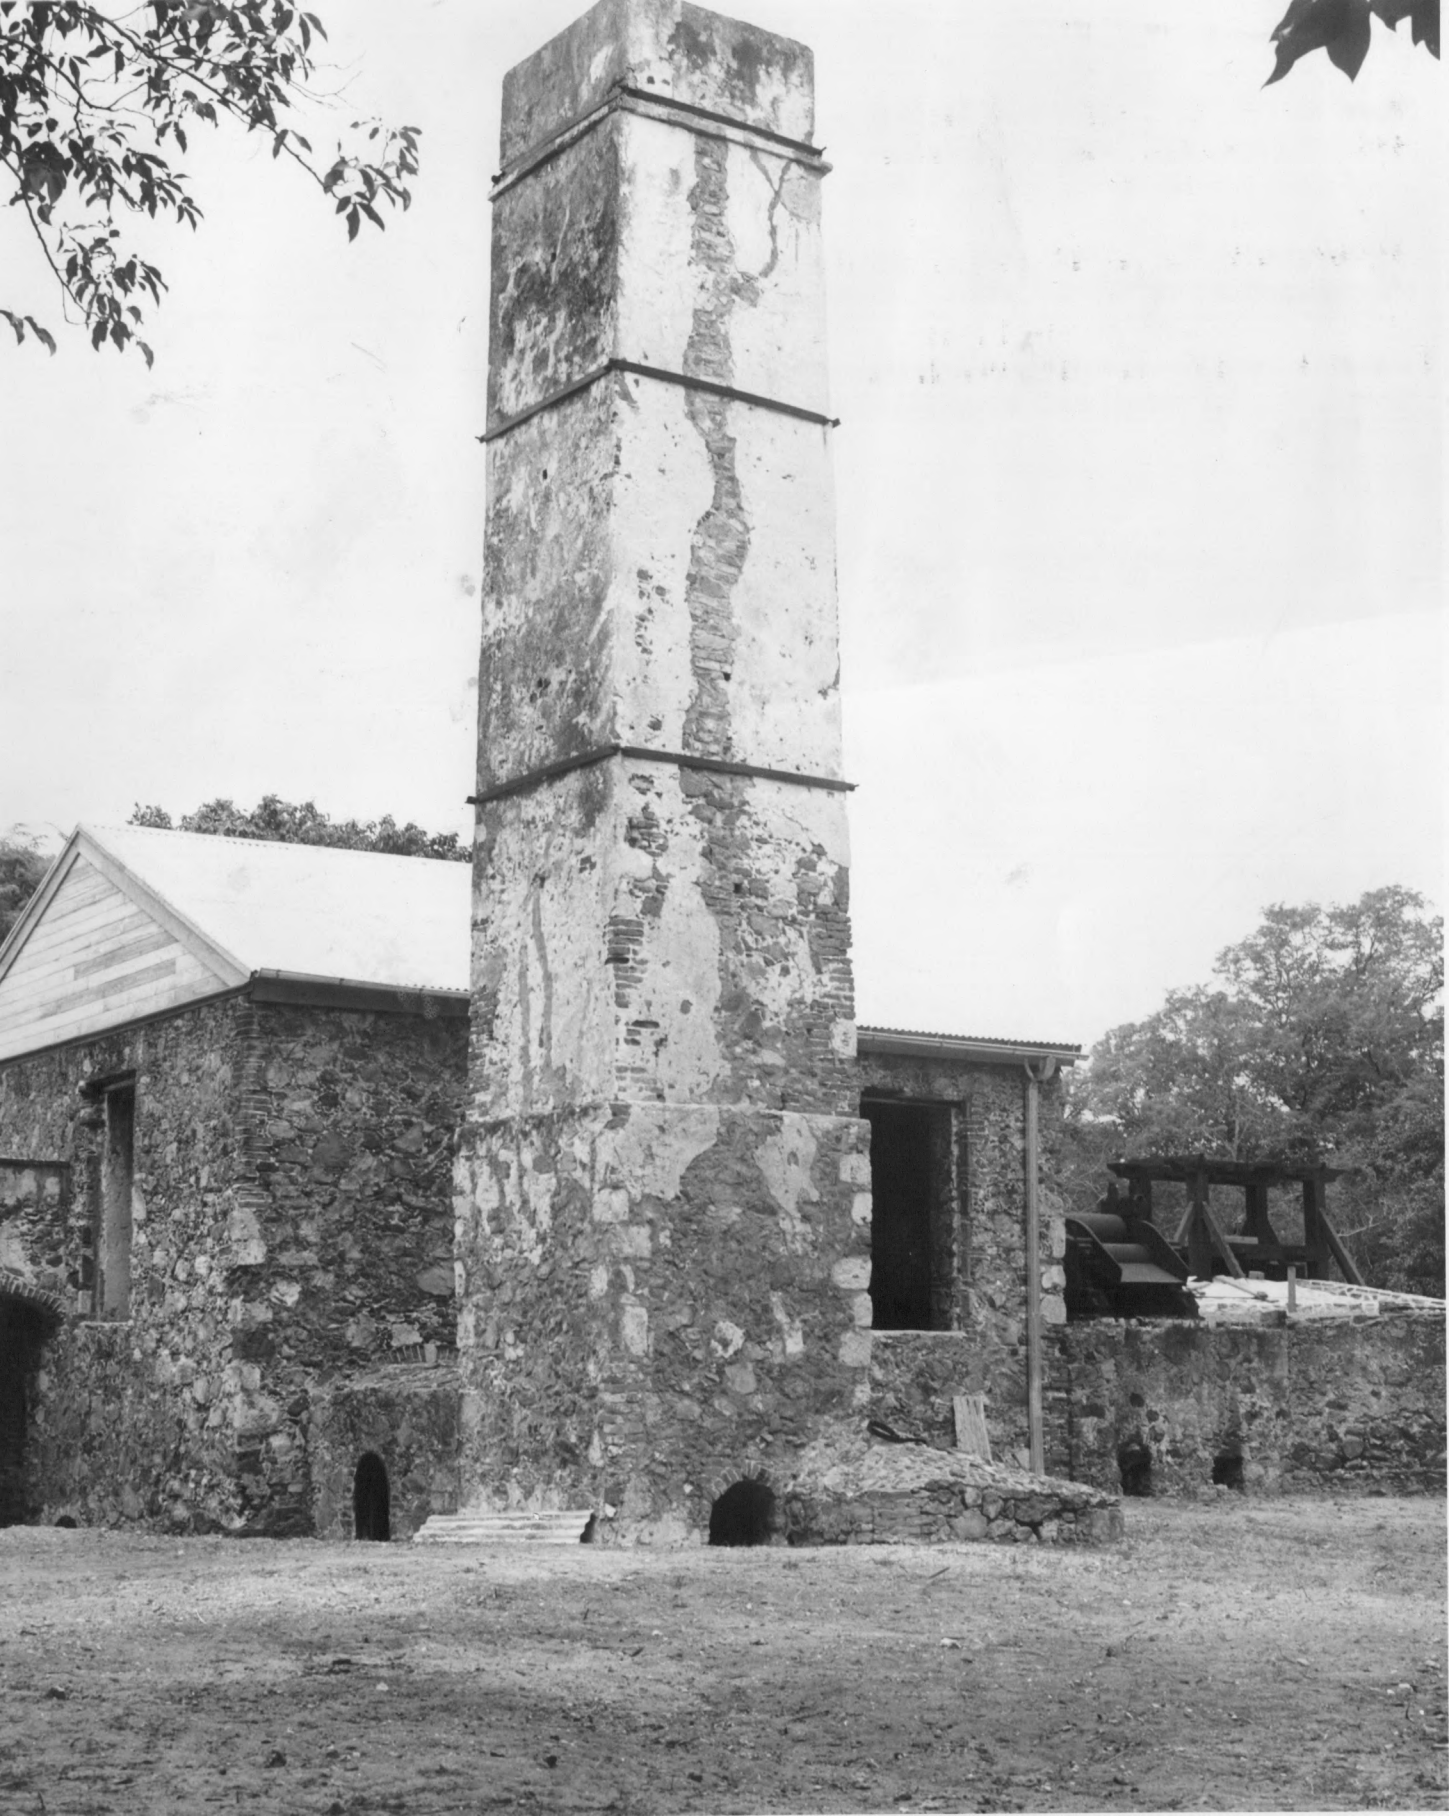
Engine House

West and north elevation of engine house of factory  
(H-13, 1) mill round and cane crushers to the right  
(H-13, 1).

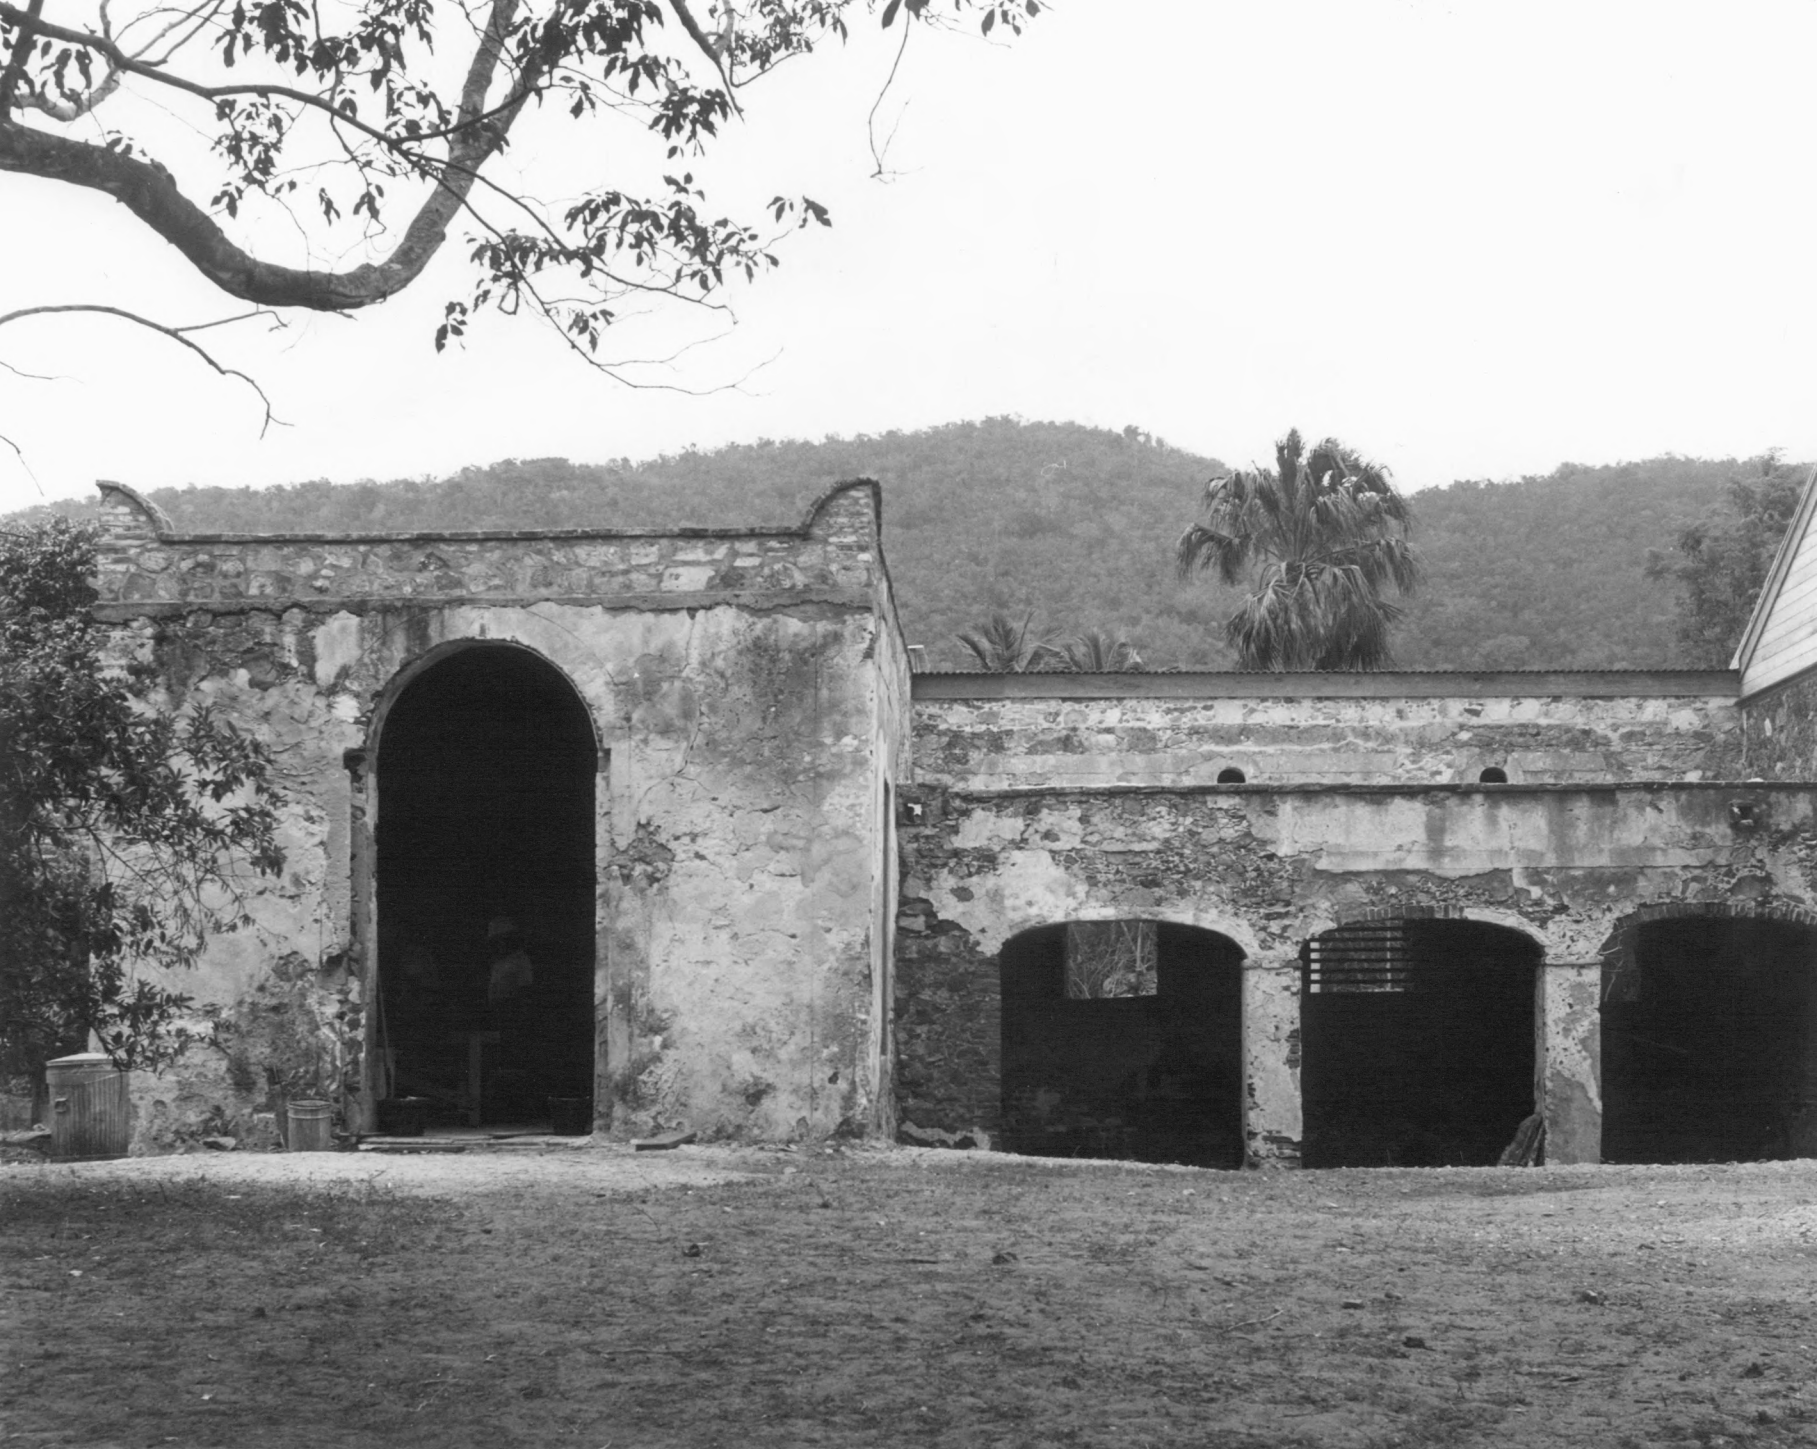
# Factory

**Storage wing (Left) and firing trench (right) of factory**

**(H013, 2) viewed from the west.**

Physical Description: The factory is of brick and rubble masonry construction with stuccoed and plaster walls. The older section of the factory had a flat roof, the addition of the 1860s, a hipped roof. The older section of the factory is "T" shaped in plan, almost identical to the illustration of the ideal factory in P. J. Oxholm's book, Over de Vestindiske Øers Tilstand, published in Copenhagen in 1797. The stem of the T is 40'6" wide by 37' long, and contains the boiling house with a boiling bench of five "coppers" along the west wall over a flue and a furnace. West of the boiling house, but within the stem of the "T", is the firing trench, where the furnace was stoked. The firing trench had a roof supported on arches and square pillars. Three rectangular windows below the level of the firing trench roof and two circular vents in the space between the roof of the firing trench and the higher roof of the boiling house allowed the steam from the boiling bench to escape. The boiling house is divided into two sections by a wall running north-south with the large arched openings. The eastern section, like the firing trench, had a slightly lower roof and houses the crystallization pans. Two windows and a door in the east wall and south wall, respectively, provided additional ventilation

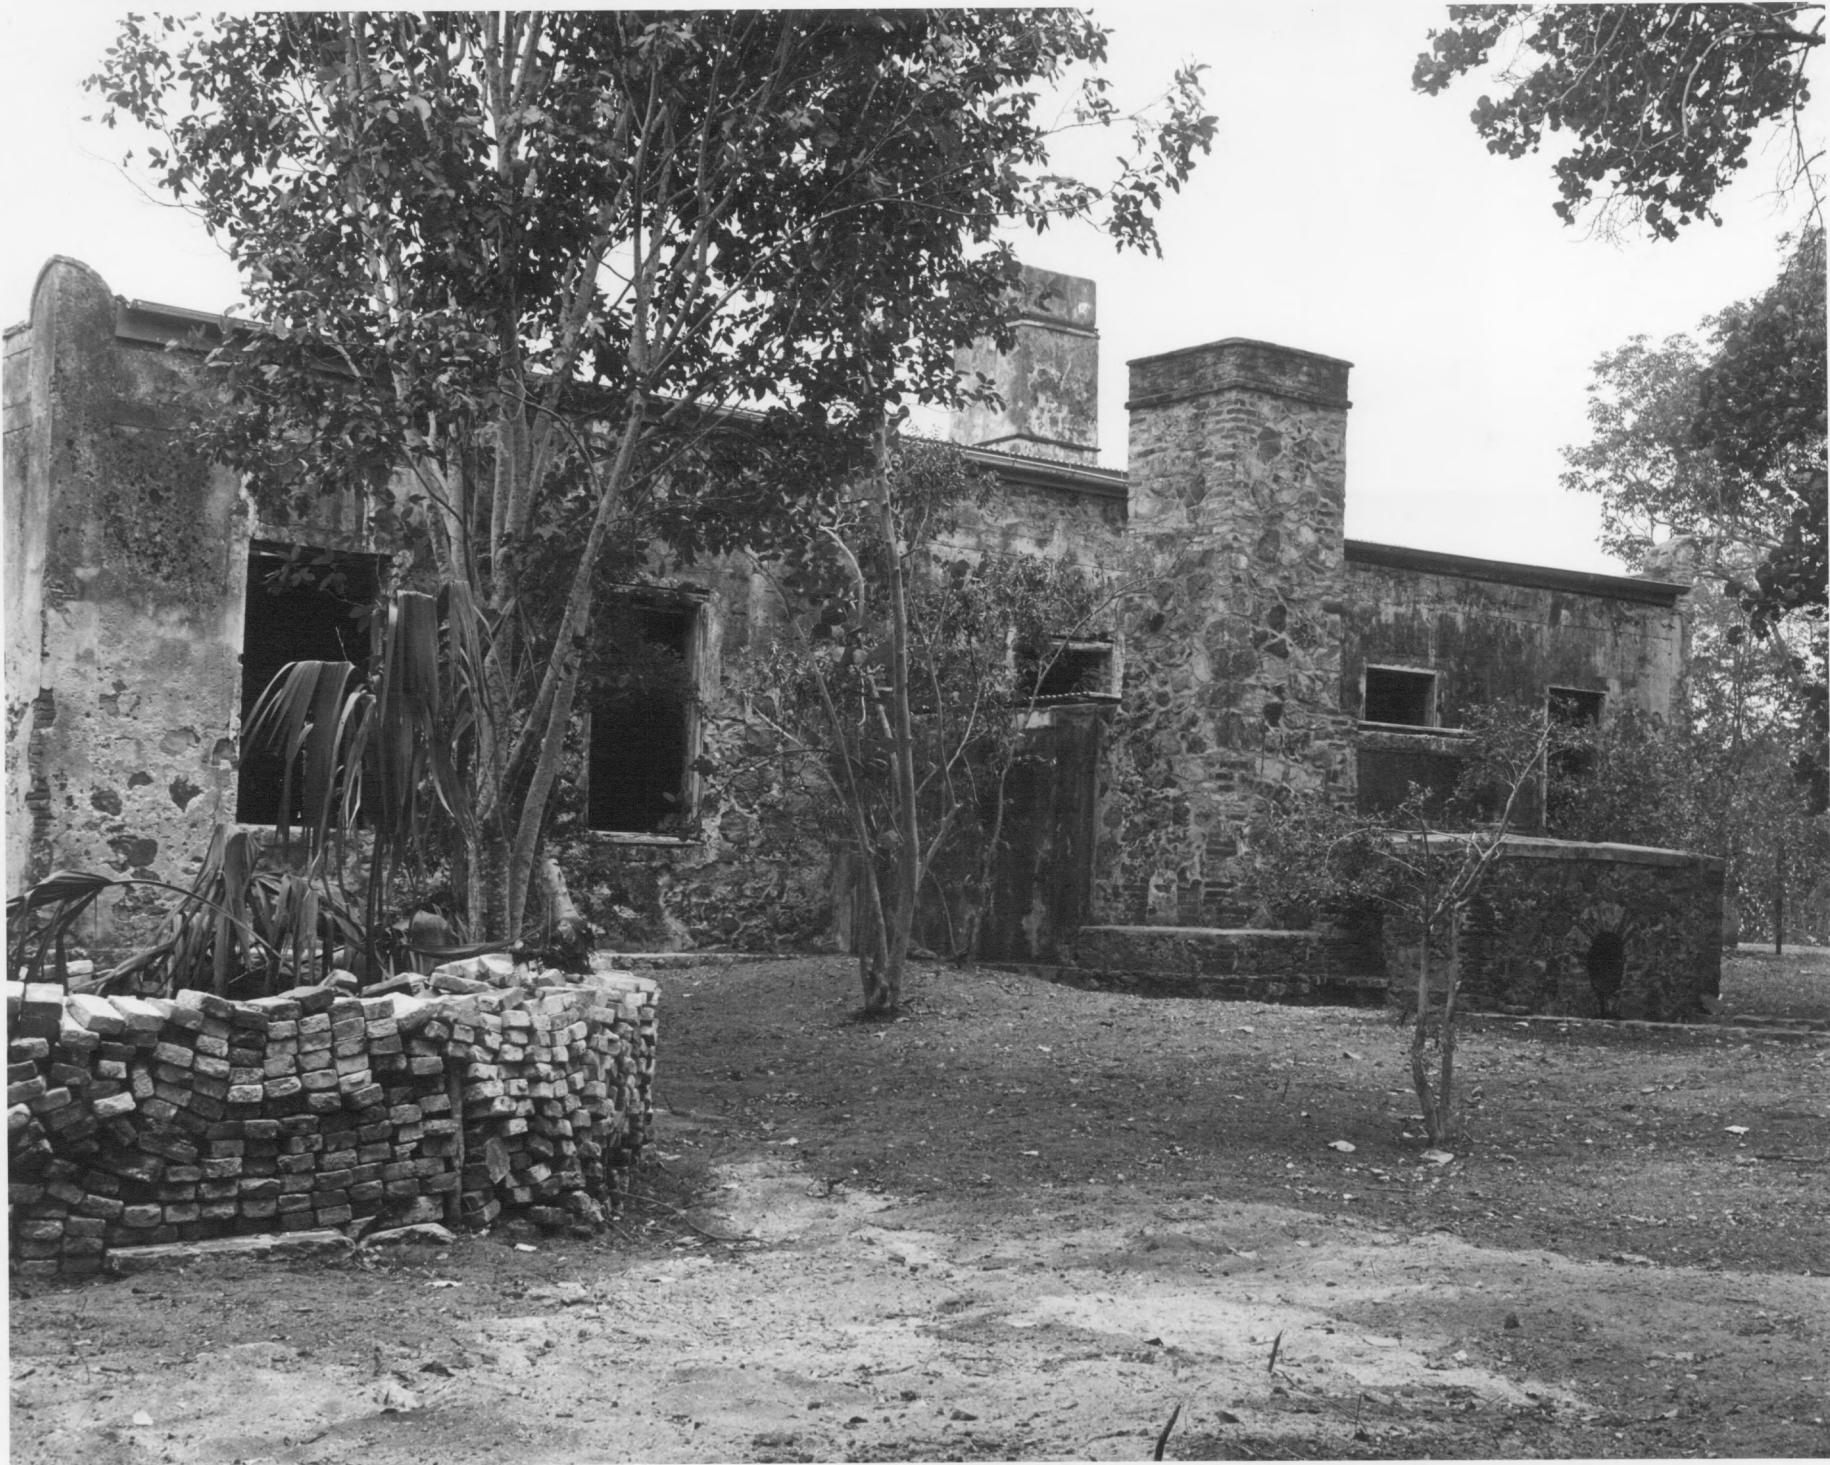
# Factory

**Curing and storage wing of factory viewed from the northeast, still in foreground (H013, 2).**

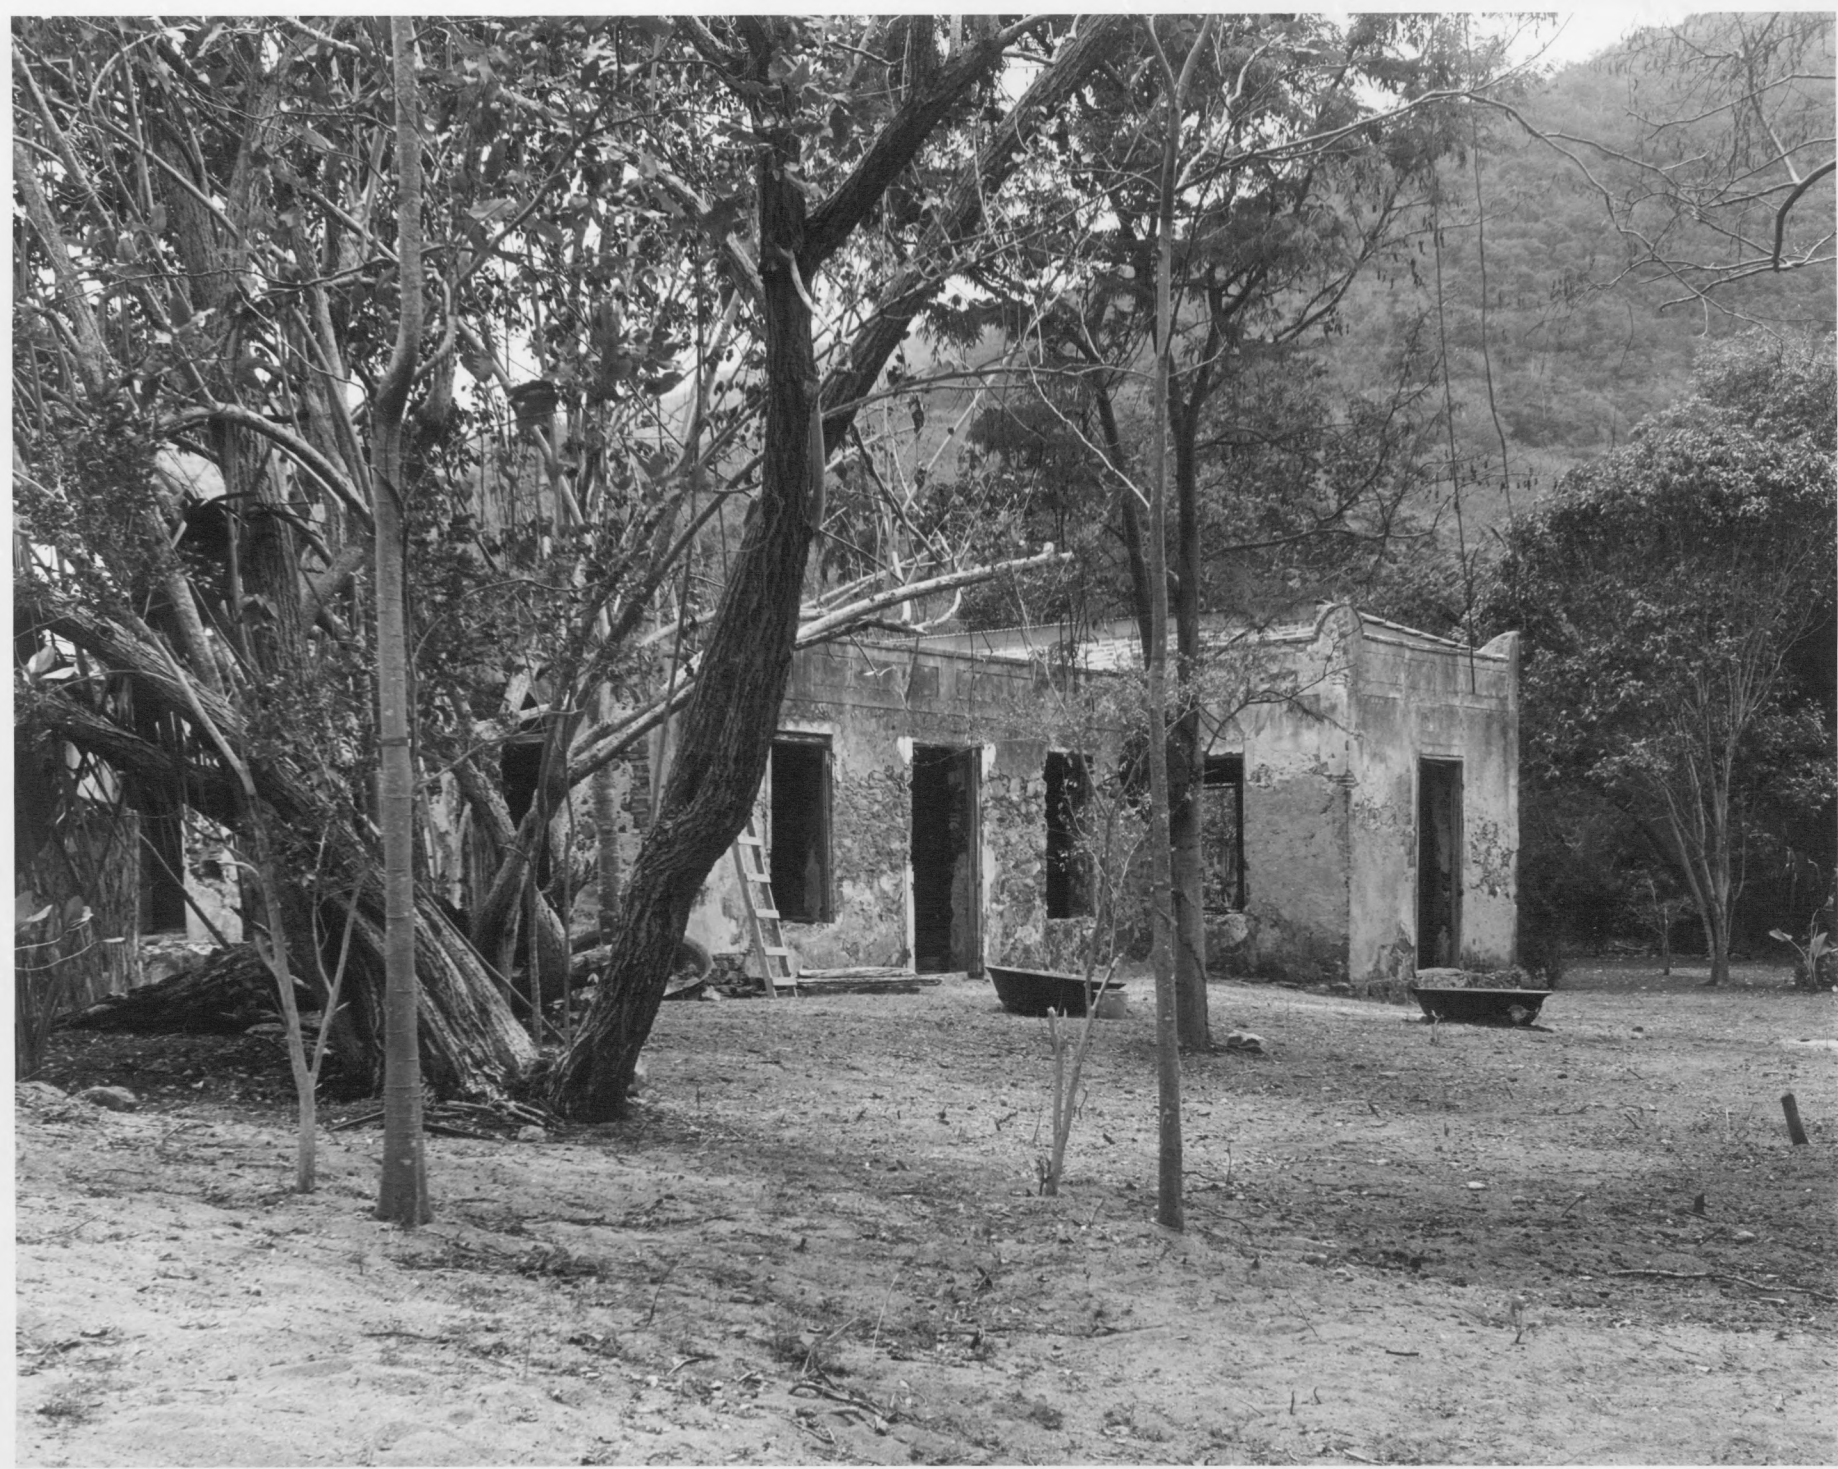
## Factory

**Factory building viewed from the southeast, curing house to the right and boiling house to the left (H-12, 2).**

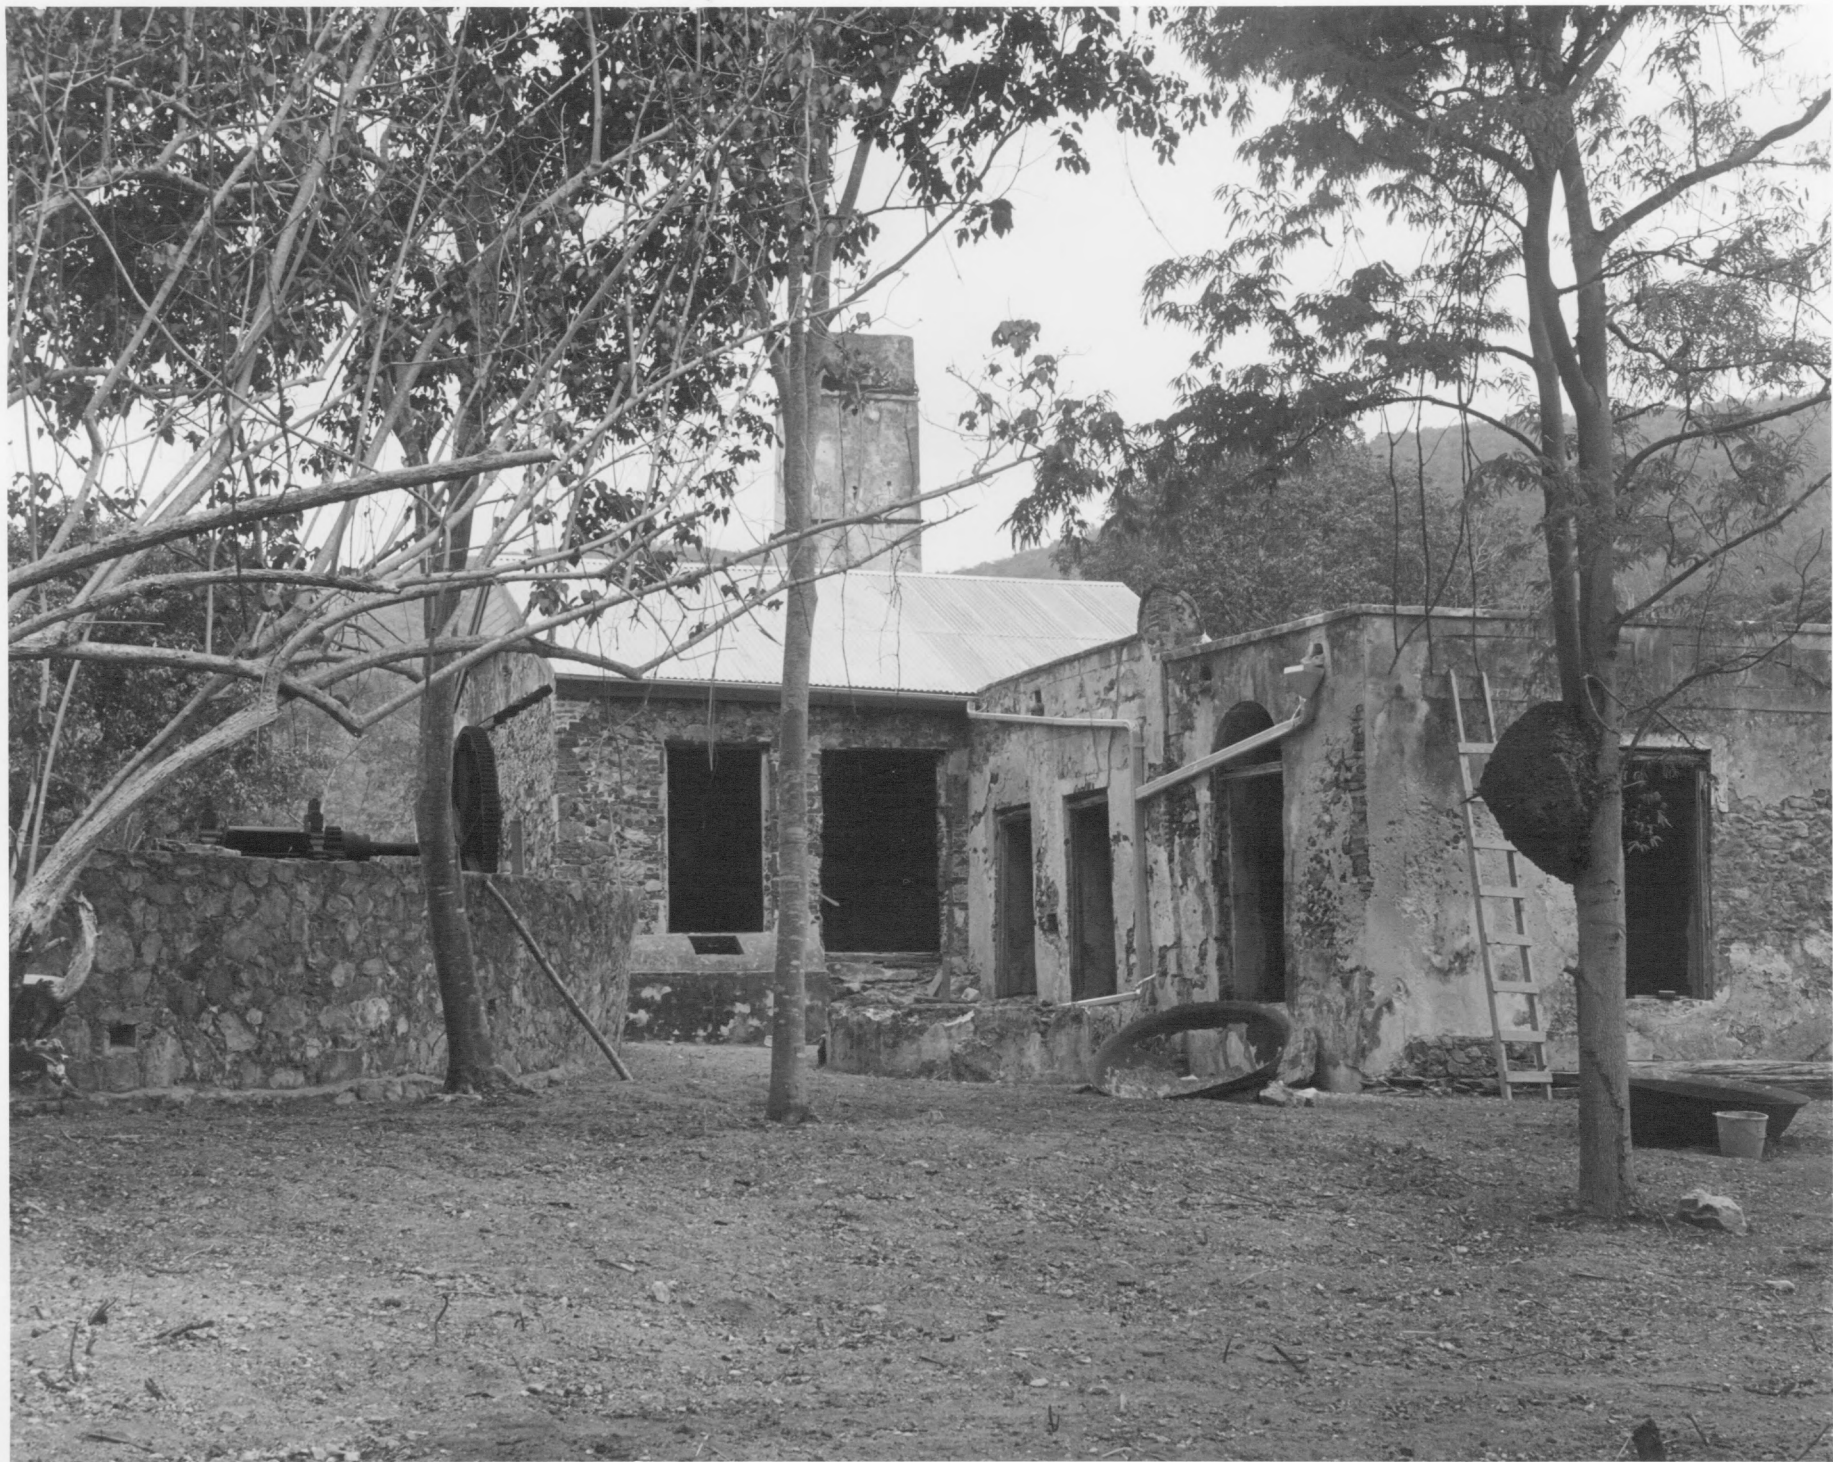
# Horsemill and Factory

**Horsemill, H-13, 1 (Left) and factory building (H-13, 2)**

**viewed from the southeast. 1860's engine house in center of view with boiling house to the right.**

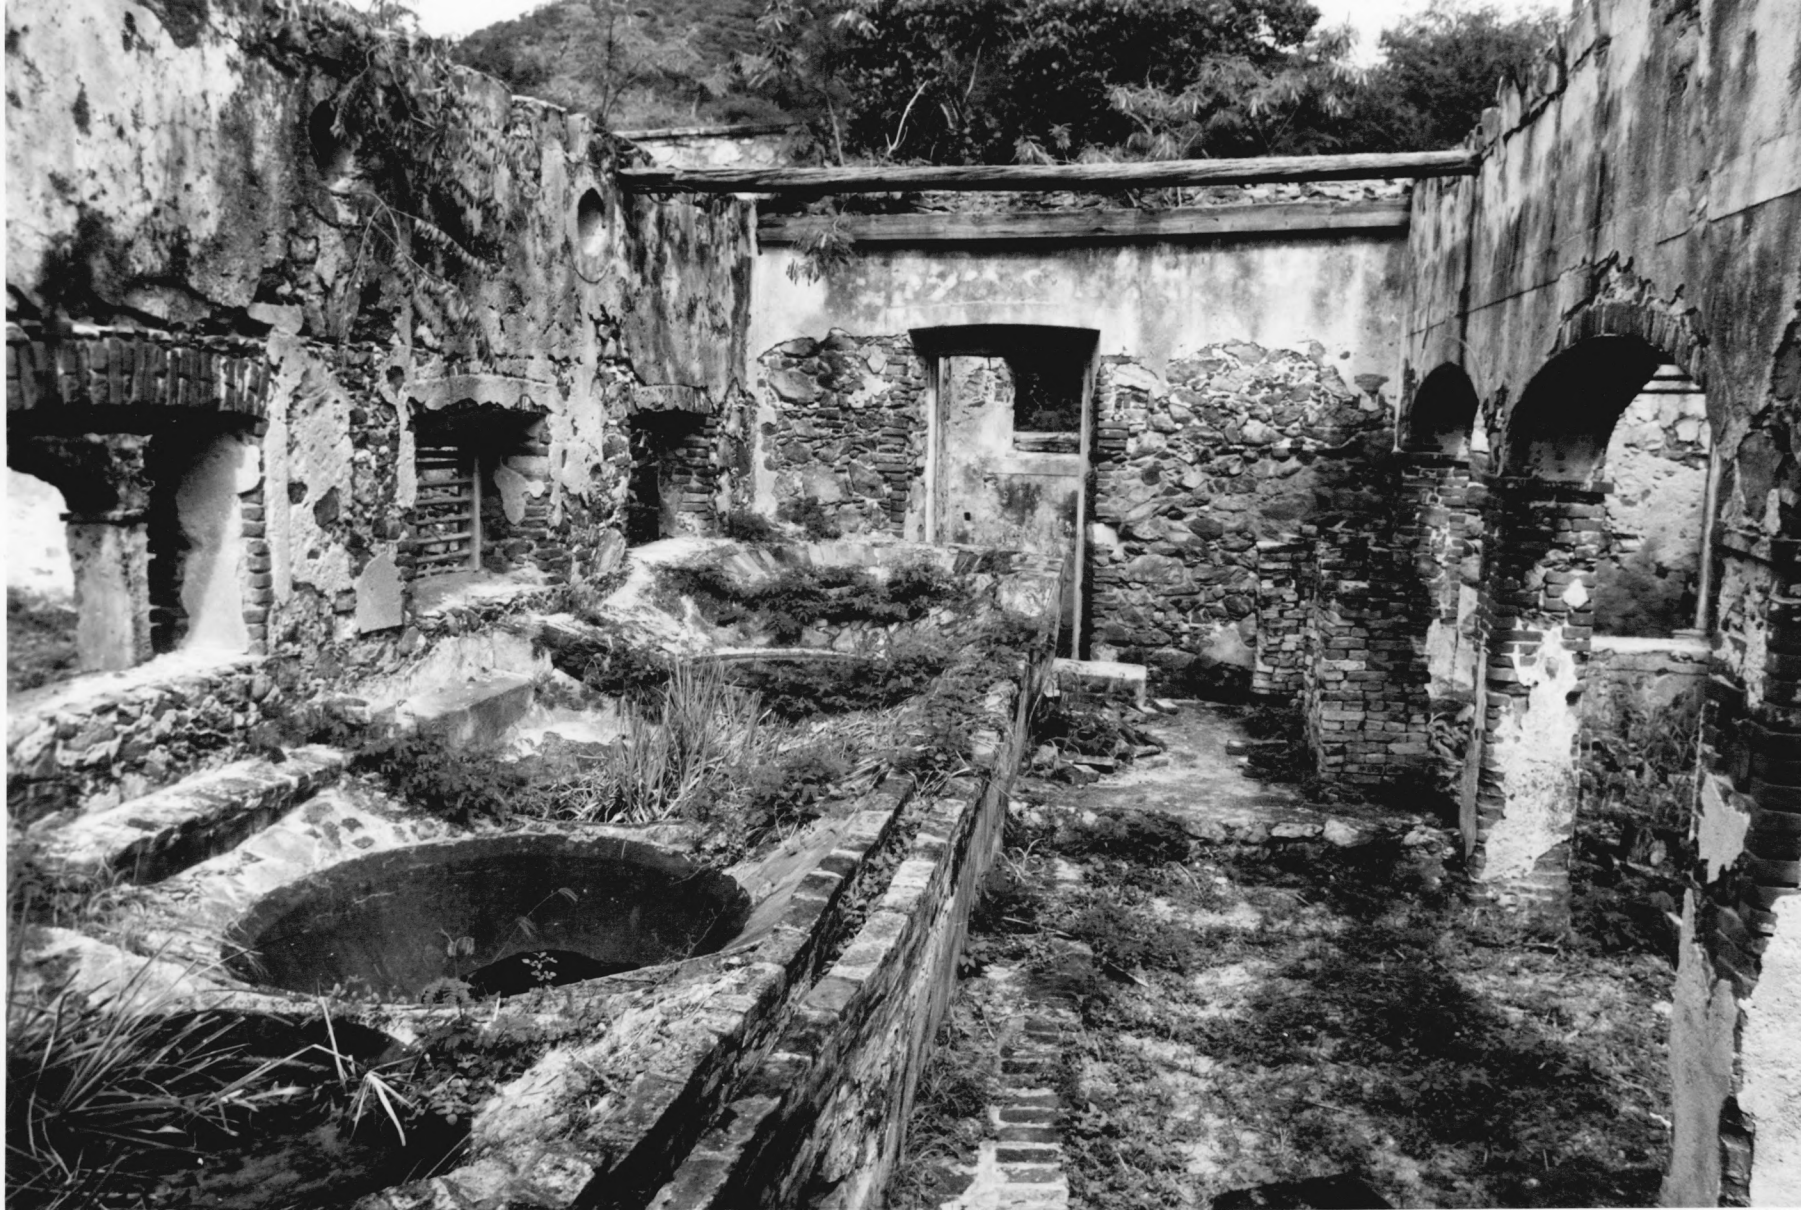
# Factory

**Interior of boiling house of factory (H-13, 2) viewed from the south, prior to reroofing.**

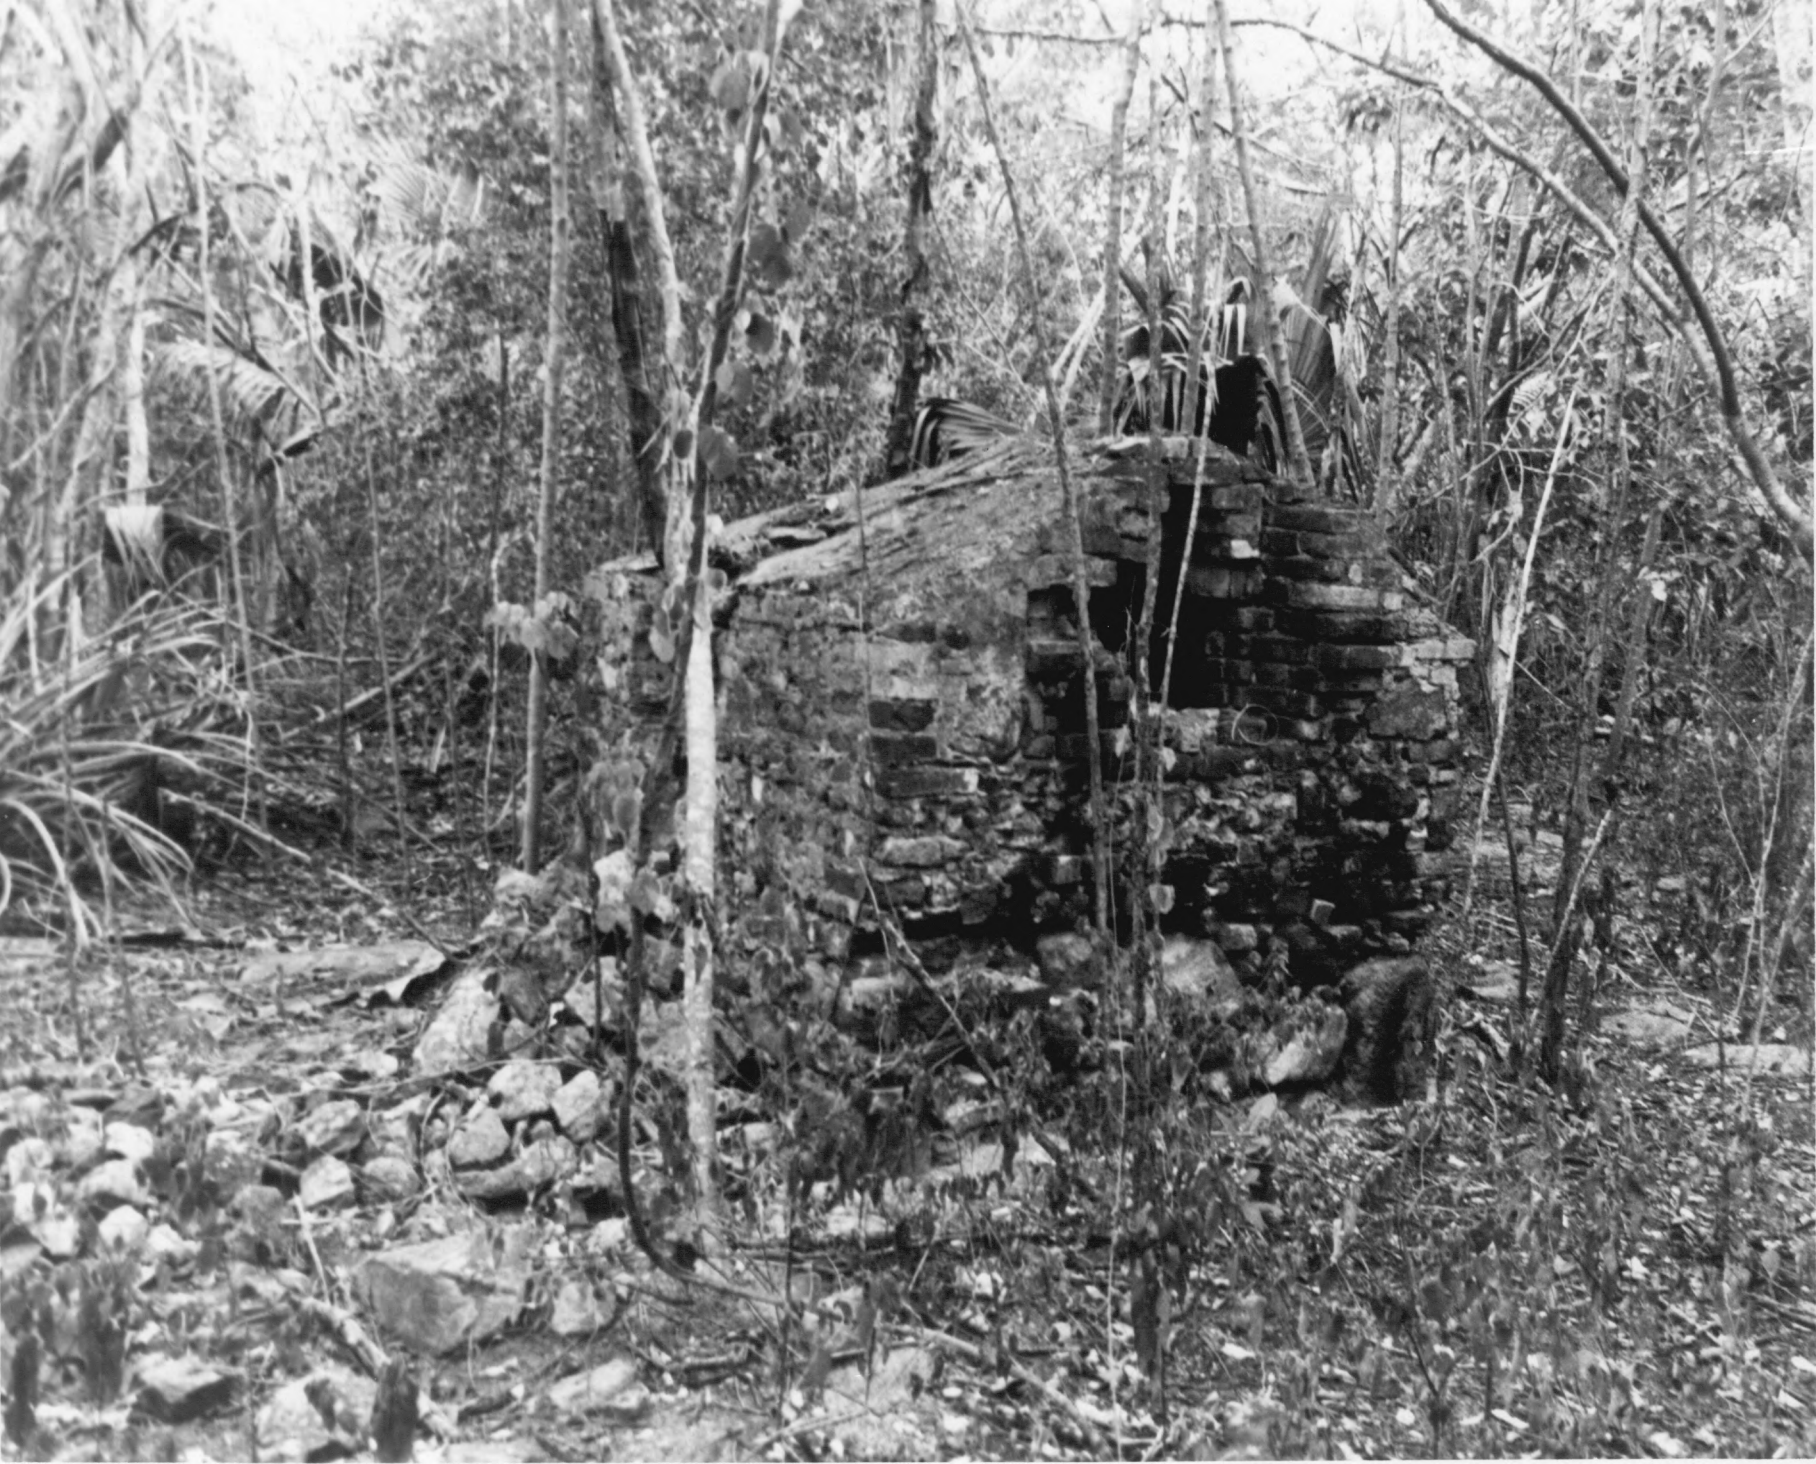
# Bake Oven

Bake Oven H-13, 6 viewed from the south.

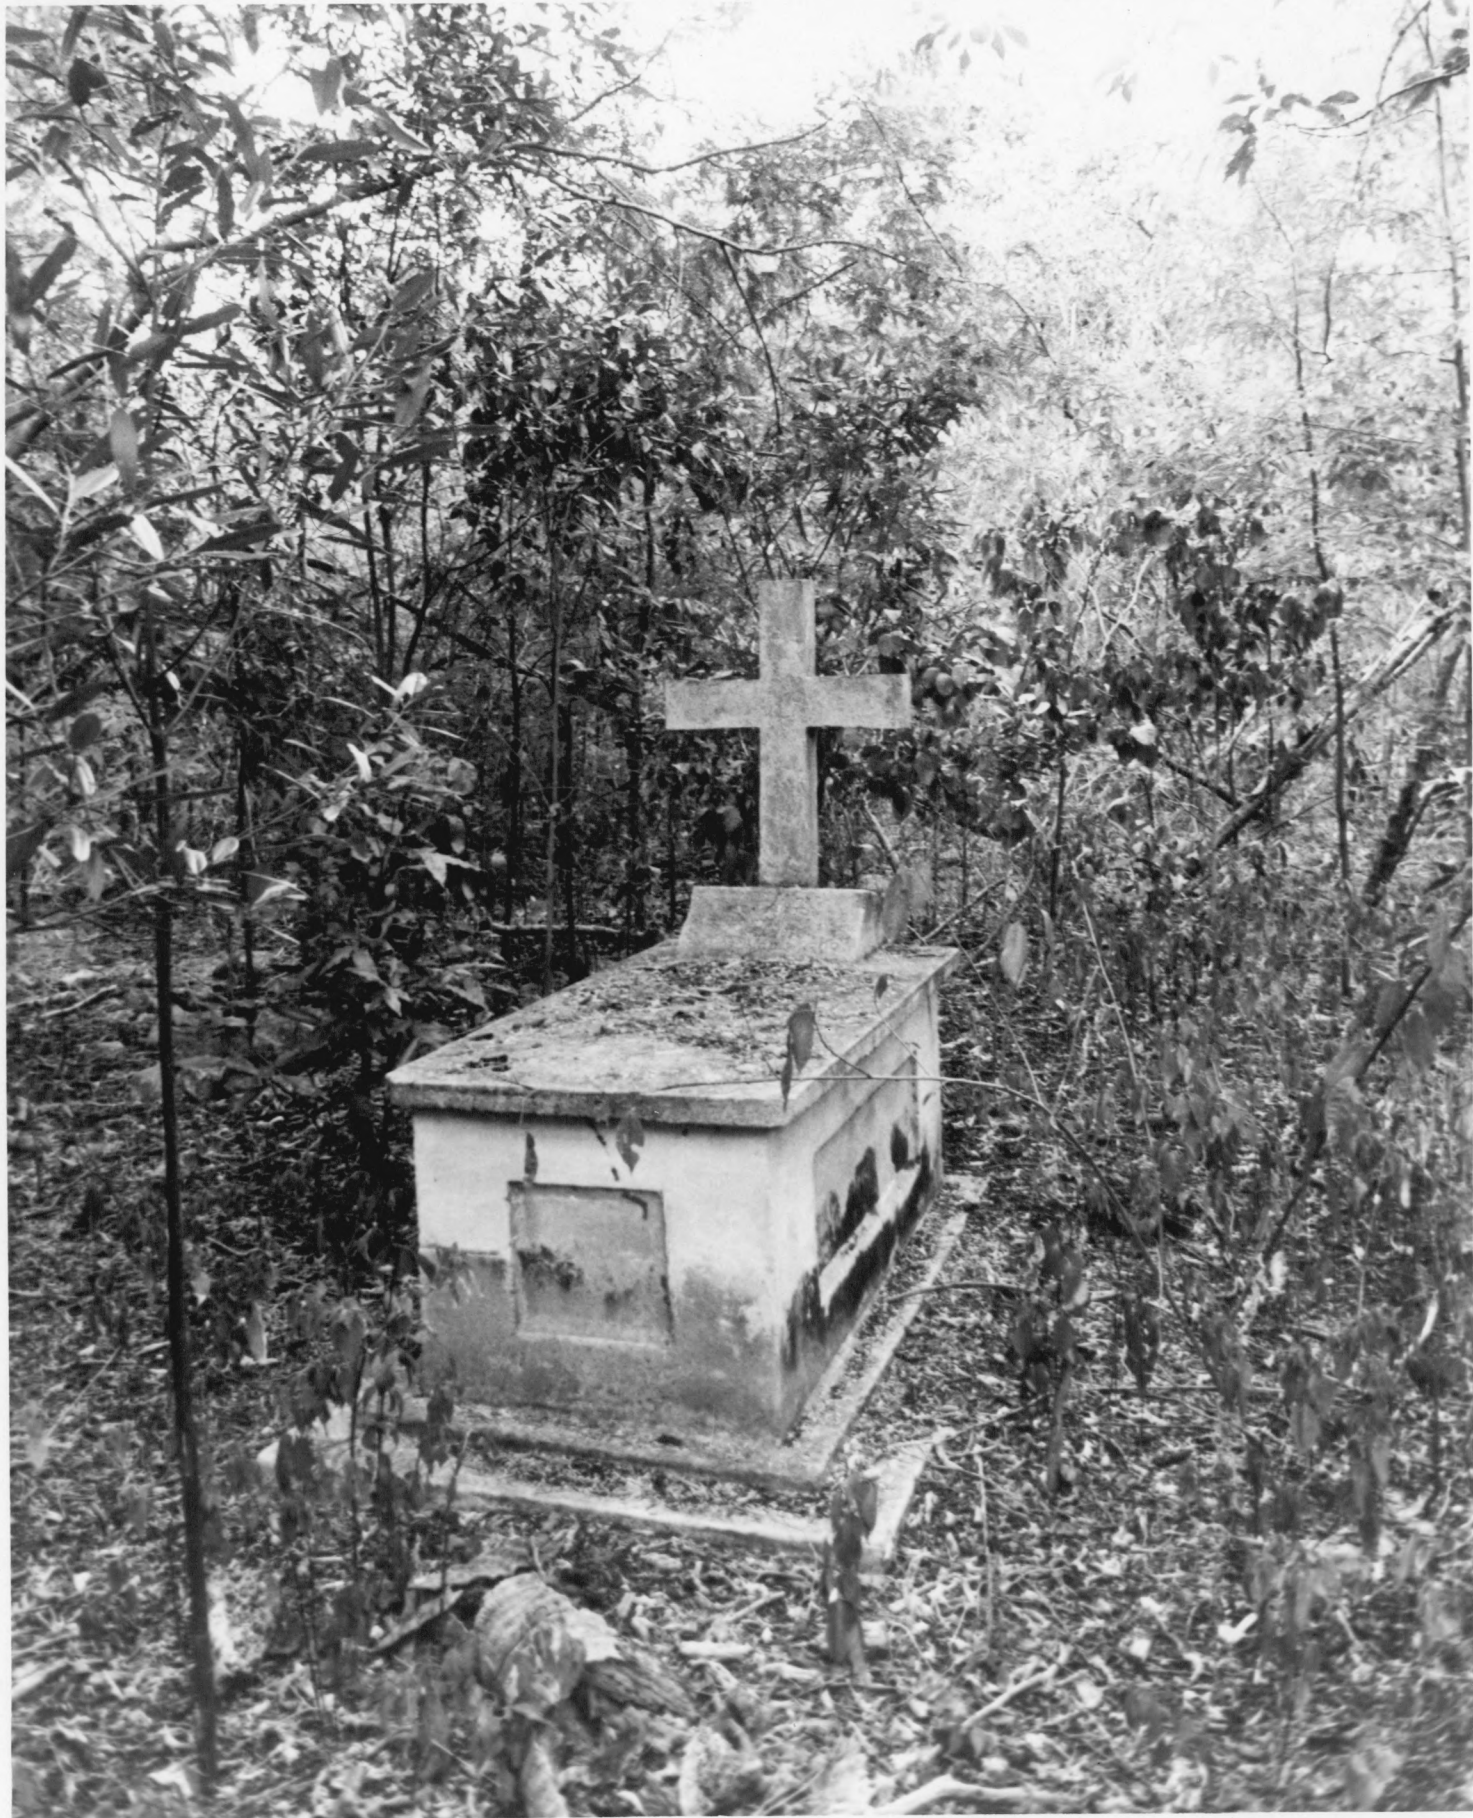
# Grave

Grave of William Marsh viewed from the north (H-13, 8).

An ill-defined cemetery is located southeast of the horsemill and south of the oxpound. It is known to contain the graves of three members of the Marsh family. Only one, the grave of William Marsh is monumented, by a built up masonry structure surmounted by a standing cross.
