APPENDIX B  
MORE HILL HISTORIC DISTRICT

Appendix B,  
Historic DistrictCLASSIFIED STRUCTURE FIELD INVENTORY REPORT  
(Attach 4"x5" B&W Photo)

REGION Southeast PARK/AREA NAME Virgin Islands Nat'l Park CODE NO. 5360STRUCTURE NAME Residence, More Hill STRUCTURE NO. H-38,1ORDER OF SIGNIFICANCE: National ☐ State ☐ Local ☒LOCATION OF STRUCTURE: 500 yards east of More Hill on east end of St. John

MORE HILL H-38

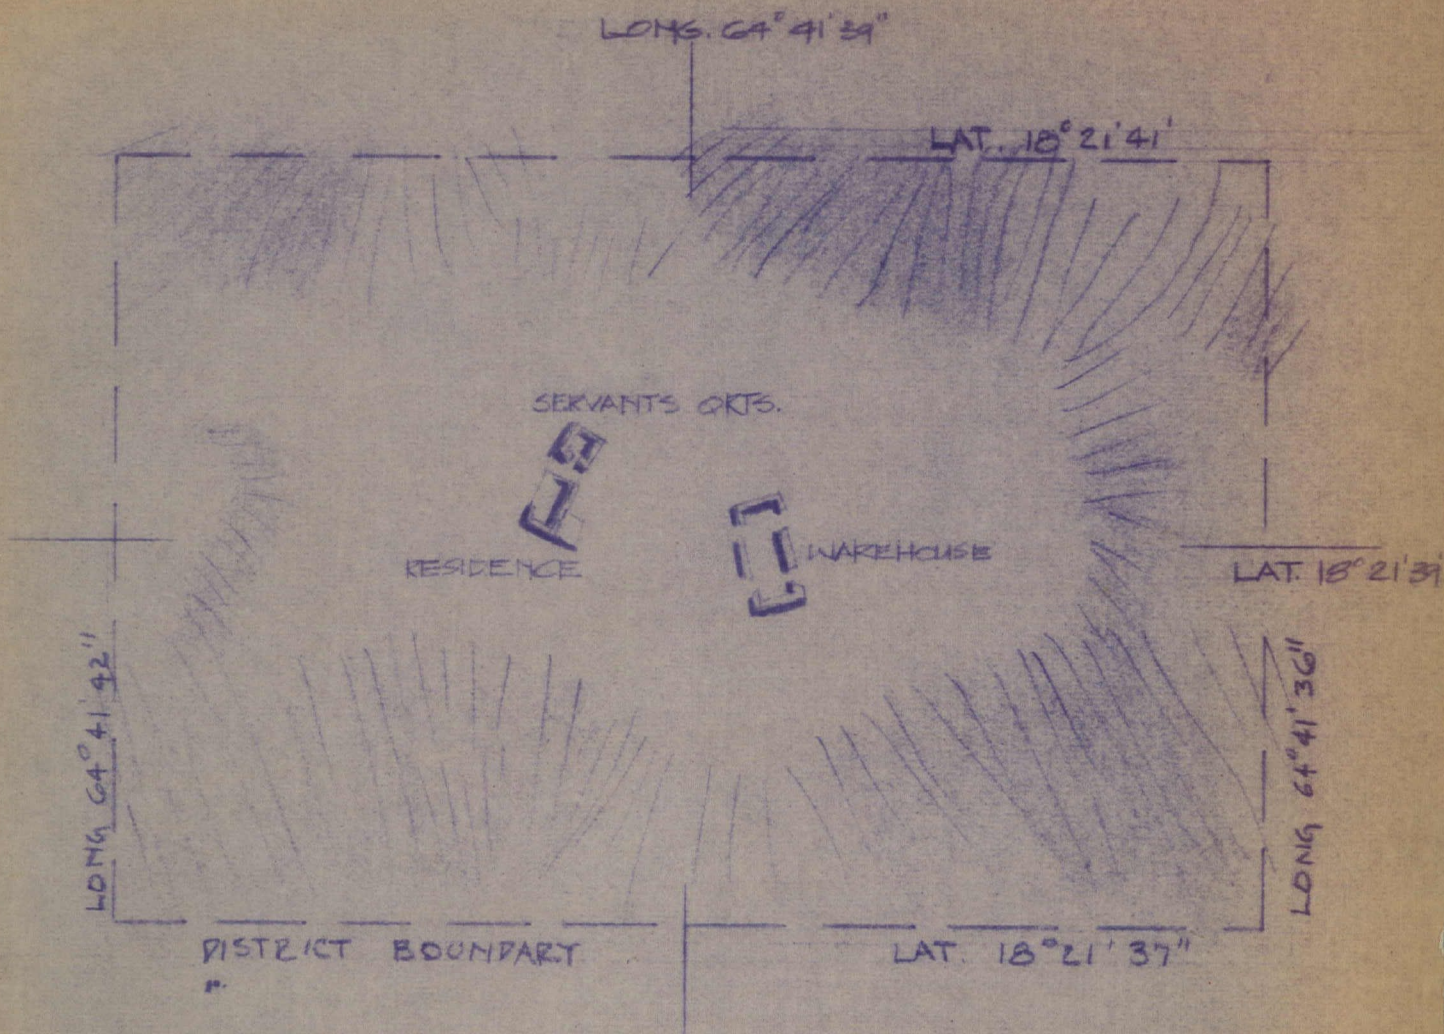
SERVANTS QRTS.

RESIDENCE

WAREHOUSE

DISTRICT BOUNDARY

More Hill Historic District is located in an area of dense bush without any distinct natural or man made features and is surrounded by protected park lands. For this reason the District has arbitrarily been defined as the area bounded by latitudes 18° 21' 41" and 18° 21' 37" and by longitudes 64° 41' 42" and 64° 41' 35".
