## **US Fish and Wildlife-Caribbean Region**

### **Final Project Report**

**Project Name:** Erosion Control Strategy for the Fish Bay Watershed  
**Recipient Organization:** Island Resources Foundation (IRF)  
**Recipient Contact:** Bruce Potter, President  
**Recipient E-mail:** [bpotter@irf.org](mailto:bpotter@irf.org)  
**Recipient Phone:** 202-265-9712  
**Recipient Web Address:** <http://www.irf.org>

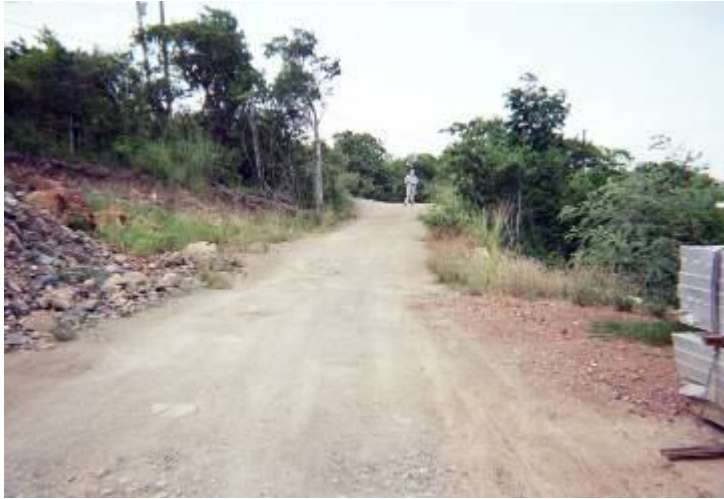
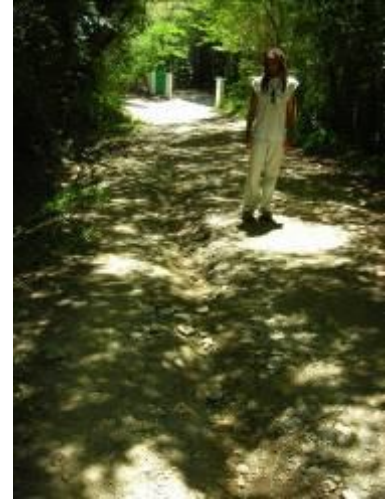
Carlos Ramos-Scharrón prepares a sketch map of a road segment on the Upper Fish Bay basin (left). Kevel Lindsay observes the damage done on an unpaved road segment by erosion (right).

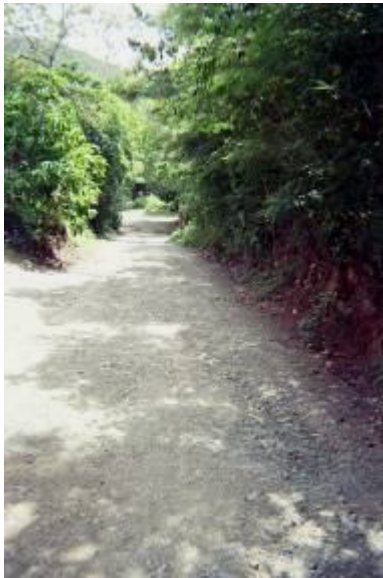
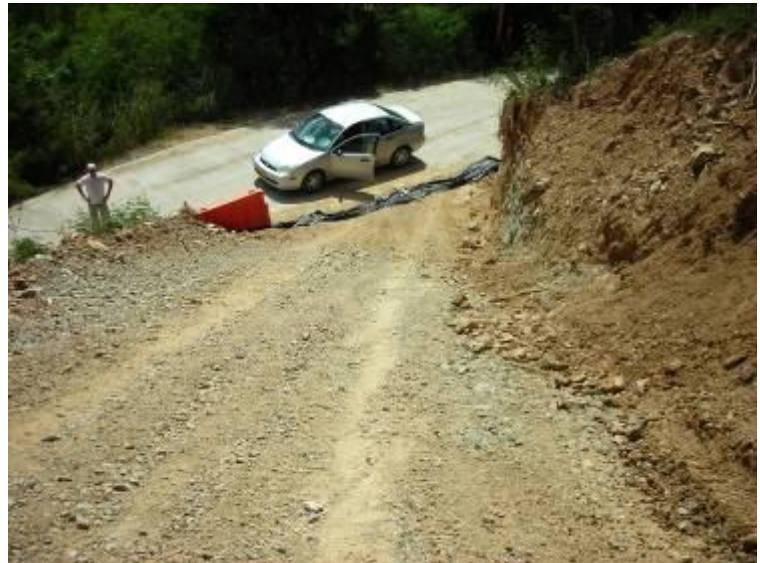
Road segment on Catherineberg Estate which eventually became a site for erosion control implementation (left). Jean-Pierre Bacle observes a steep, recently-constructed, unpaved driveway on Estate Fish Bay (right).

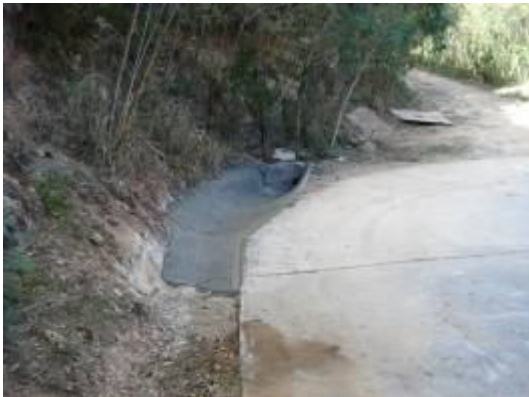
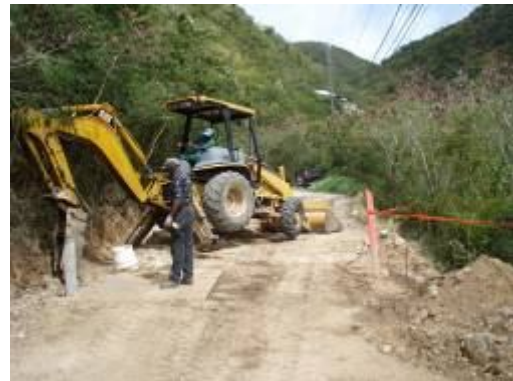
New culverts installed at Caribe Road (Point 1 in map on the left; Point 2 on the right).

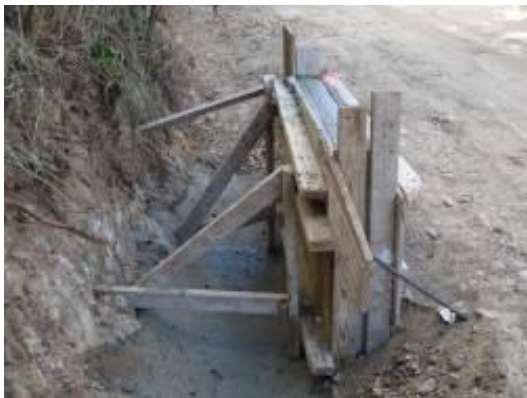
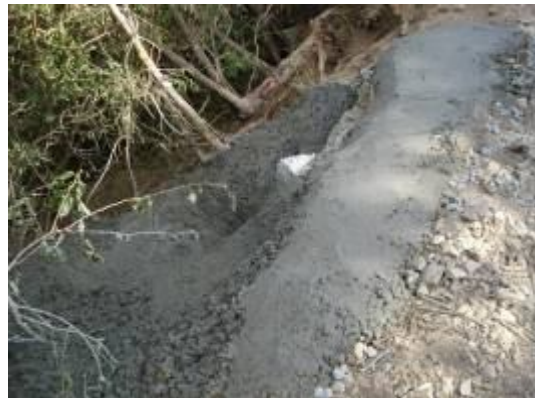
New headwall & culvert installed at Caribe Road (Point 2 in map).

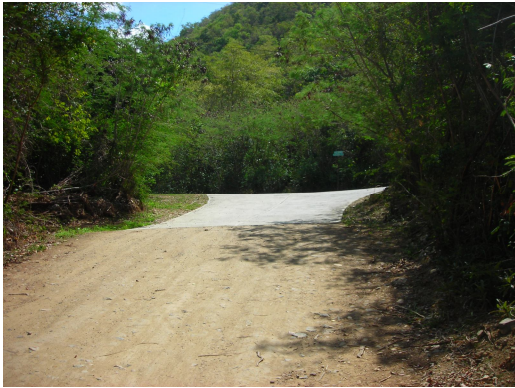
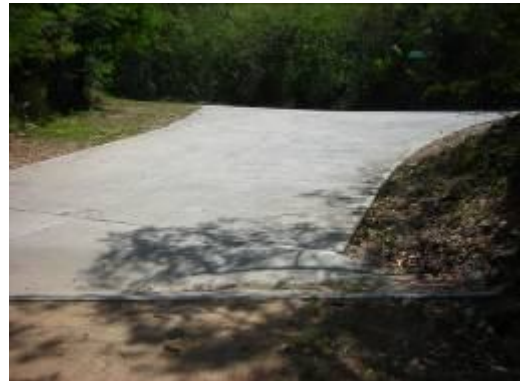
New cemented swale on Cocoloba Trail at Point 1 in map. Swale diverts upslope runoff from flowing over the lowermost sections of Cocoloba Trail.

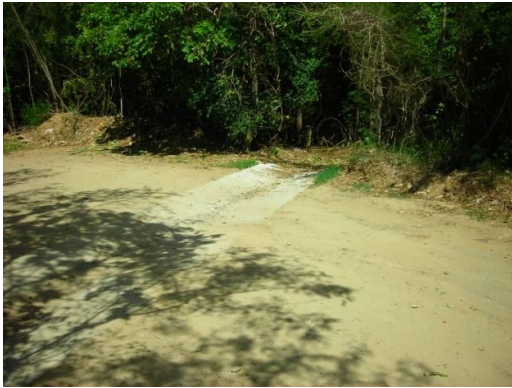
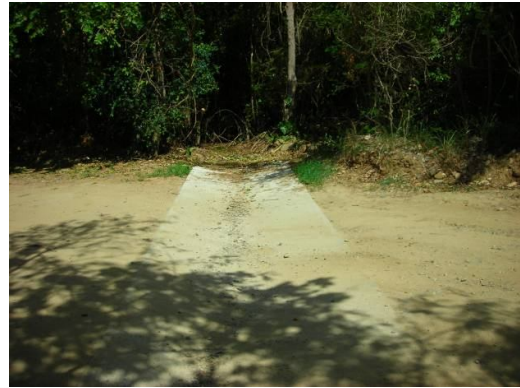
New cemented swale along Cocoloba Trail at Point 2 in map.

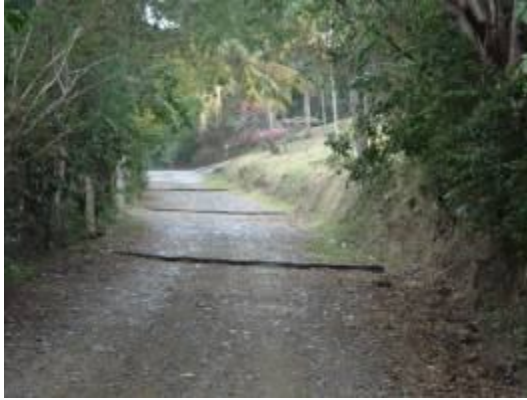
Deflectors along Flamboyant Road (Point 2 in map).

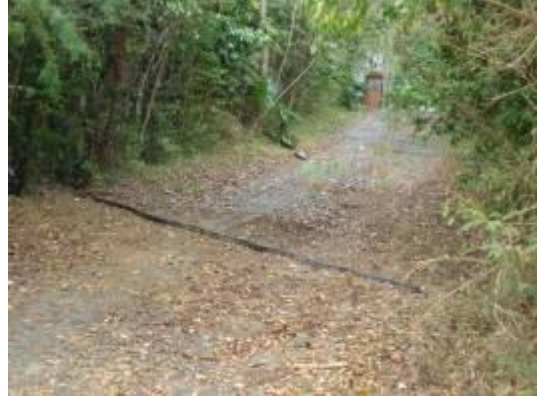
Deflector along Flamboyant Road (Point 1 in map).

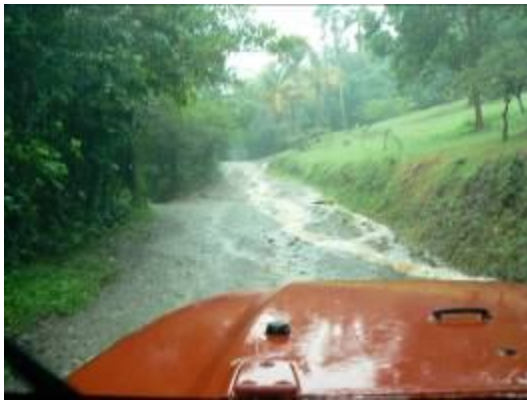
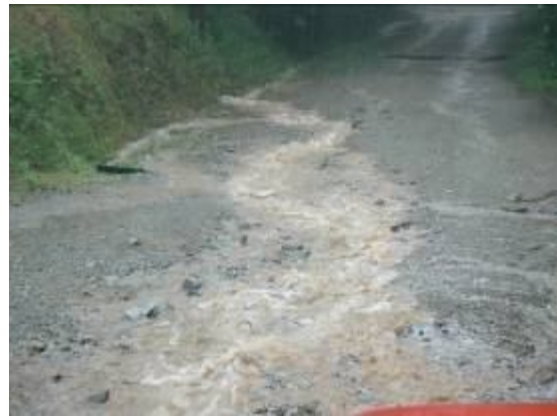
Deflectors during an intense rain event in October 2008. Pictures show that the deflectors were unable to maintain runoff on the inside portions of the road due to runoff overflow and the lack of a new deep ditch.

Erosion control measures at this road segment consisted in the installation of deflectors. This road segment receives very little traffic (~5 vehicles per day during most of the year) and our intention was to test a different type of road drainage control method. Deflectors are made of pieces of skidboard rubber that are vertically-installed and set on trenches dug out of the road surface. The deflectors were meant to force drainage into the inside section of the road where a ditch was intended to be dug out. This ditch was never dug by the contractor. By splitting the road segments into shorter sections we intended to reduce the erosive power of runoff from eroding the road surface. A combination of problems made this method ineffective. First, the rubber material quickly broke down after several weeks. This could have been caused by an already deteriorated condition of the material and by improper installation by the contractor which failed to install them following guidelines provided to them which included the use of wood planks to help stabilize the rubber in a vertical position. The contractor's failure to dig a new ditch also create problems as this allowed the runoff on the inside parts of the road to overflow onto the road surface and continue to erode. Due to its high cost and propensity to breakdown, we do not recommend the use of this method as an erosion control strategy.

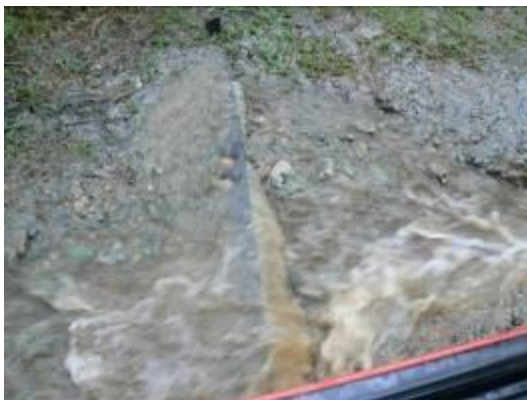
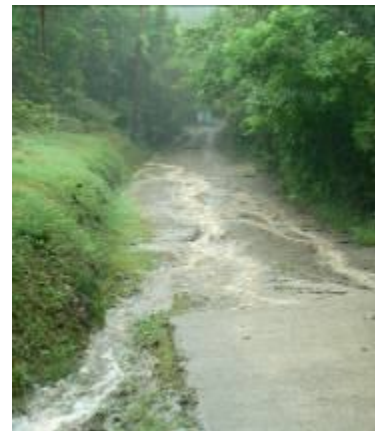
Deflectors during intense rainfall event in October 2008. Picture to the left is a close-up of runoff overtopping the deflector. Picture to the right shows runoff continuing to flow on the road surface instead of the intended purpose to maintain in on the inside ditch.

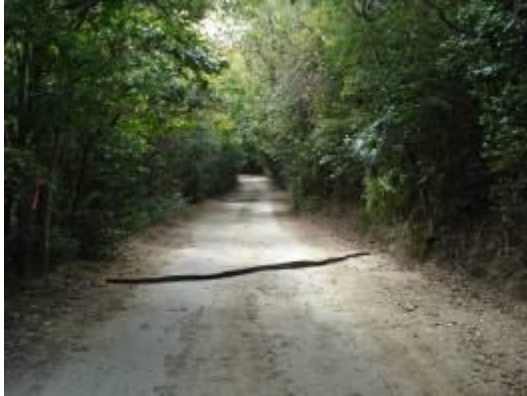
Deflectors along John Head Road.

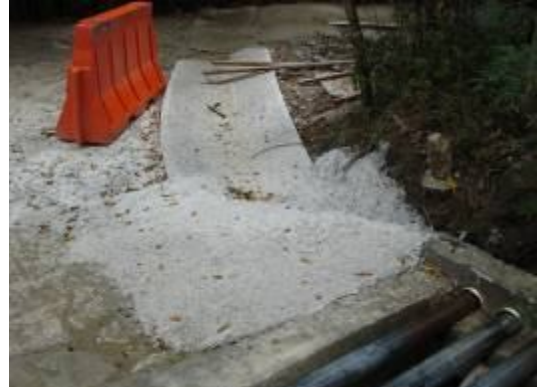
Cemented swale along JH Rd (construction phase).

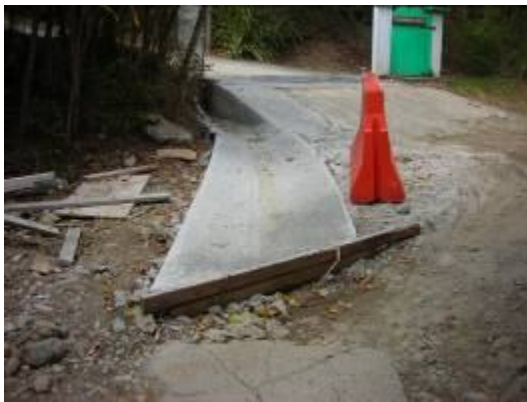
Cemented swale & pre-existing cattle-guard drain along John Head Road (construction phase).

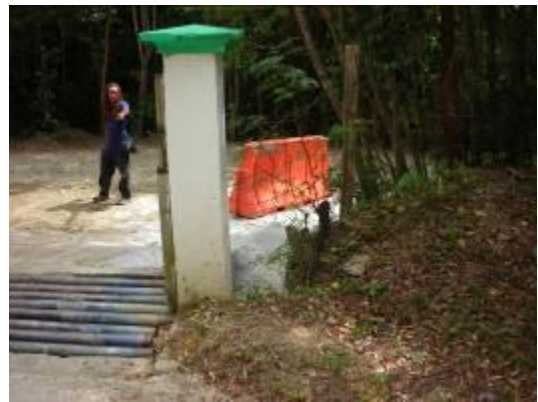
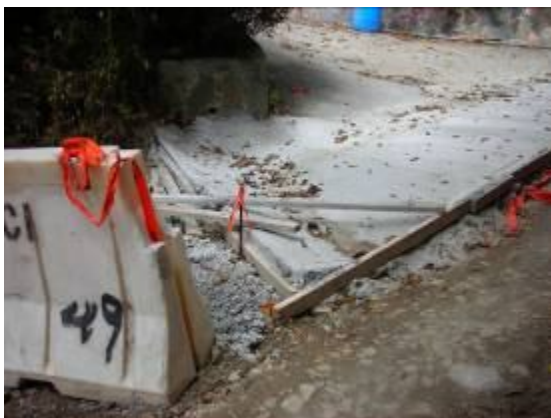
Cement slab and cemented swale along John Head Road (construction phase).

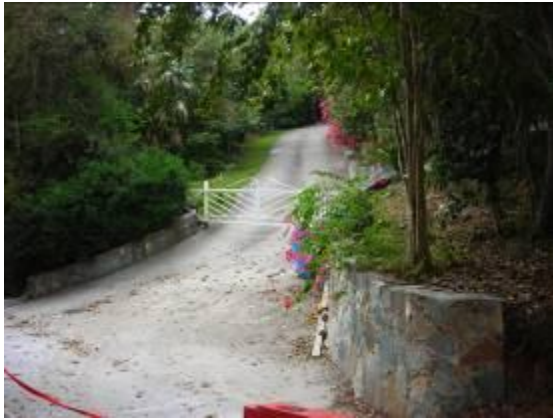
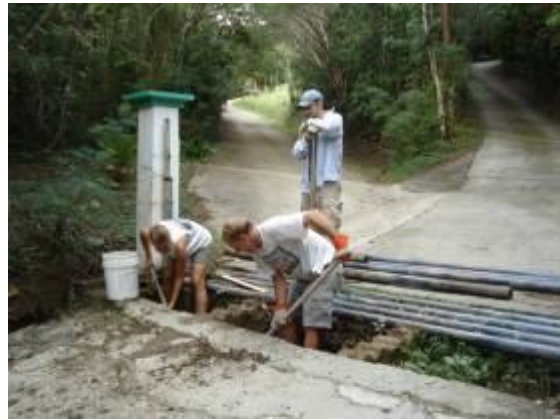
Cement slab and cemented swale at the bottom of a paved driveway along John Head Road (left). Dr. Ramos-Scharrón and volunteers help clean out a clogged runoff drainage structure (right).

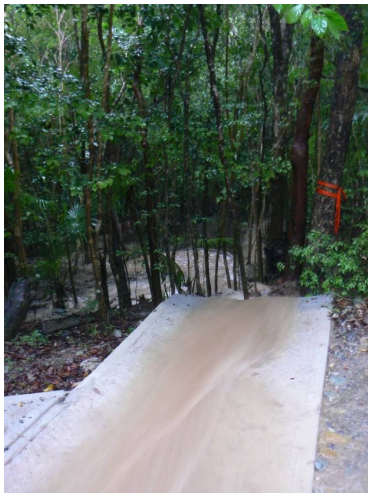
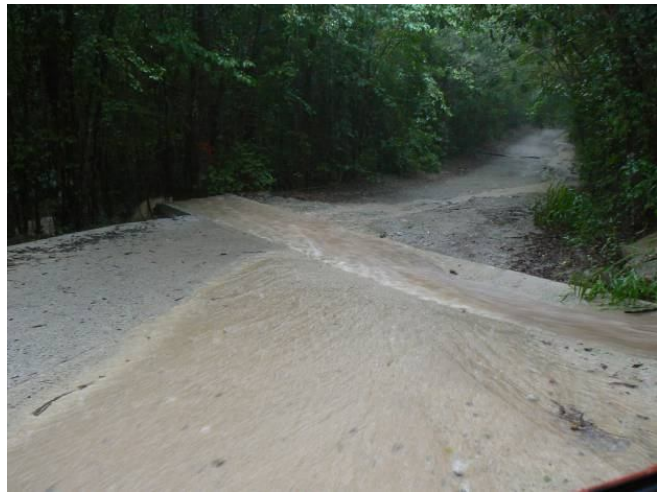
Cemented swales at Points 1 (left) and 3-4 (right) in map during an extreme rainfall event in October 2008. Notice on the picture to the right that some runoff is overtopping the swale and inducing runoff concentration and erosion on the lower portions of the road.

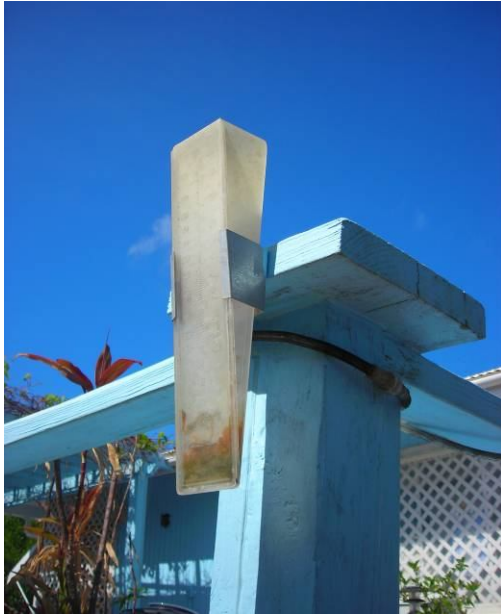
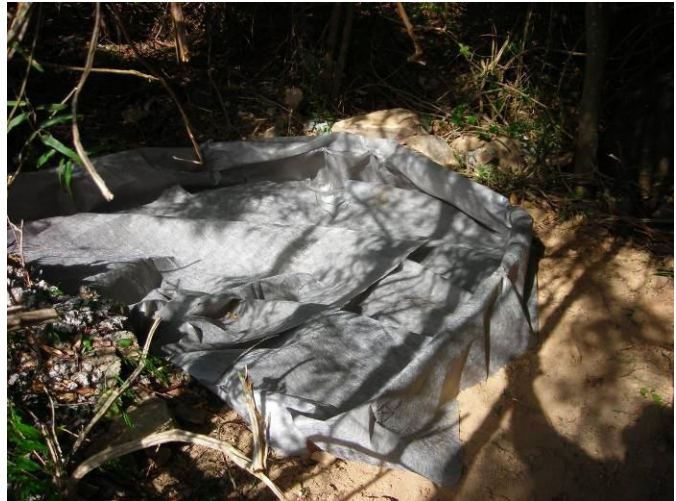
Rain gauge used to measure daily rainfall at Fish Bay. Recently installed sediment trap at Caribe Road.

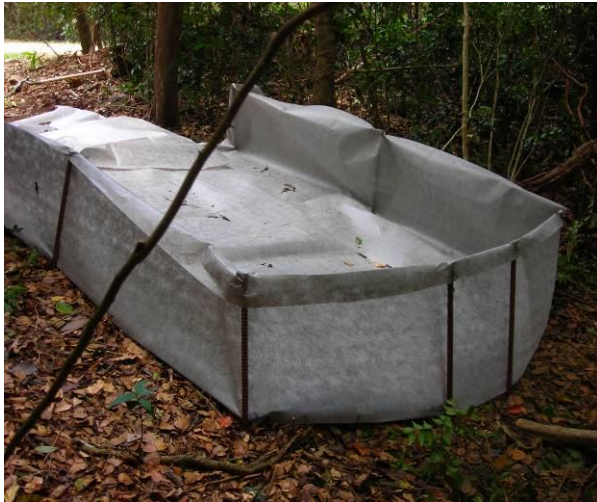
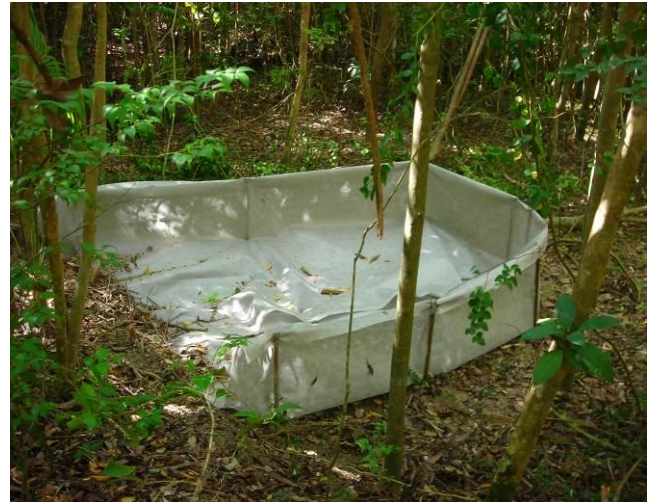
Sediment traps at Cocoloba Trail and John Head Road.
