APPENDIX B  
BROWN BAY PLANTATION HISTORIC DISTRICT

STRUCTURE NAME Sugar Factory , Brown Bay Plantation

STRUCTURE NAME Plantation House, Brown Bay Plantation STRUCTURE NO. H-36.3

Historic Name: Brown Bay, Brynes Bay (1800),

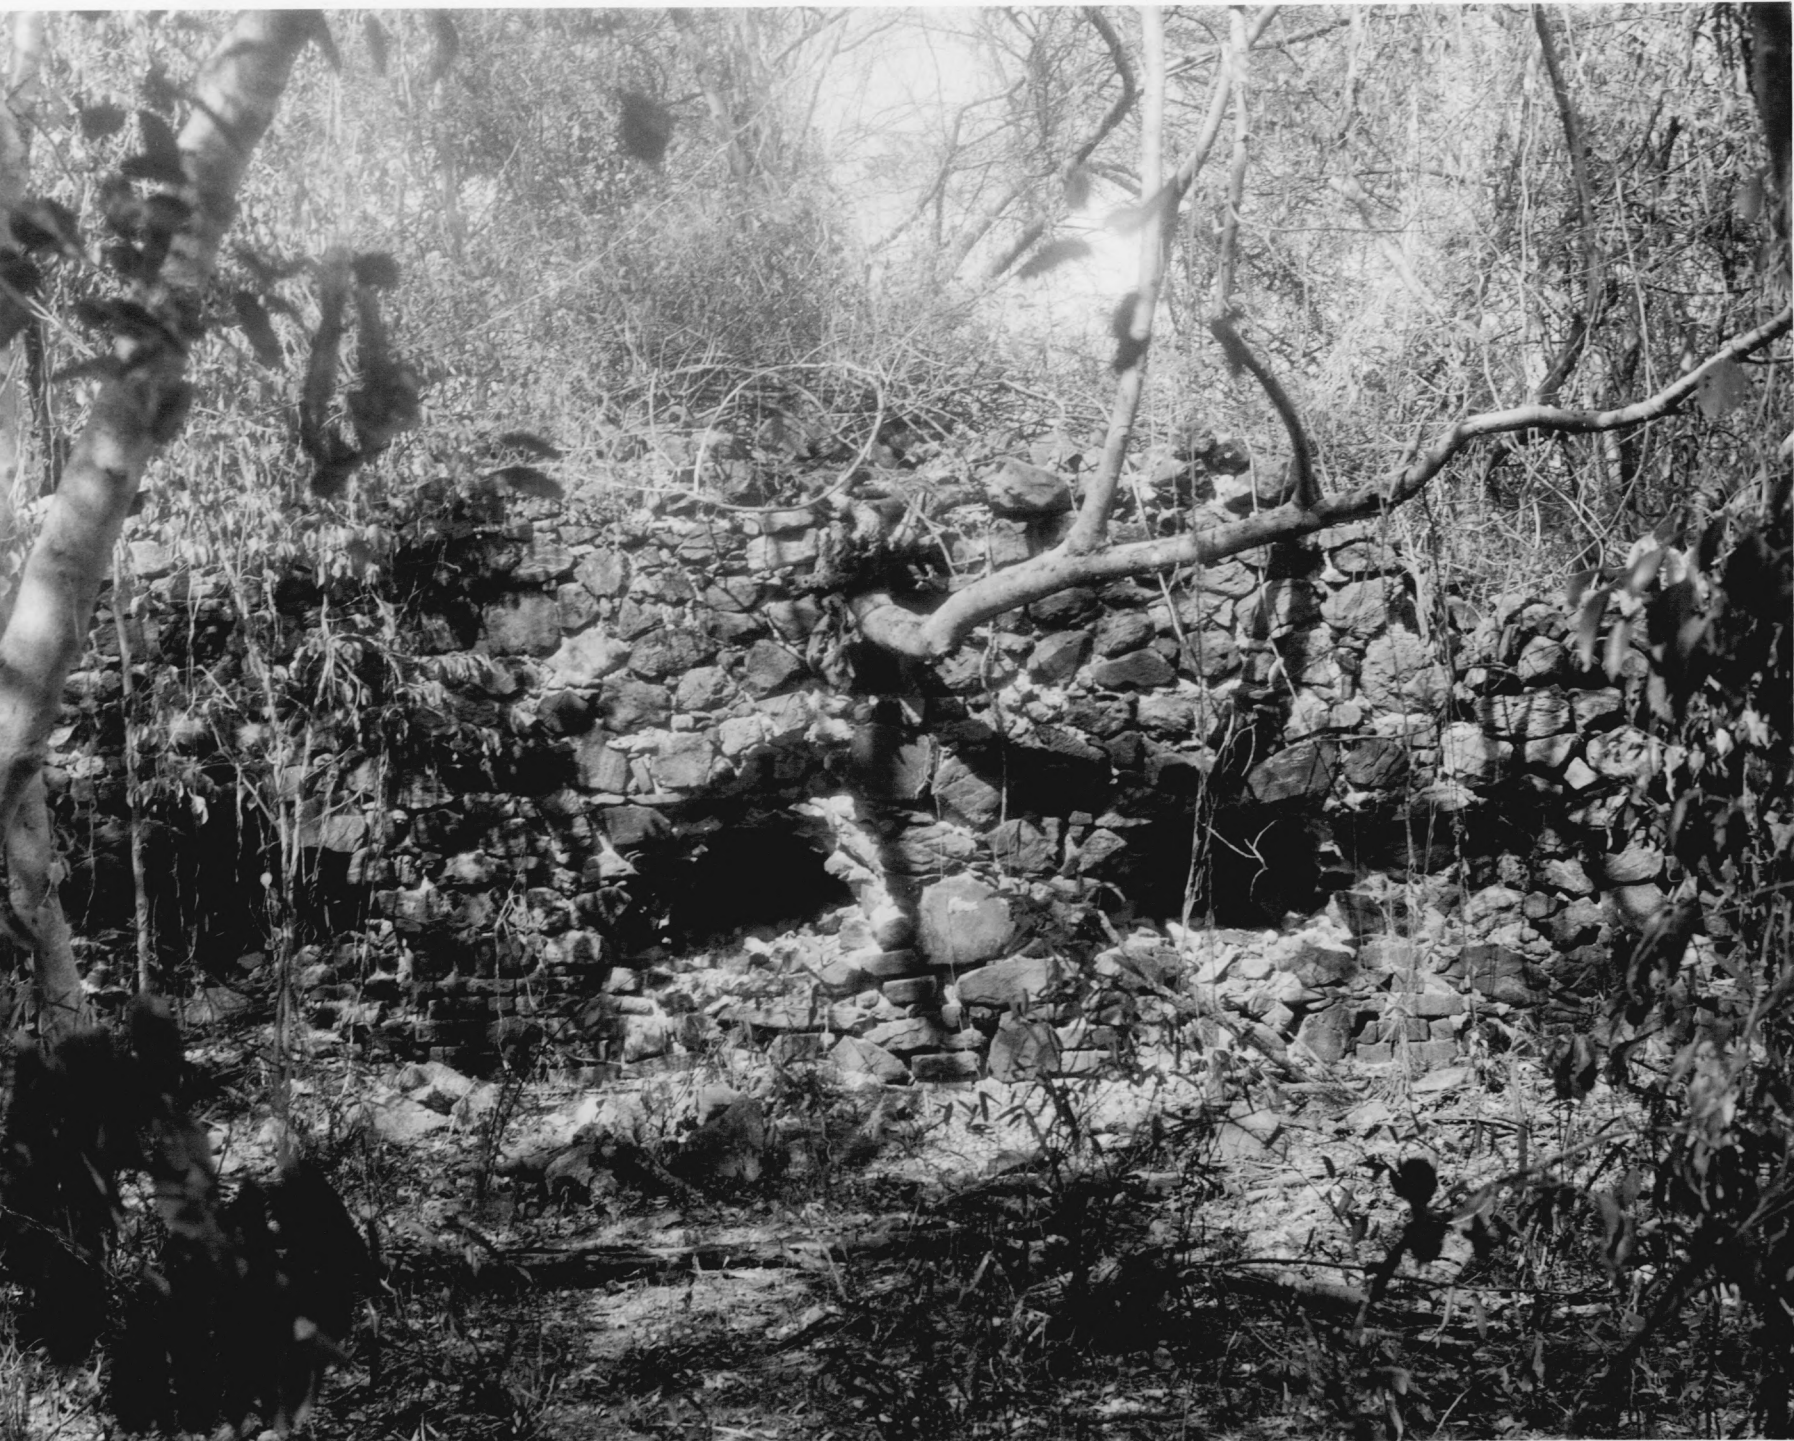
1 of 5

Section of firing trench of Factory (H-36,2) viewed  
from the south.

Physical Description: A relatively small rectangular factory 27'x42' consisting of only a boiling house. The factory was intended to be "T" shaped in plan but was either never completed or altered. The unfinished section, the curing and storage wing is now a walled open courtyard between the completed section of the factory and the newer plantation house to the east. The ruins stand to the head height of the windows. The chimney is missing. The curing and storage wing, the head of the "T" shaped plan layout was apparently intended to be 2 stories. The building in all probability was erected during the last decades of the 18th century.

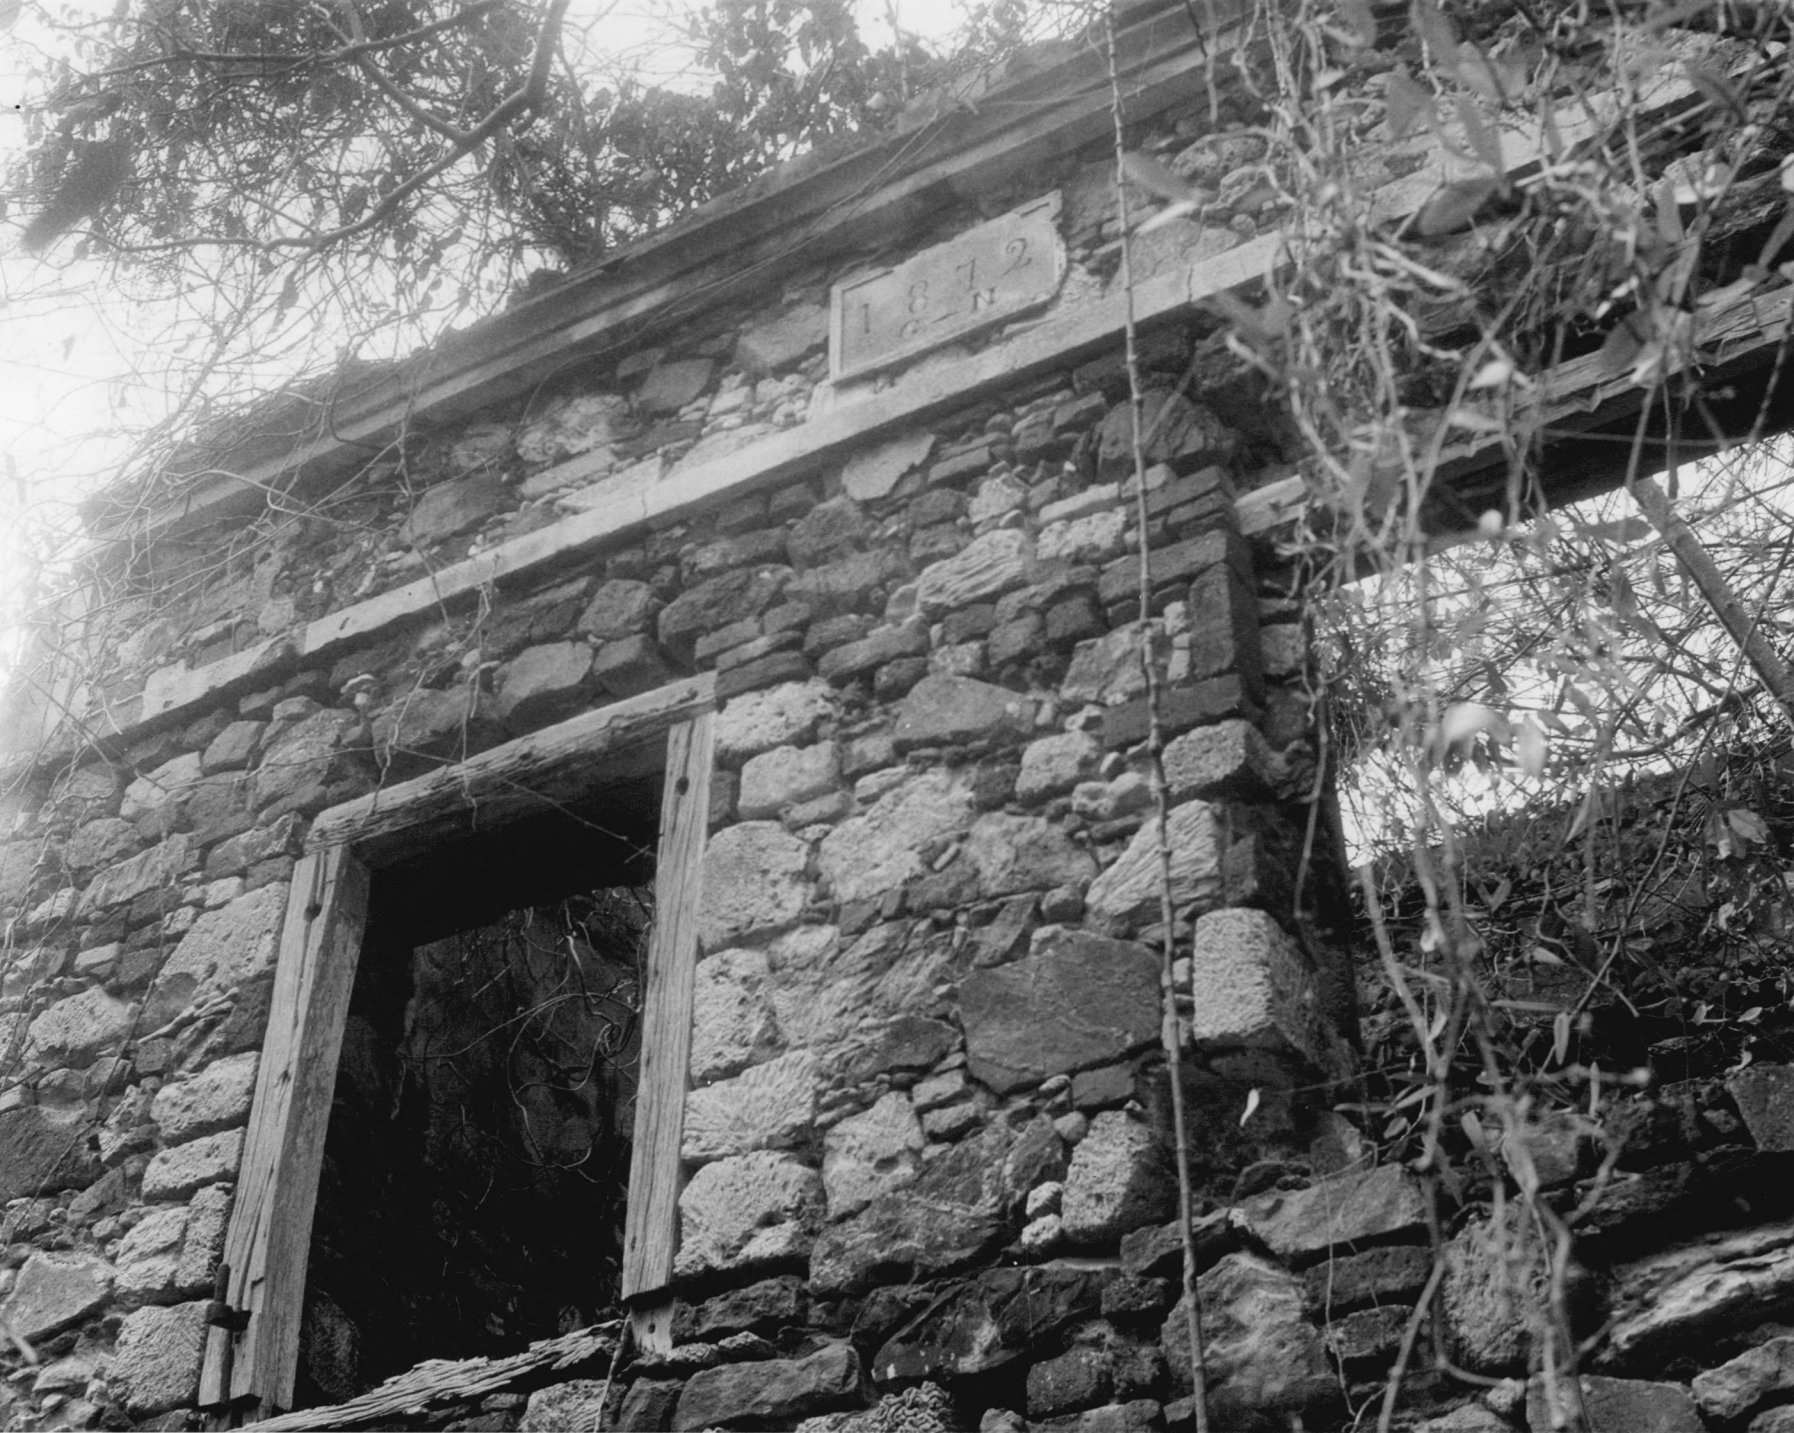
2 of 5

Detail of the 1872 addition to the Plantation House  
H-36,3 viewed from the east.

**Physical Description:** A large and impressive ruin of a plantation dwelling house, 60'x70'. Originally a two-story building with a masonry grand floor and a second story in wood, it was expanded with a late 19th century two-story masonry addition as well as additions of one story masonry construction. It incorporates storage and other work functions of the plantation. The walls still stand to their full height with masonry staircases to the former wood second story. There are 3 cisterns, two of which still hold water. The exterior still exhibit considerable architectural embellishment such as projecting quoins, bands, raised panels and fragments of cornices with classical revival mouldings.

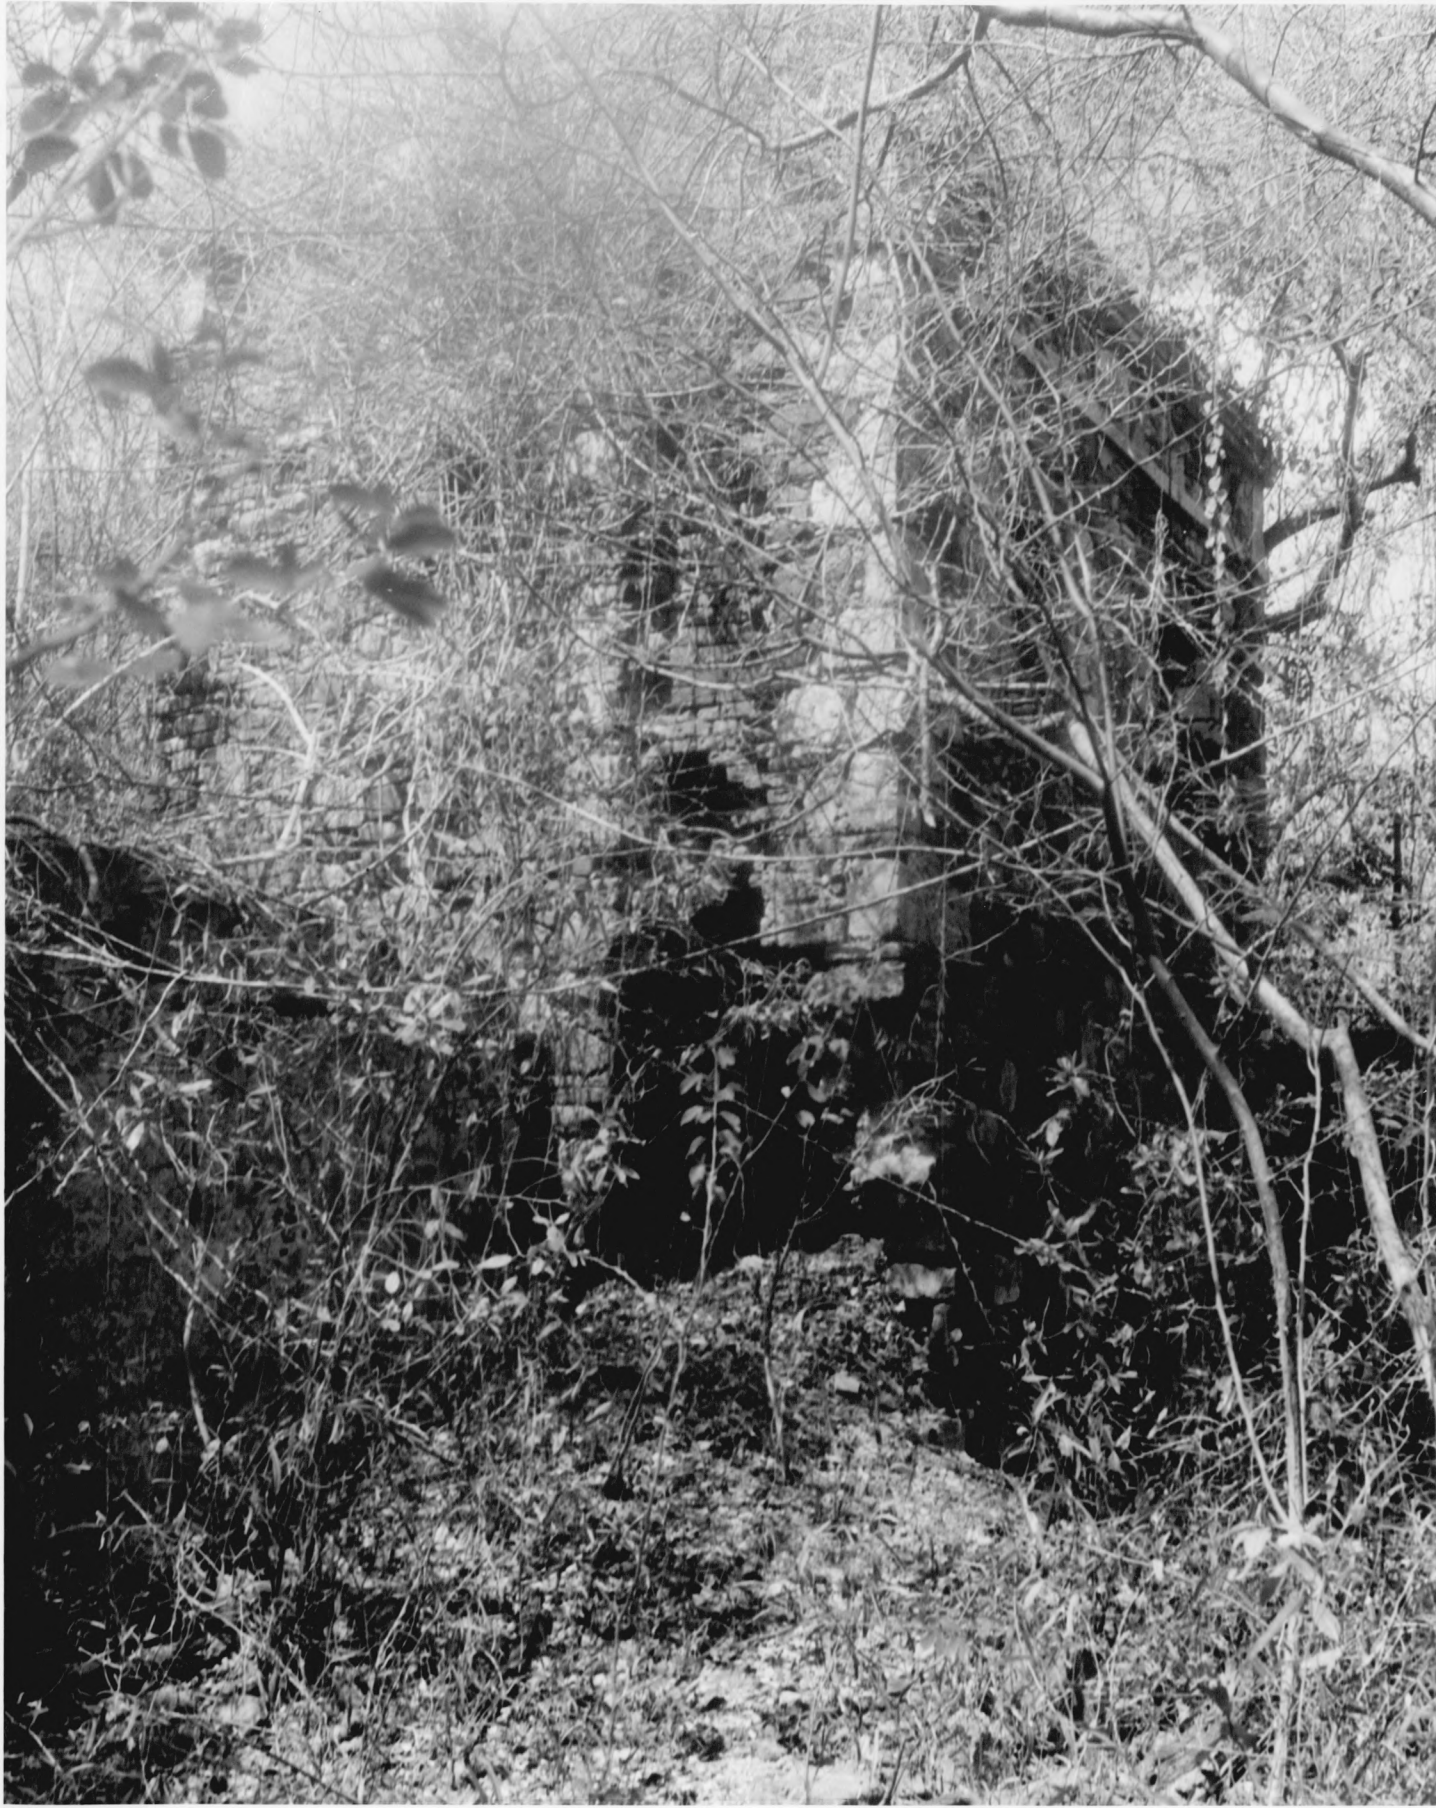
(V1 National Park Molt. Res. time) JUN 8 1981 3 of 5

South section of the Plantation House H-36,3 viewed  
from the southwest. JUL 23 1981

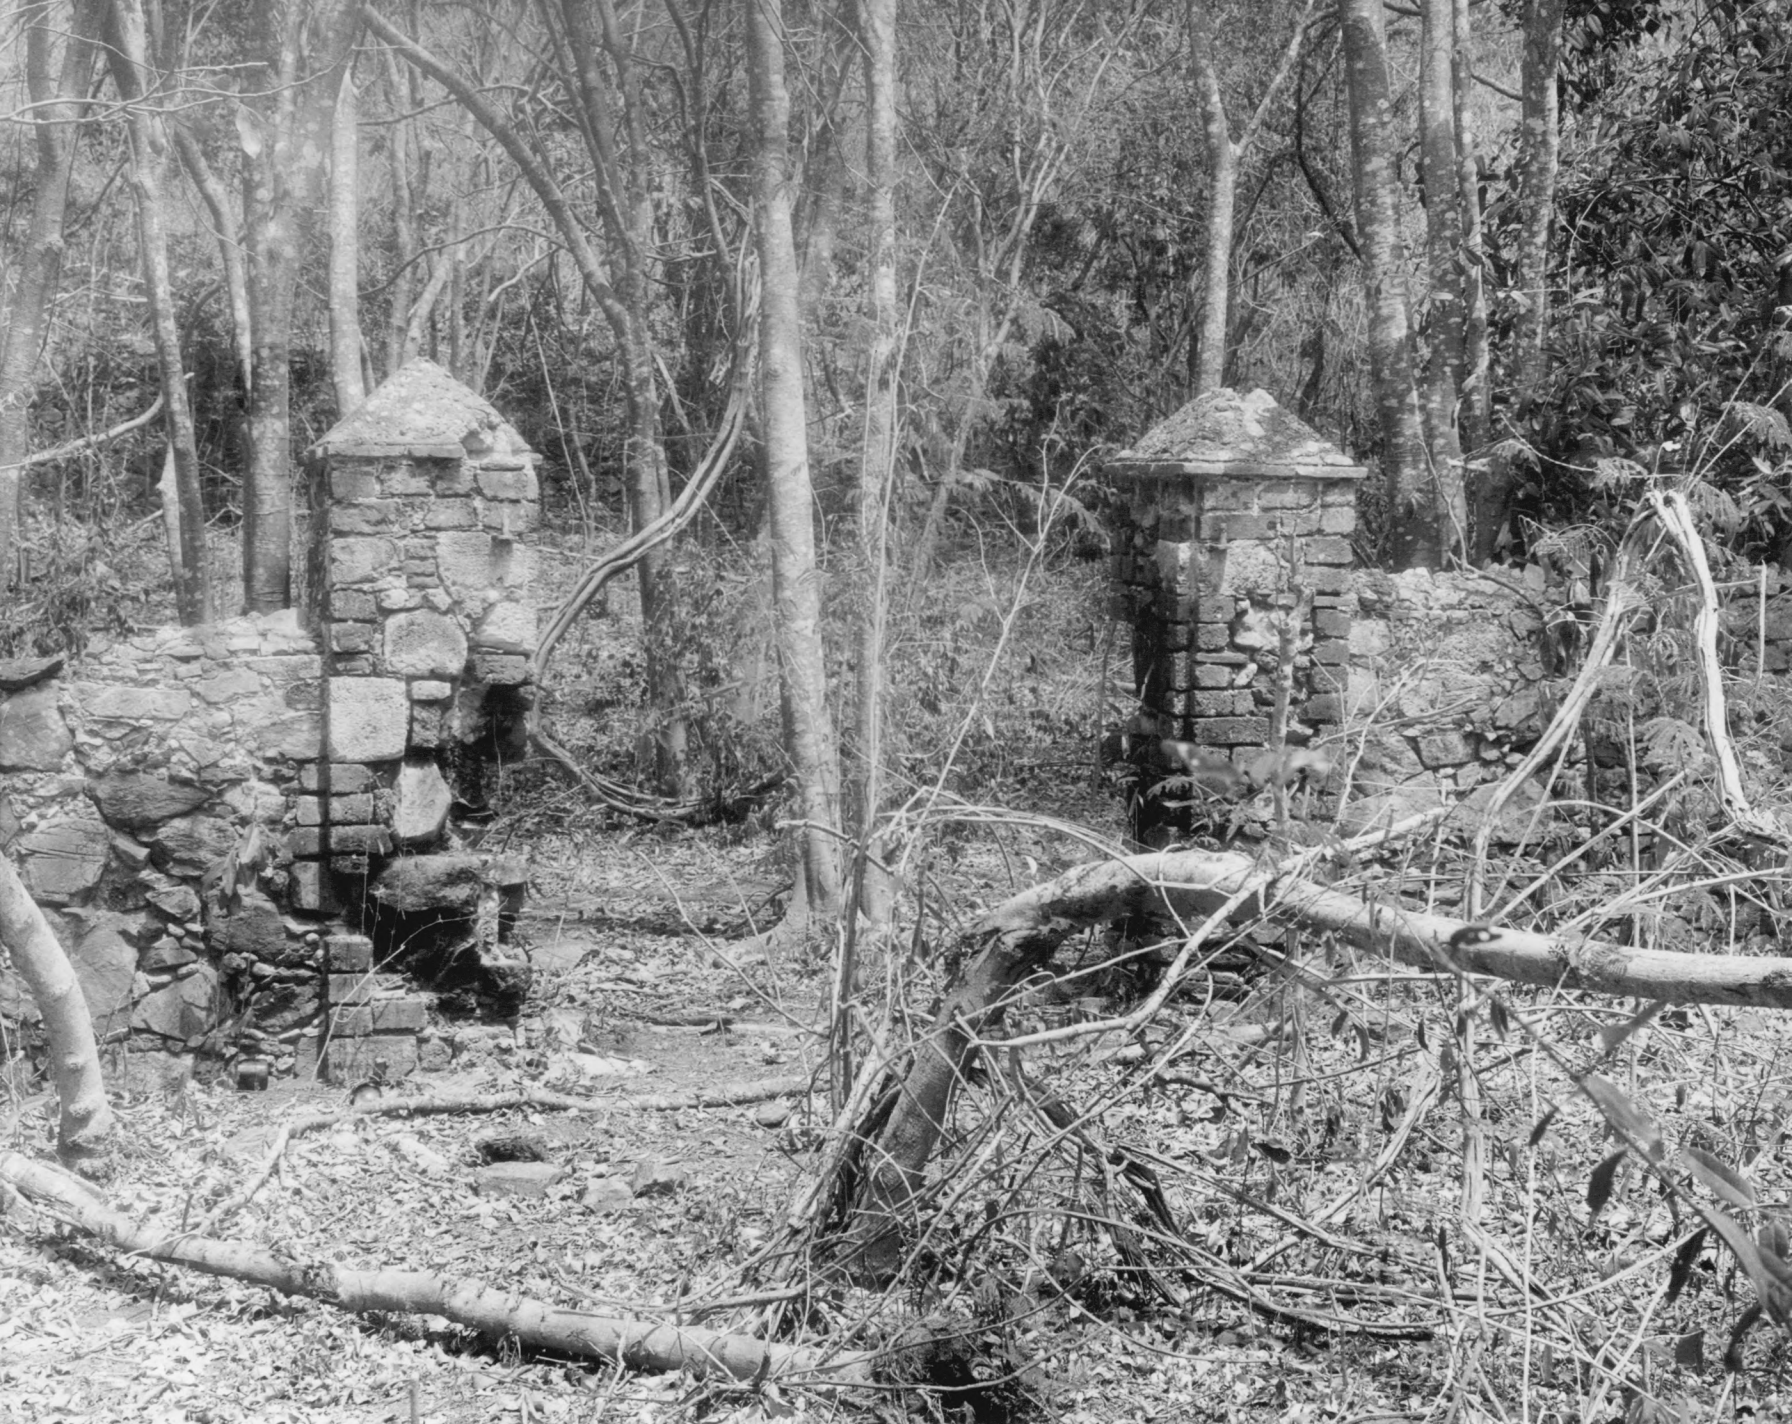
4 of 5

Gate of cemetery No. 1 H-36, 10viewed from the south.

Physical Description: A walled cemetery is located 30 yards southeast of the road  
that from Hermitage crosses the northeast peninsula of St. John and enters Brown  
Bay from the east and then continues westward to meet the Coral Bay-Leinster Bay  
trail. The cemetery is approximately 400 yards southeast of the plantation house  
H-36,3. It is rectangular in shape and measures 25 by 38 yards. The plastered  
rubble masonry walls are four feet high and are in a fair state of preservation  
except towards the northeast where sections of them have collapsed. The corners  
are accentuated by pillars with a projecting band and a pyramidal finial.

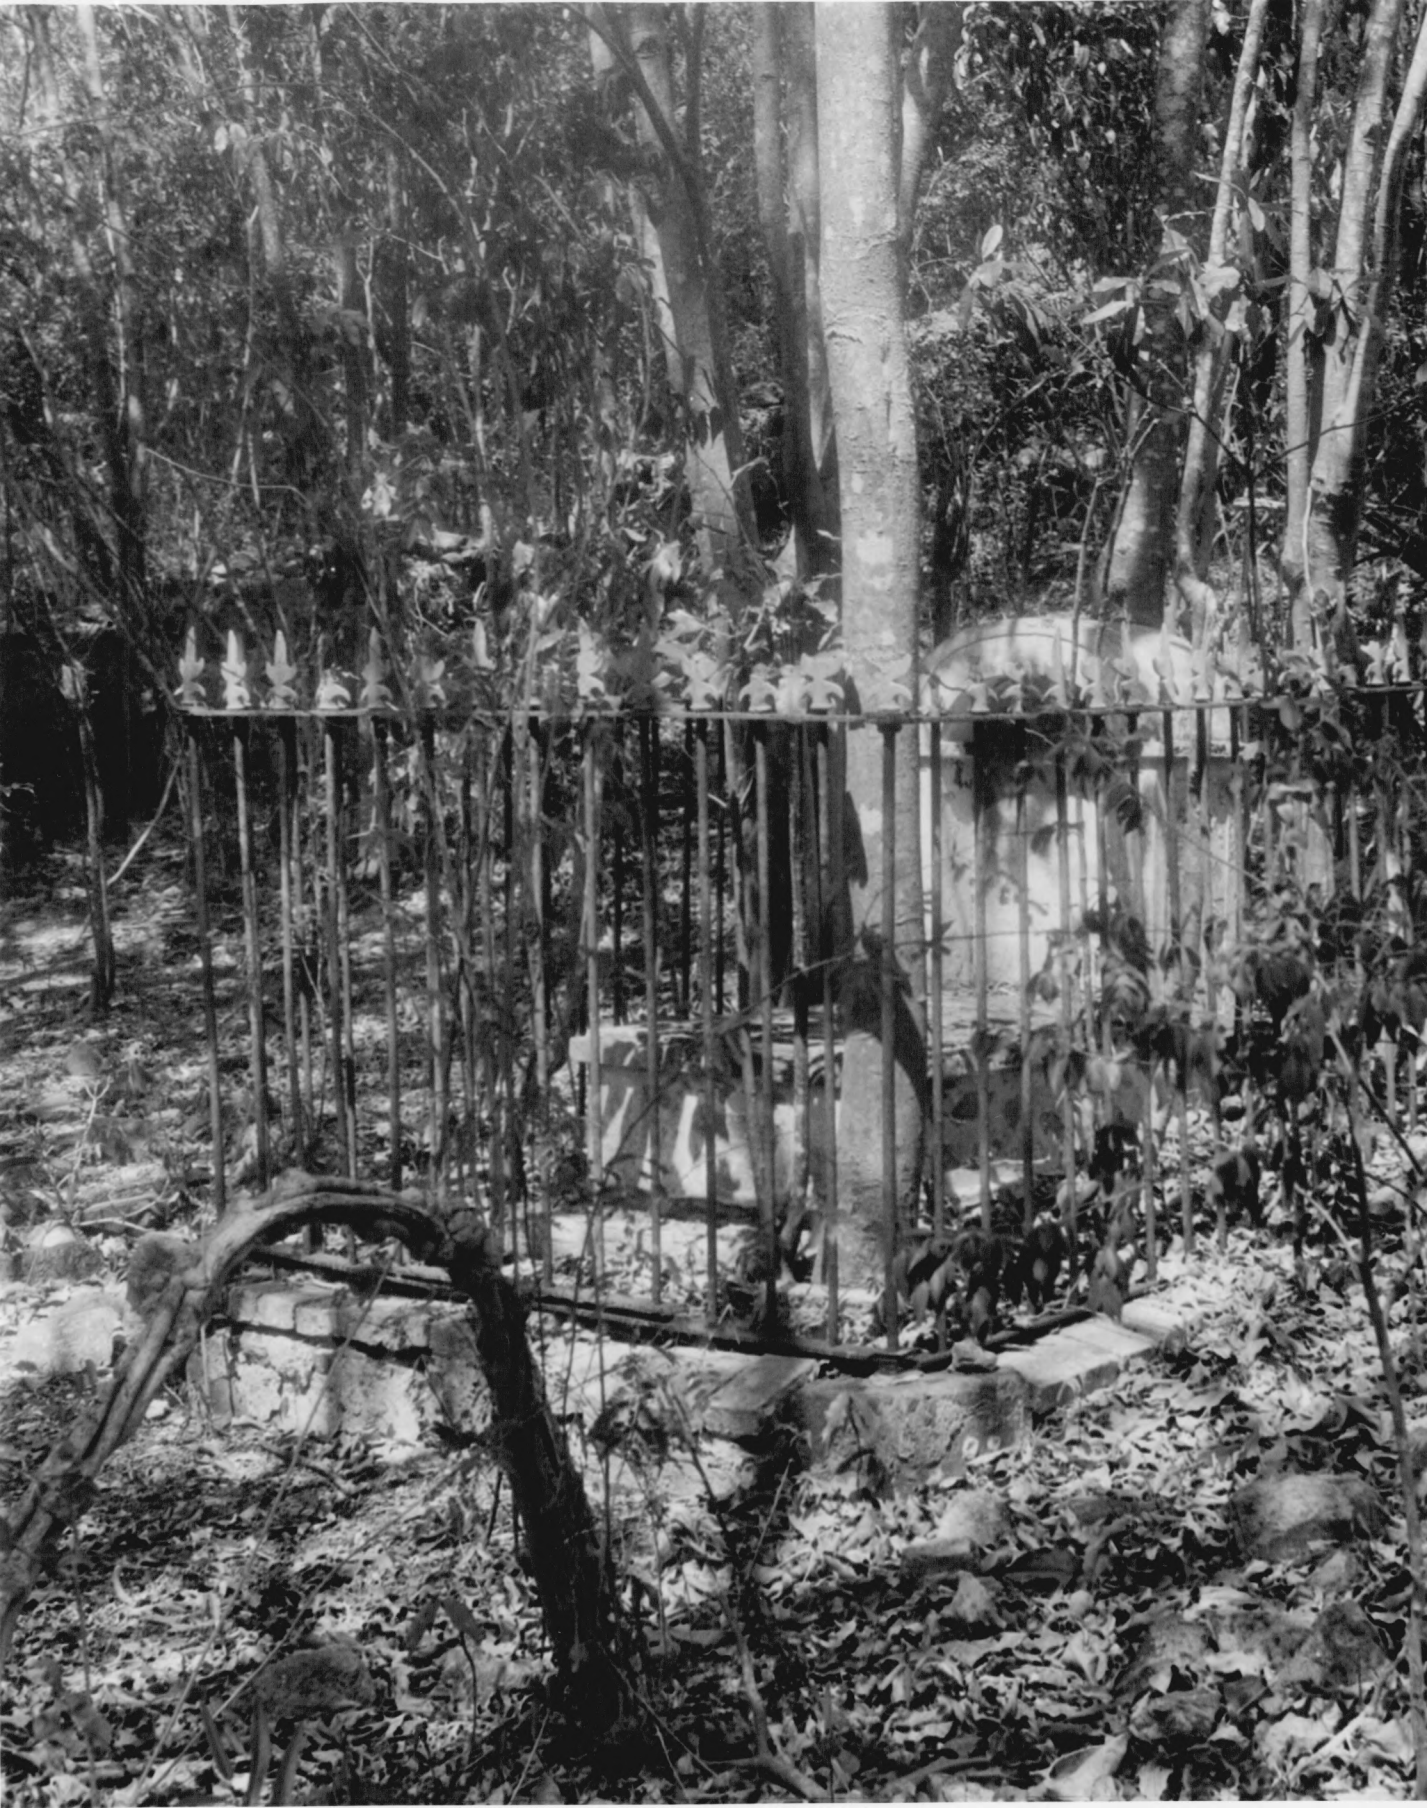
5 of 5

Monument over James Thomas Abbot Davis

Cemetery No. 1 H-36,10 viewed from the southeast.

The cemetery contains a number of identifiable graves without markings but only  
one monument. This is a small sarcophagi raised 30 inches above grade and topped  
with an upright inscribed marble slab set in a niche at the head of the grave. The  
monument is surrounded by a cast iron fence on a raised brick masonry curb. It  
is set over the grave of James Thomas Abbot Davis, a 2 and a half year old boy who  
died Nov. 20th, 1860.
