# MAJOR WATER PERMIT APPLICATION

Environmental Assessment Report

**Applicant:** Trans Americas Fiber (TAF) U.S., LLC.

**Project:** Magen's Bay, St. Thomas USVI Trans-Caribbean Fiber System Cable Landing Project

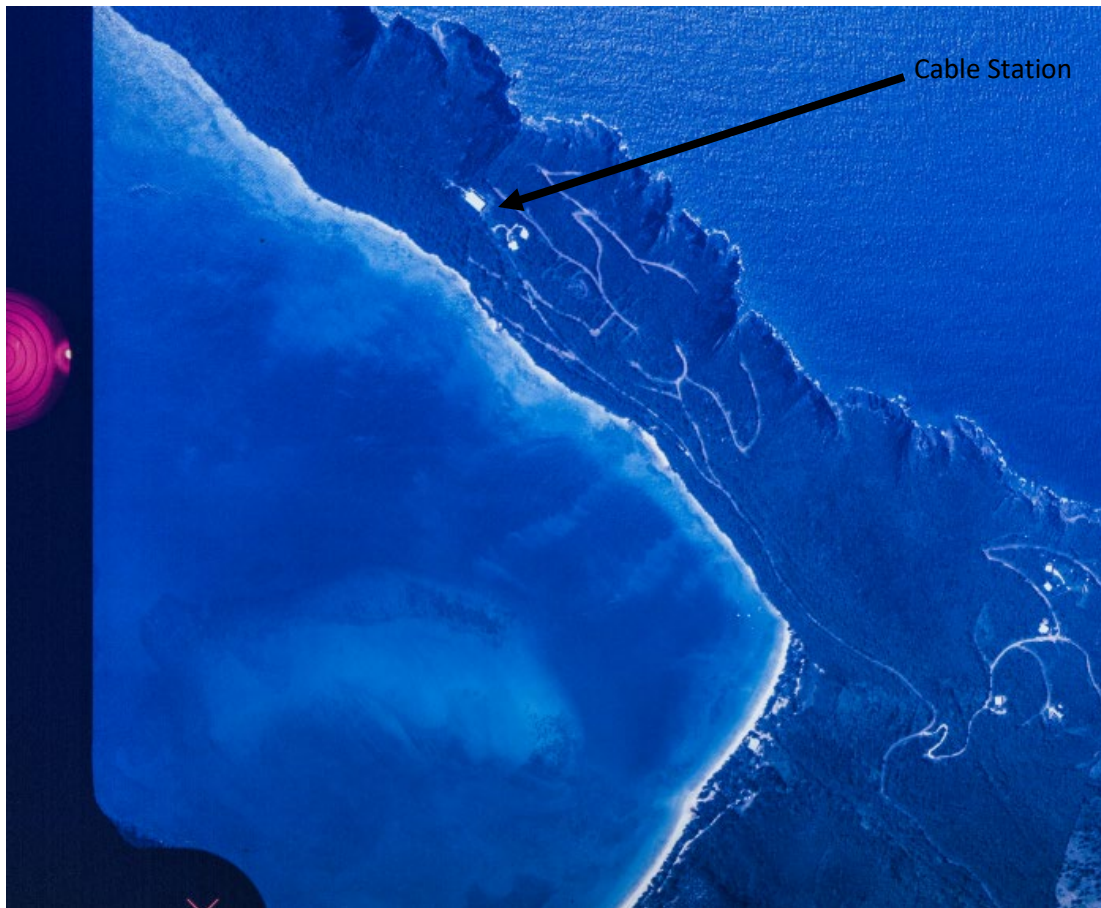
*Figure 6.02.5 – 1970 Historical Photo, Magen's Bay, Source: USGS.*

The building structure and driveways have been built on the property since at least 1970, per satellite photos published by USGS.

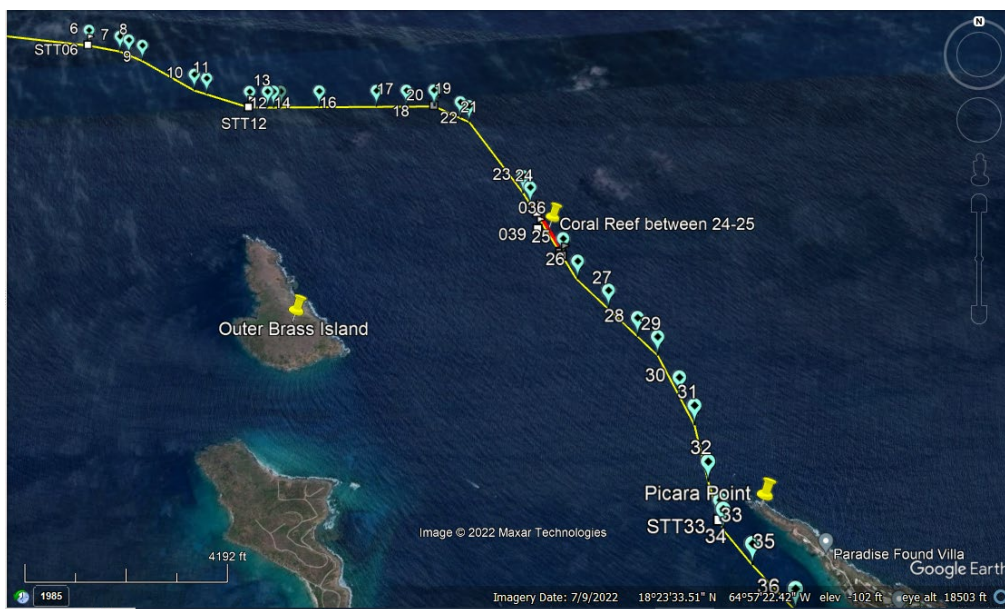
Figure 6.06.6 – Location of reef between GPS Points 24 and 25 that is east of Outer Brass Island)

Video and still photos were collected from a mid-point on the 70-foot-deep reef discovered between GPS 24 and GPS 25 (Figure 6.06.6). Two 25 meter long transects, one running north and the other south, were laid from this center point via SCUBA with Nikon W300 and GoPro Hero 4 cameras. An existing cable is plainly visible with no observed disturbance of benthic habitats as with other existing cables found elsewhere, some on the reef and some well off the bottom. No evidence of habitat degradation was observed anywhere near existing cables.

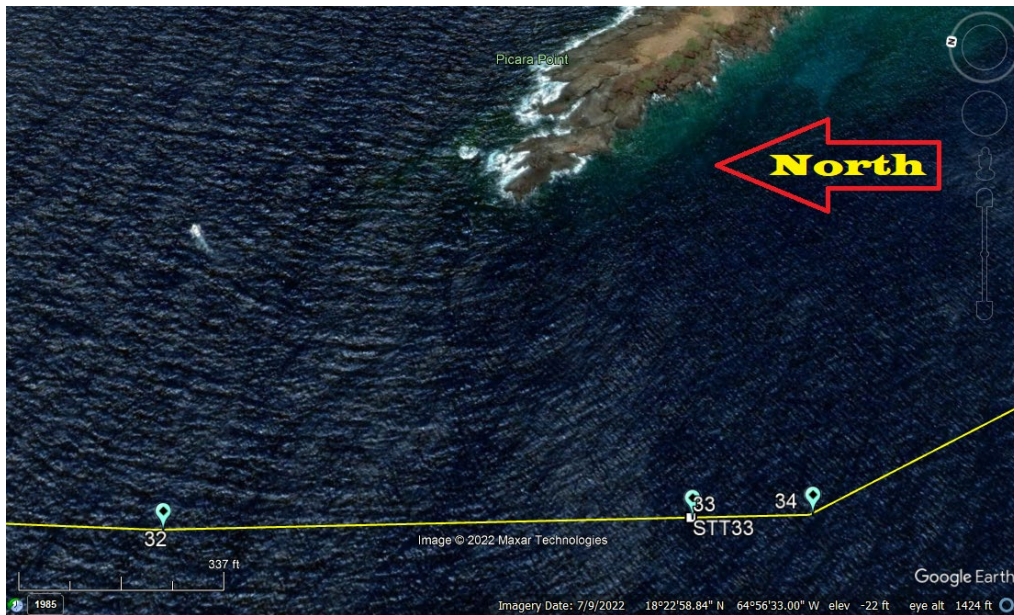
Figure 6.06.7 – Proposed Cable Route as it passes closest to Picara Point
