# VI NPS Update

Nonpoint Source Pollution Committee Newsletter

December 1998

## SUCCESSFUL EROSION CONTROL - CARET BAY VILLAS

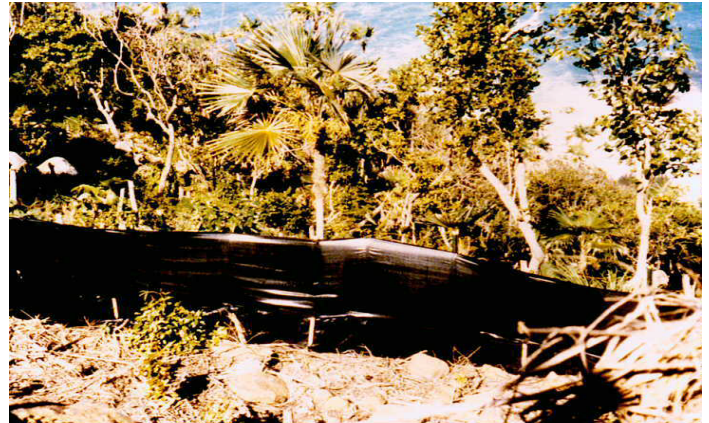
**Wire mesh reinforced silt fence with steel posts installed prior to clearing along the downhill side of Caret Bay Villas site.**

Before earth-work began, a **sediment control (silt) fence** was installed immediately above the cliff's edge and along the entire western portion of the site. The fence was built using silt fabric laid against 6"x6" wire mesh, anchored with boulders, and fastened to metal fence poles spaced between 3 and 10 feet apart. ***This is the only method of***

***installing silt fencing that can successfully control sediment on steep construction sites,*** states Julie Wright, UVI-CES Natural Resources Specialist. Road excavation, the first **phase** of construction, did not begin until all silt fencing was installed below the work area.

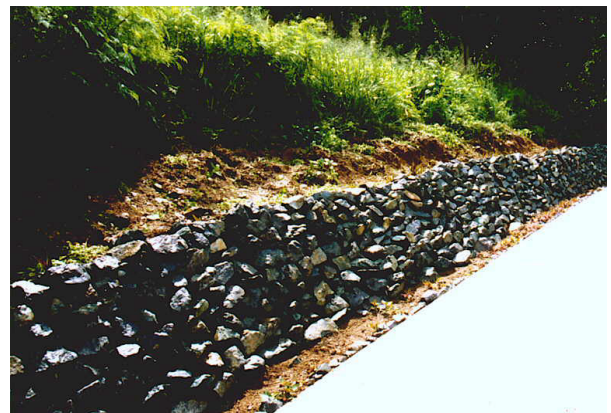
Stone terrace built to retain soil on driveway cut in Fortuna, St. Thomas.

CES client, Anna, requested a home visit to assess a small gut on the edge of her property that was eroding into her land. During the site visit, staff also found a three foot vertical cut adjacent to the driveway behind her house.

***We recommended she stabilize the drainage channel with large rock and vegetation, and pointed out that the cut was unstable and could potentially cave into her driveway,*** according to Morton and Julie Wright. A retaining wall was recommended to prevent landslide risks. Due to cost constraints, a loose stone terrace was built for her by CES client, farmer Elridge Thomas. Anna praised CES staff's assistance: ***Extension Service recommended an inexpensive way to reduce soil loss on my land. I would highly recommend their free service.*** For further information or to request a site visit, contact CES at (340) 693-1080.
