# Erosion & Sediment Control in the Virgin Islands

Sediment can come from construction sites, dirt roads, roadsides, unpaved parking areas, or cleared farmland. To help solve this problem, the UVI Cooperative Extension Service (CES) started a demonstration project to introduce new erosion and sediment control (ESC) practices. The project's goals were to show how these practices should be properly used and to learn how well they work in the Virgin Islands.

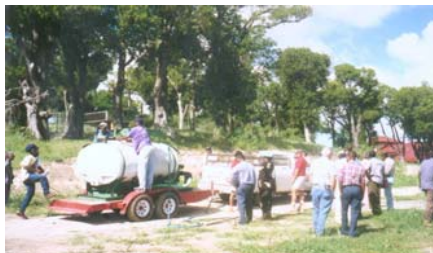
Hydroseeding is an erosion and sediment control practice that rapidly covers bare soils with grass and mulch. Grass seed, water, and mulch are mixed in the hydroseeder tank and then sprayed on bare soils with a hose. CES used hydroseeders to seed steep slopes on St. Thomas and St. Croix. Grass seed hydroseeded included: bermuda, rye, fescue and bahia (a drought-tolerant grass species native to the V.I.) as follows:

- C Bahia grass: behind the UVI St. Croix cafeteria and outdoor sport facility.
- C Bahia and bermuda grass: on steep, south-facing slopes at the Cost-U-Less construction site, St. Thomas, with cellulose (paper) fiber hydromulch, and a soil binder.
- C Bahia grass: on a steep slope with cellulose hydromulch and a soil binder at a site in Estate St. George's Hill, St. Croix.

**Hydroseeding bahia grass at the UVI St. Croix Cafeteria.**

Bahia grass hydroseeded at the St. Croix sites was quickly overgrown by guinea grass. However, bahia grass seed that was hand broadcast and then covered with erosion control mats sprouted and spread.

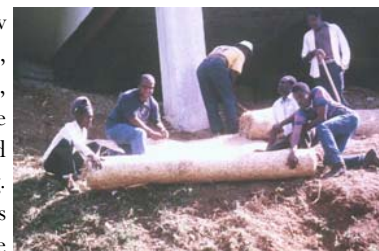
CES worked with the VI Housing Authority (VIHA) to stabilize bare slopes at the Donoe Housing Community, St. Thomas, with erosion control mats. We installed 70% straw/30% coconut fiber and 100% straw fiber erosion control mats on steep (>60%), stony, dry, bare slopes along the Donoe Road.

VIHA grounds crew cleared brush, debris, stones and stumps, raked to smooth the slope surface, and installed the matting. Coconut/ straw mats were used for the steepest sections and straw mats were used

**CES & VIHA staff install erosion control mats at Donoe Housing Community.**

for less steep sections. Mats were installed around ornamental plants (ginger thomas, pink cedar and bougainvillea) that were kept on the slope during the clearing process.

The mats at all sites have broken down. The straw/coconut fiber mats lasted the longest, taking about six months to break down. The excelsior mat installed on St. Croix broke down after only 2 ½ months.

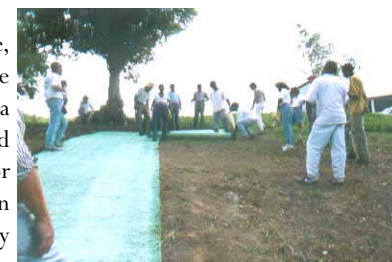
At the St. Croix site, trainees first seeded the bare slope with bahia grass and then covered one area with excelsior mats. They covered an adjacent area with hay mulch to compare how well the two practices controlled erosion and how long the materials lasted.

**Workshop participants install excelsior erosion control mat on St. Croix.**

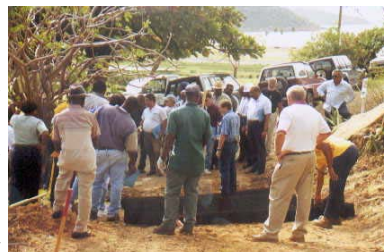
GeoWeb® was installed in the driveway during a hands-on workshop. After participants saw a video describing the use of the webbing, they helped install it by stretching sections over the driveway and

Workshop attendees learn how to install GeoWeb®.

anchoring it with j-bars. A backhoe then filled the webbing with crushed stone and soil, and a vibrating roller compacted and smoothed the surface.
