Water Quality Monitoring Project / Third Port, St. Croix

/  
Baseline Report

July 5, 1989

## Water Quality Monitoring Project / Third Port, St. Croix Progress Report

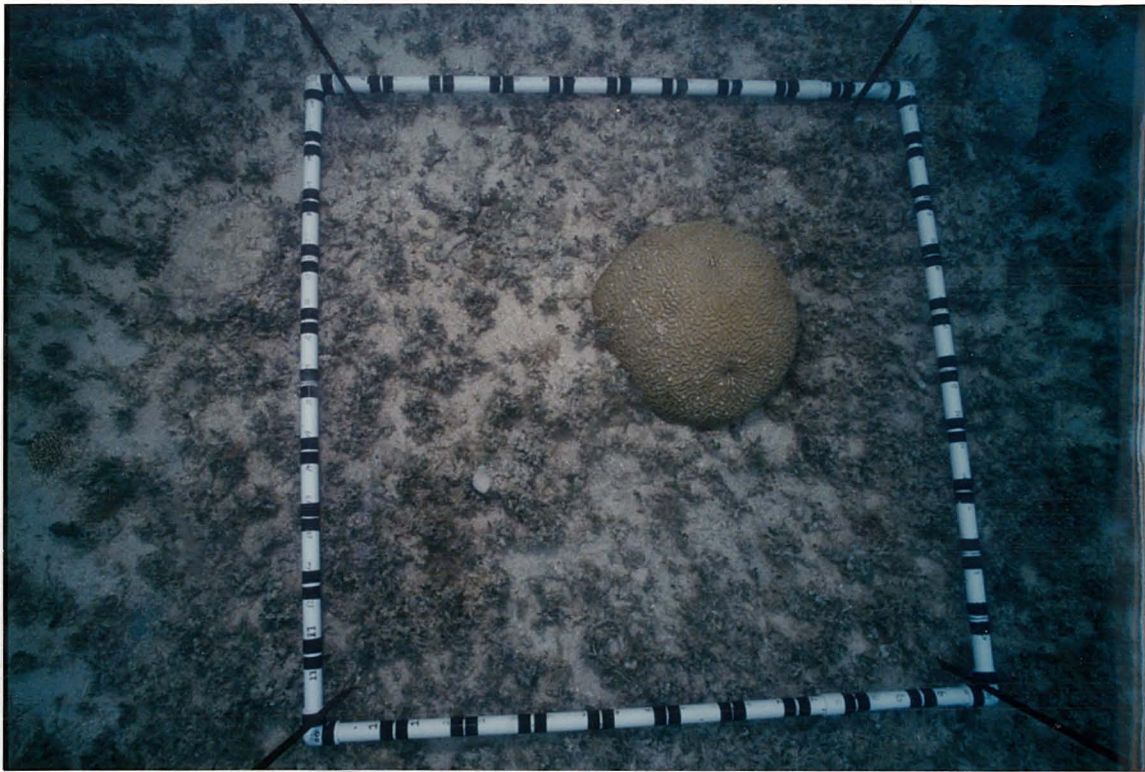
Photoquadrat (1): Single head of Diploria strigosa. Dominant species in the area with solitary heads separated by vast areas of sand-algal pavement.

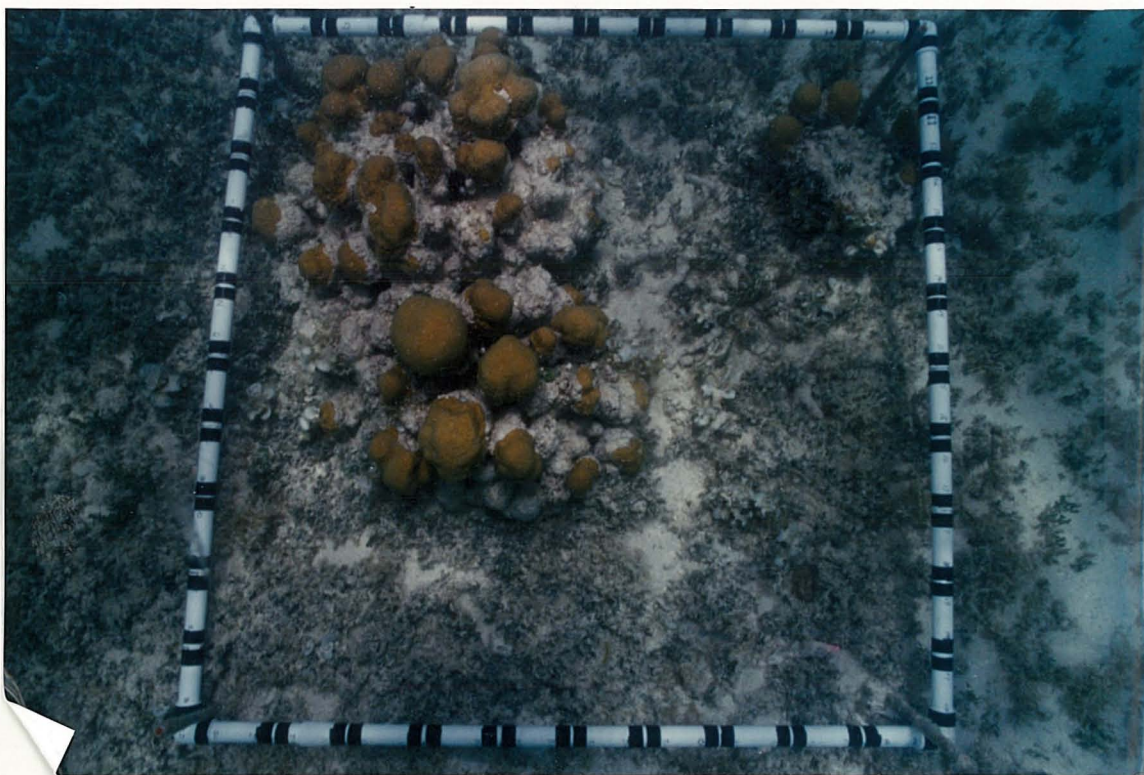
Photoquadrat (2): Small heads of Montastrea annularis. Also a dominant species in the area with similar small clumps separated by vast areas of sand-algal pavement.

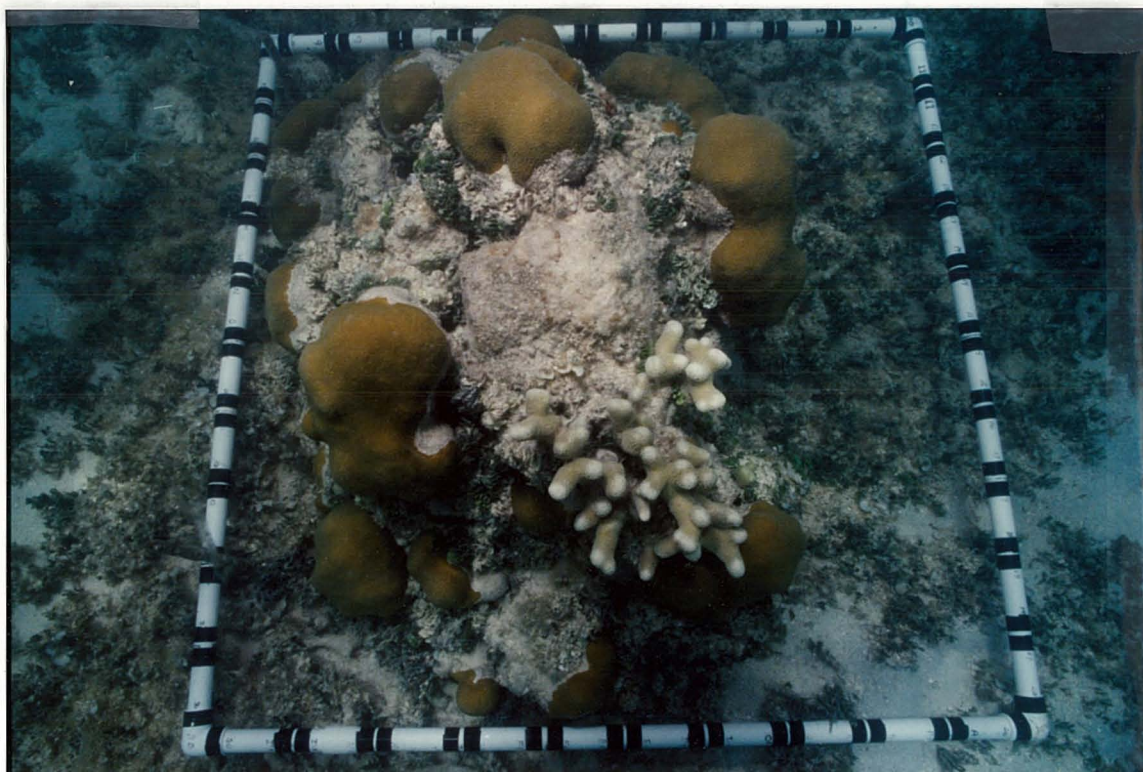
Photoquadrat (3): Small heads of Montastrea annularis with a patch of Porites porites situated in the middle of the clumps of star coral.

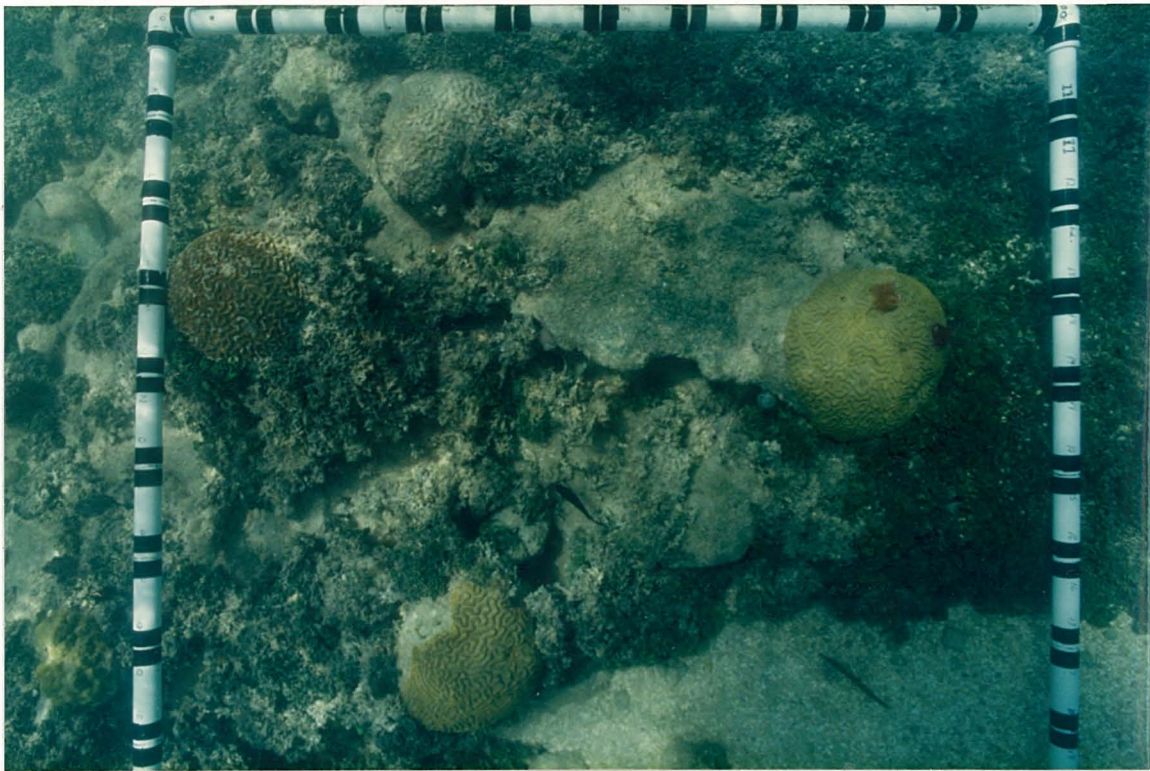
Photoquadrat (4): Small heads of Diploria strigosa. This area is on the opposite side of the channel from the dredge site and in less than 1 meter of water. It is the closest coral to the dredge site.

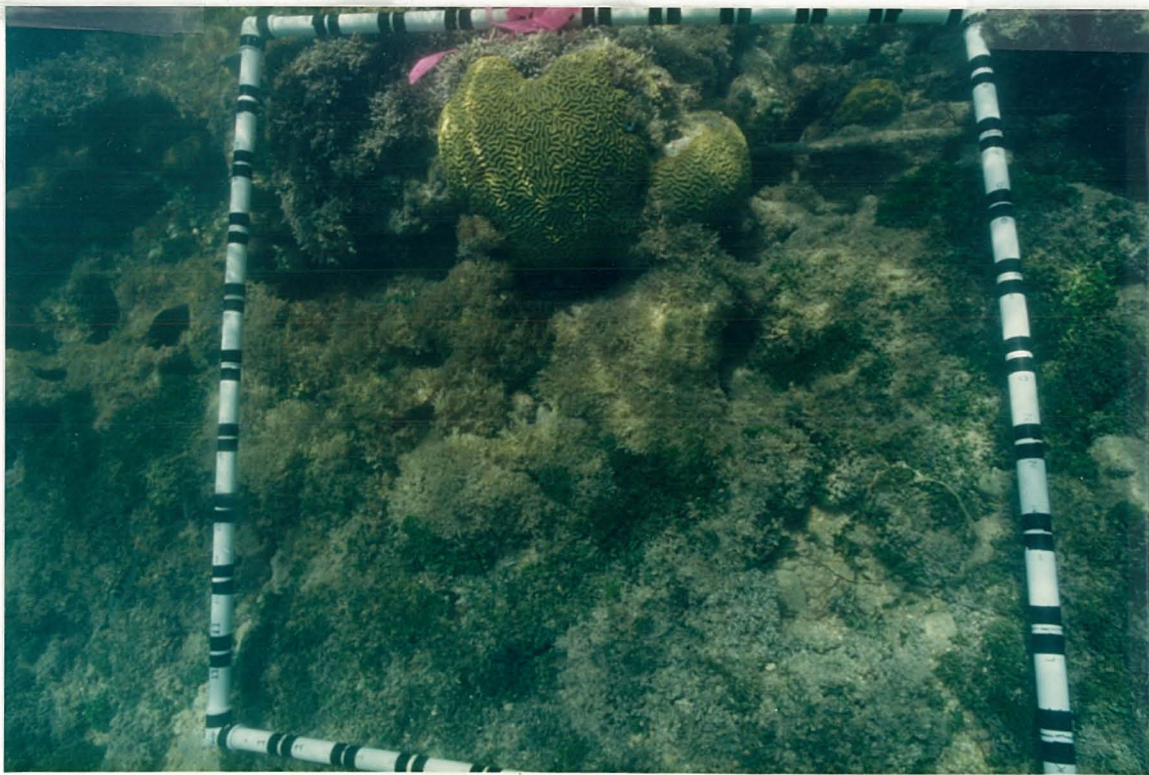
Photoquadrat (5): Small heads of Diploria strigosa. This species and several isolated patches of Porites asteroides are the only coral found in this area.

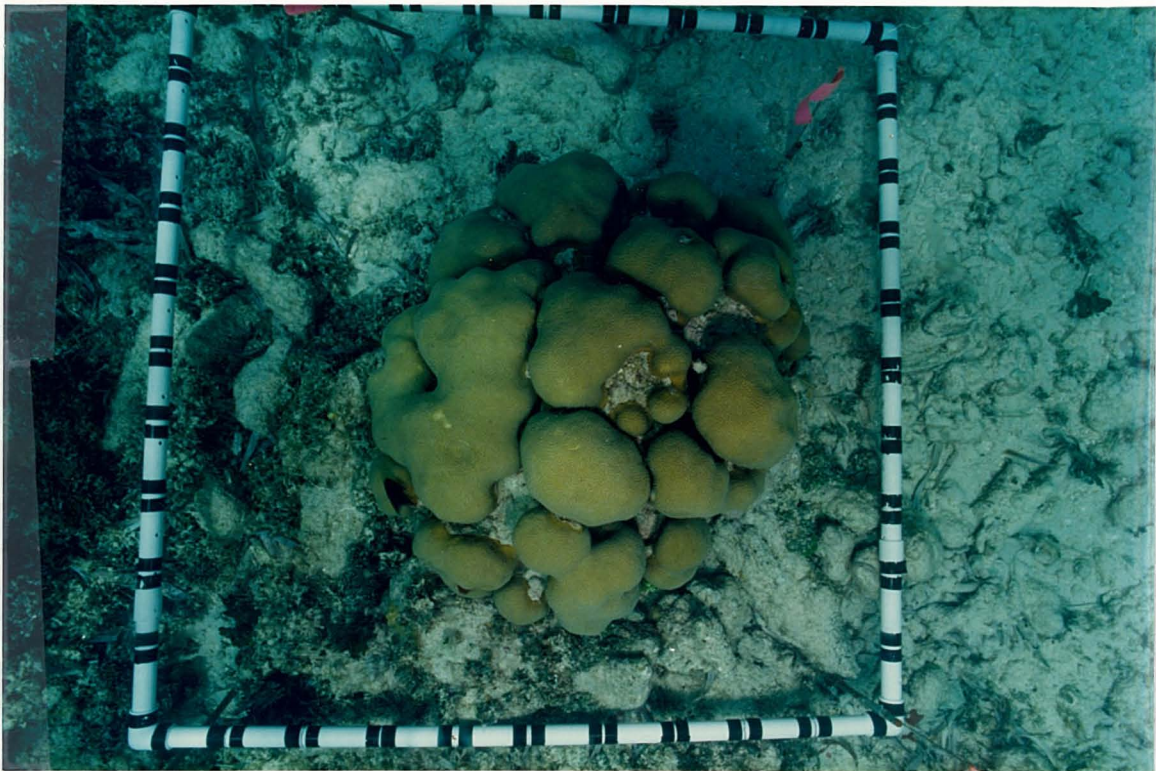
Photoquadrat (7): Montastrea annularis.

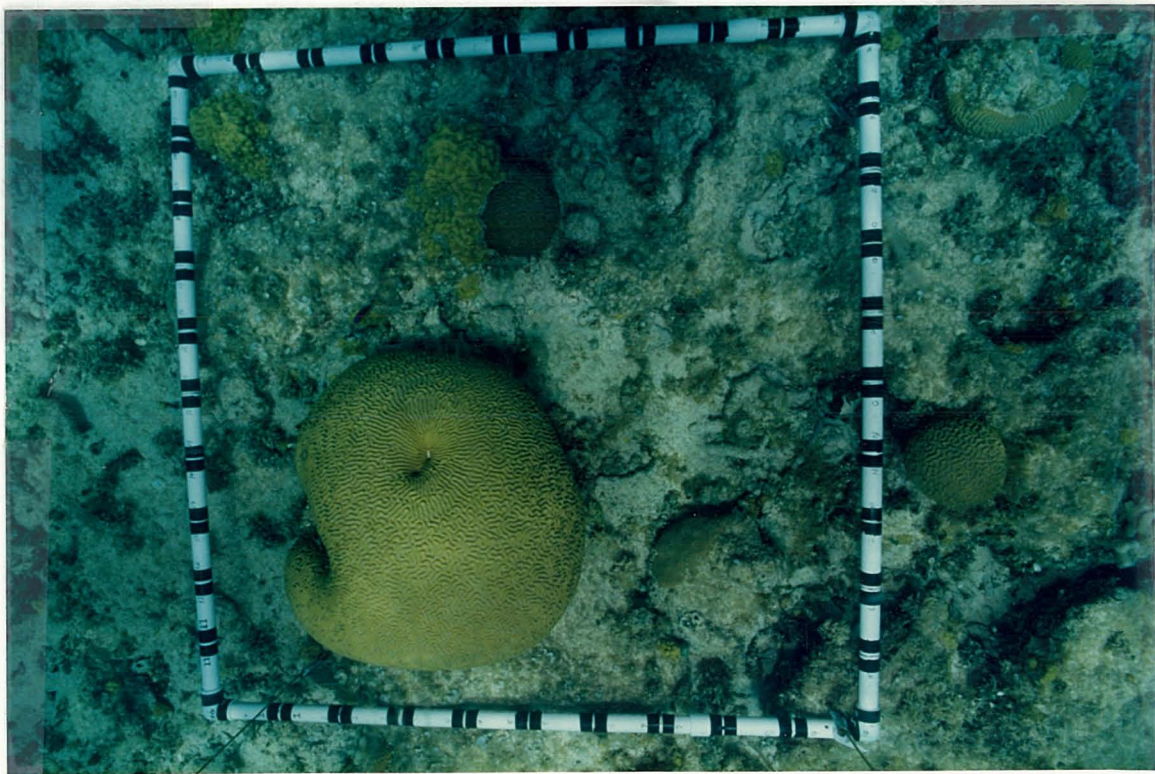
Photoquadrat (8): Large and small heads of Diploria strigosa several patches of Porites asteriodes and a small patch of Montastrea annularis.

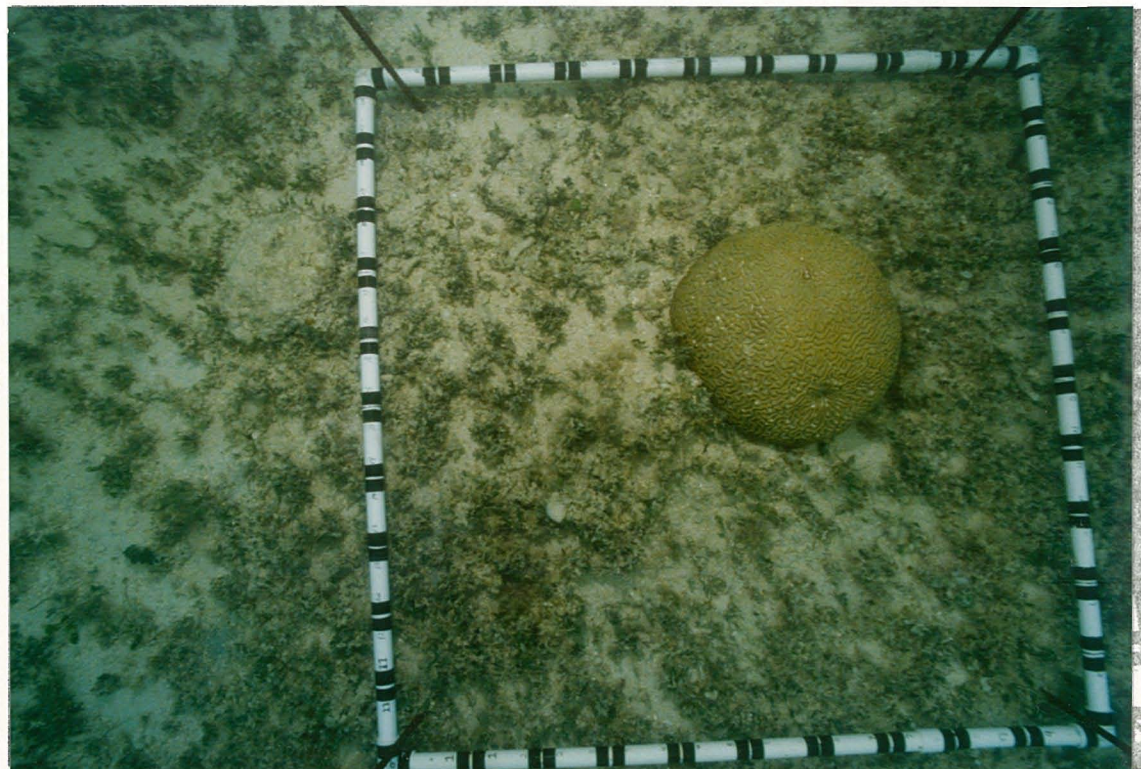
Photoquadrat (1A): Single head of Diploria strigosa taken on 6-10-89.

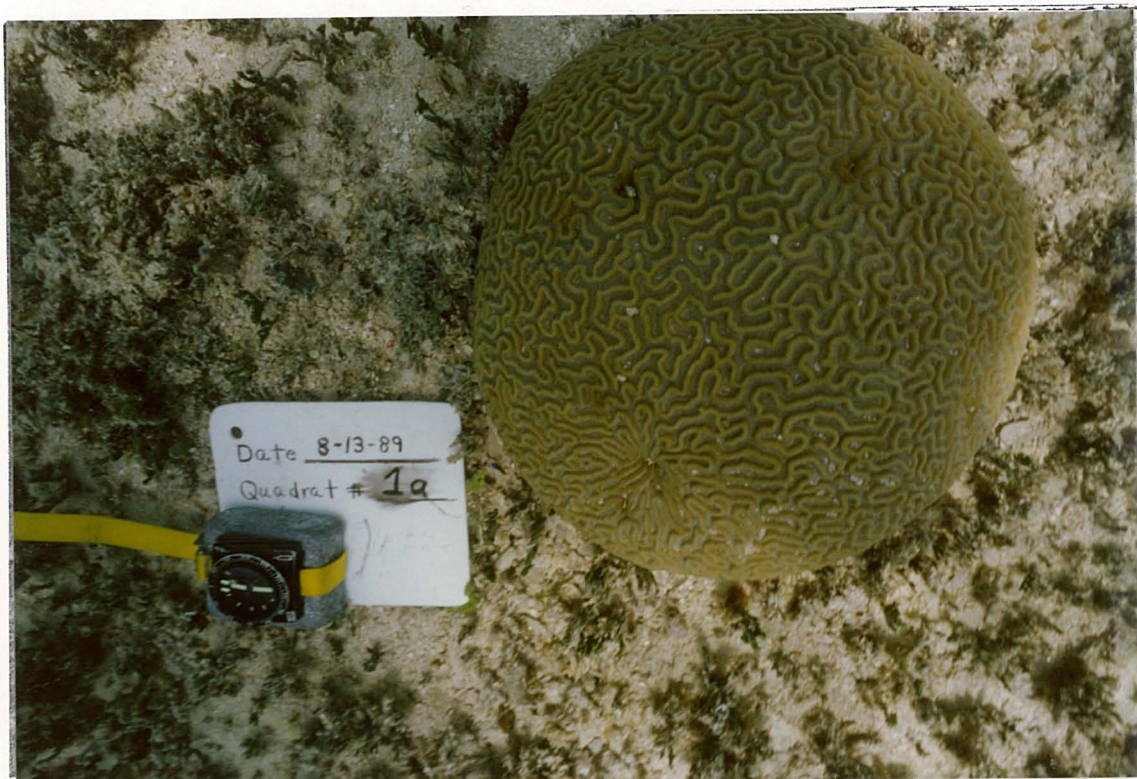
Quadrat 1A shows no change as determined by field observations. Particles of sediment have been observed on the coral head, but they appear to be removed by the coral tentacles or by the occasional strong currents through the area. Calculations were made of percent live coral cover from the photographs and are presented in Table 1. The percent cover calculation was done twice on the photograph taken during the baseline study showing little variation between calculations (8.8% and 8.7%). The calculation from the second photograph was lower (8.0%), however observations showed no damage.

Photoquadrat (1A): Single head of Diploria strigosa close up showing sediment particles. However, no damage to coral was visible at the 8-13-89 observation.

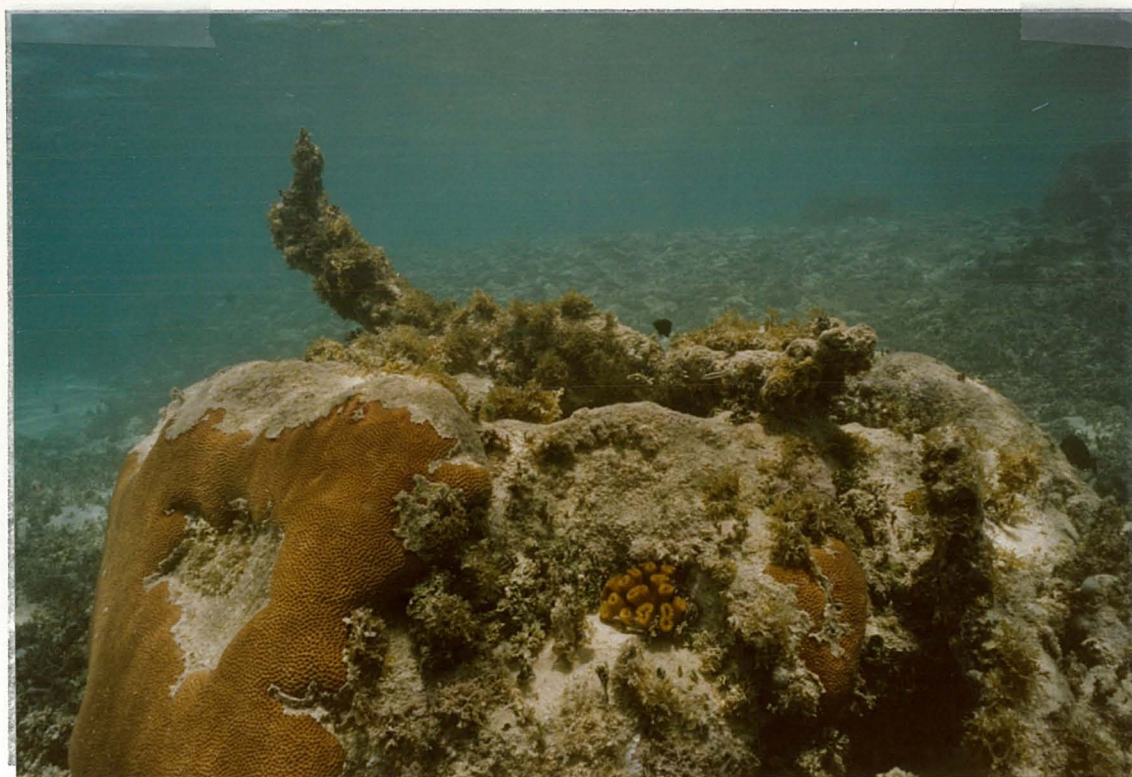
Photo of reef area just south of station #2. A healthy colony of Eusmilia fastigiata is seen on a presumably sediment damaged head of Siderastrea siderea. Several such healthy colonies were conspicuous in this area where heavy sediment damage is evident.

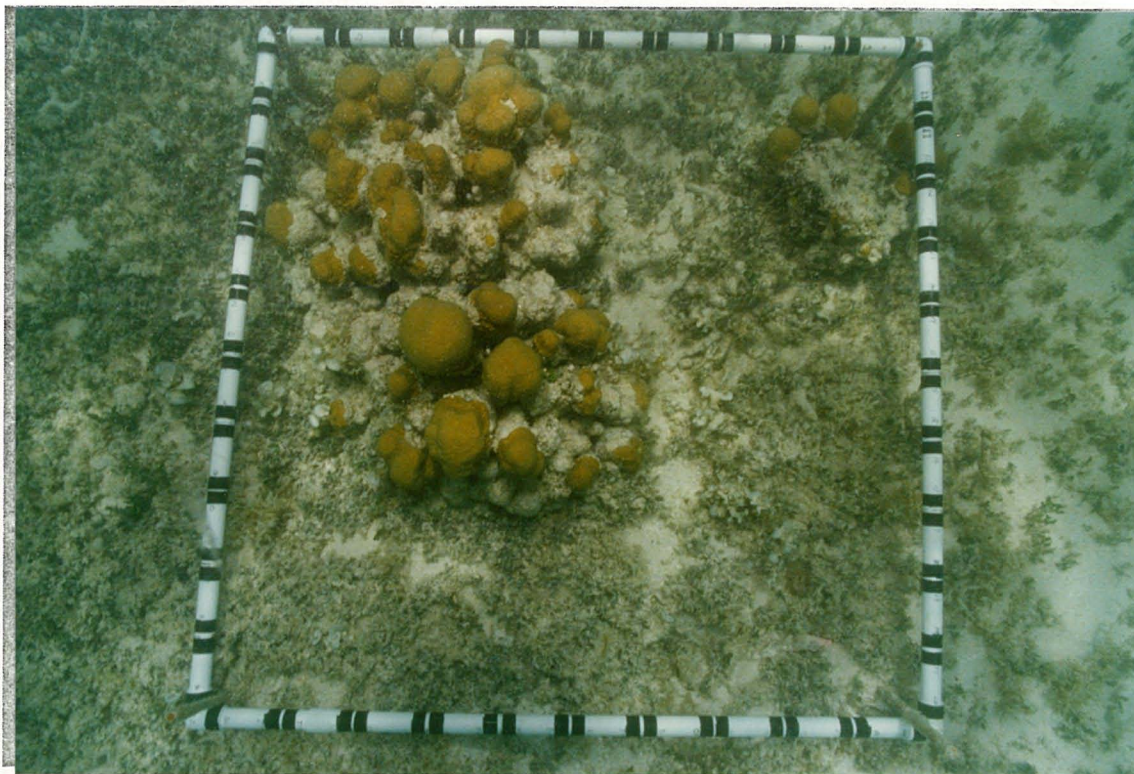
Photoquadrat (2): Small heads of Montastrea annularis taken on 6-10-89.

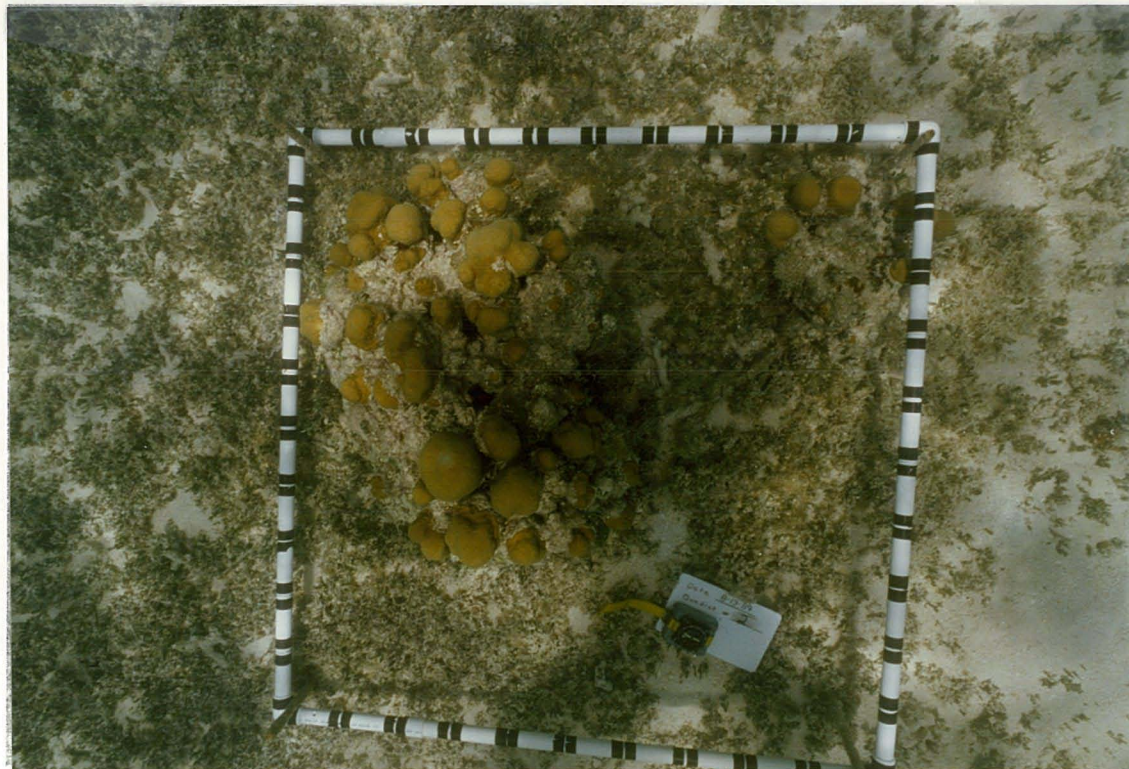
Photoquadrat (2): Same as above taken on 8-13-89.

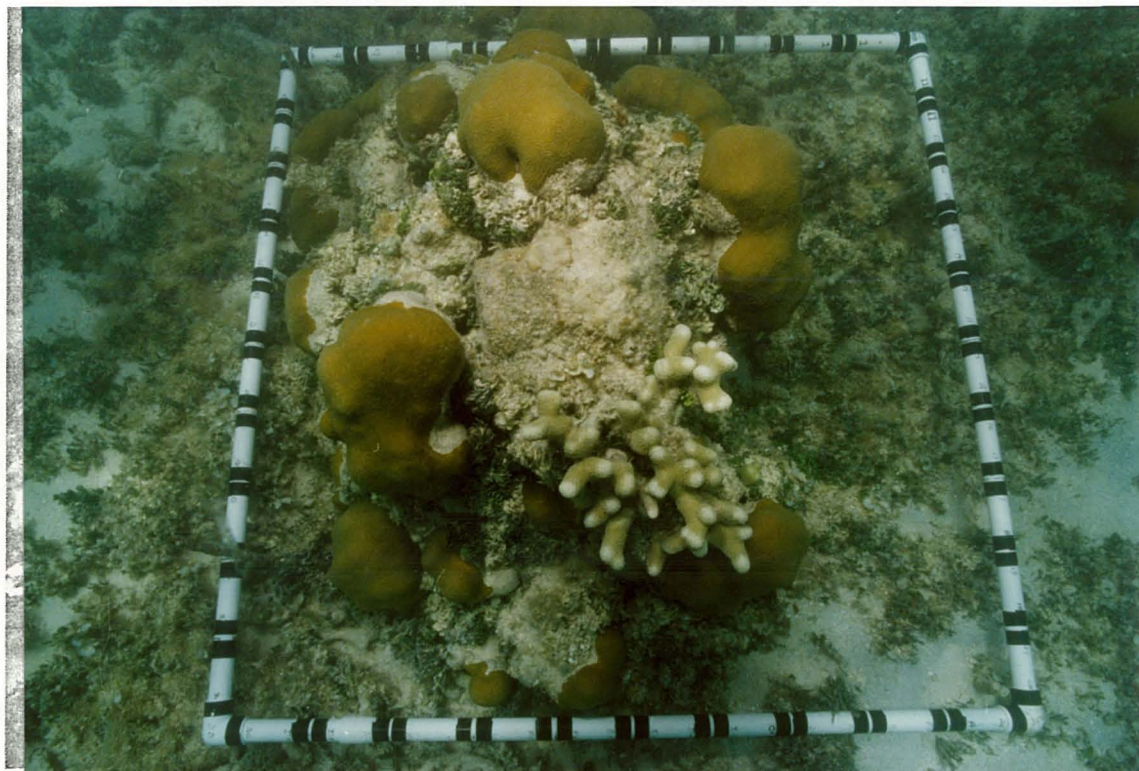
Photoquadrat (3): Montastrea annularis and Porites porites taken on 6-10-89.

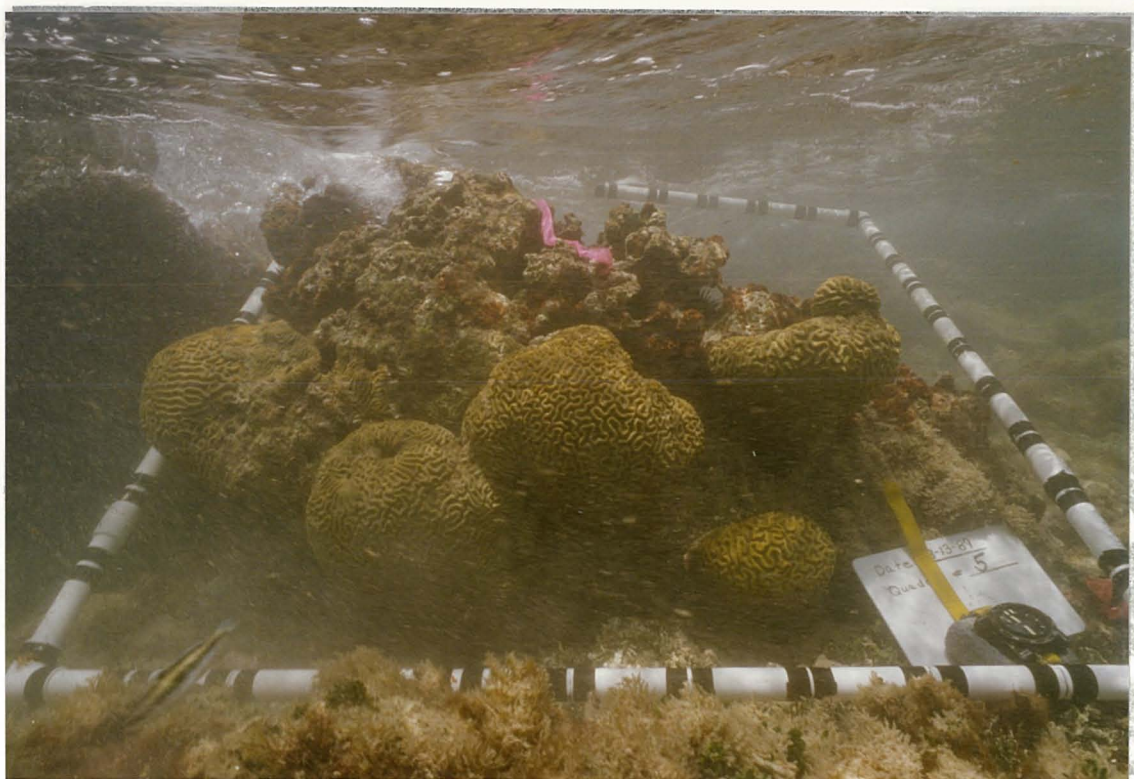
Quadrat 5 (reported as 6 in baseline study) was reported on 8-4-89 to have a worn area in one spot as determined from visual observation. A close-up photograph was taken on 8-17-89 to be later used for comparison.

Photoquadrat (5): Same as above taken on 8-13-89.

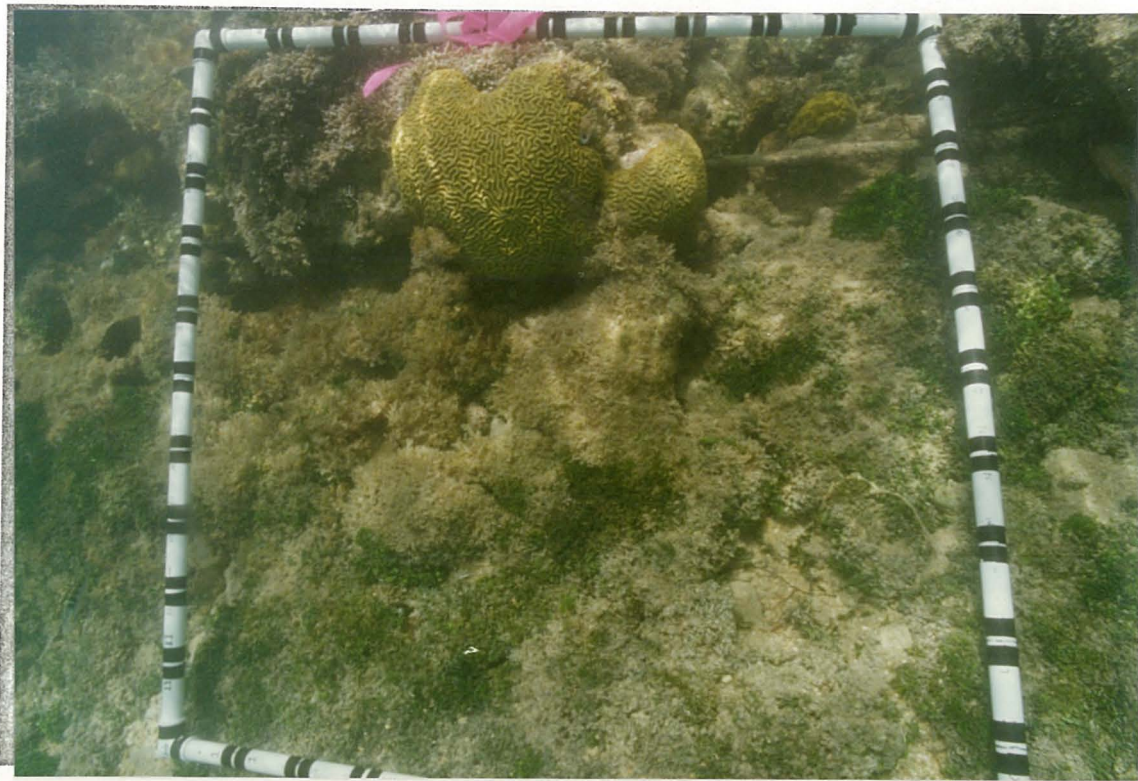
Photoquadrat (6): Small heads of Diploria strigosa and several patches of Porites asteroides taken on 6-24-89 (listed in baseline report as #5).

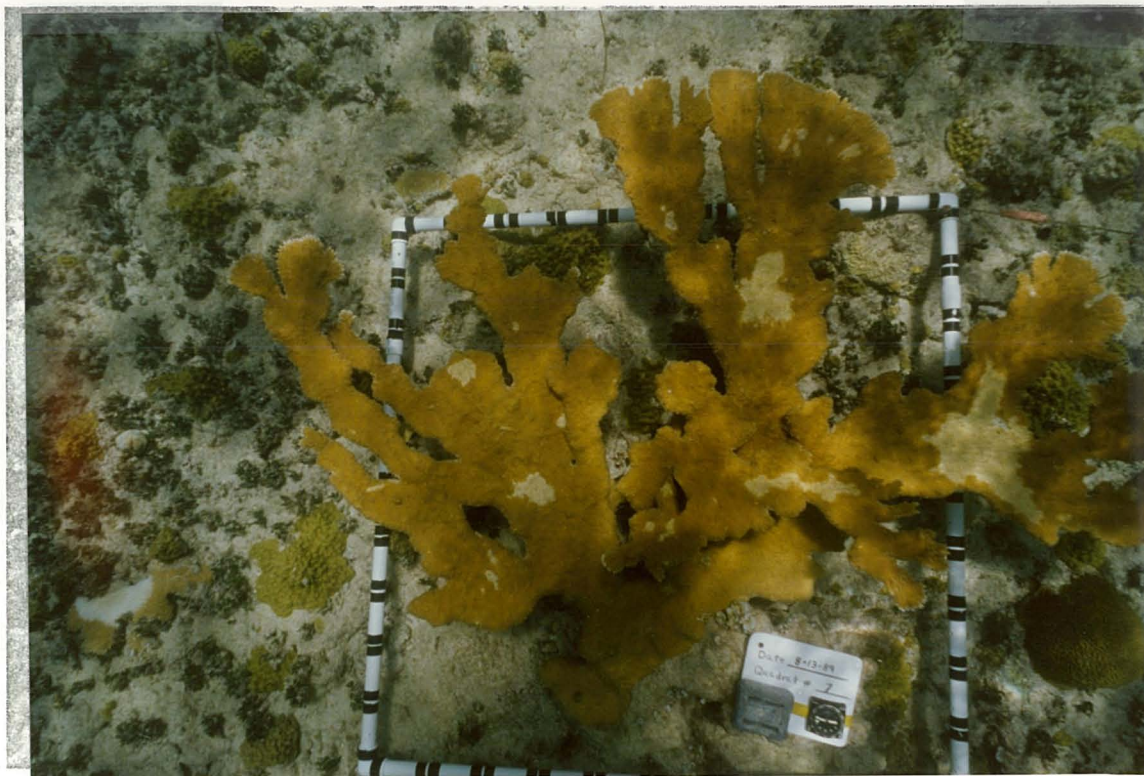
Quadrat 7 (reported as 9 in baseline study) is showing considerable change in the A. palmata. Based on the photograph taken on 8-13-89 the percent live coral cover was estimated at 46.1%. Using the same photograph, the percent live coral cover at baseline was 49.0%, thus there is a 2.9% loss. Observations by Hank Tonnemacher indicate that the coral polyps first became bleached and then they died and were replaced by algal cover. Thus the white spots seen on the coral are dead coral covered with algae. This all happened since the baseline study on 6-24-89. Because of the change in the placement of the meter square between sampling dates, the photograph taken on 8-13-89 was used to calculate percent live coral cover. Since coral death was within this percentage the calculation is valid.

Photoquadrat (7): Same as above taken on 8-13-89.

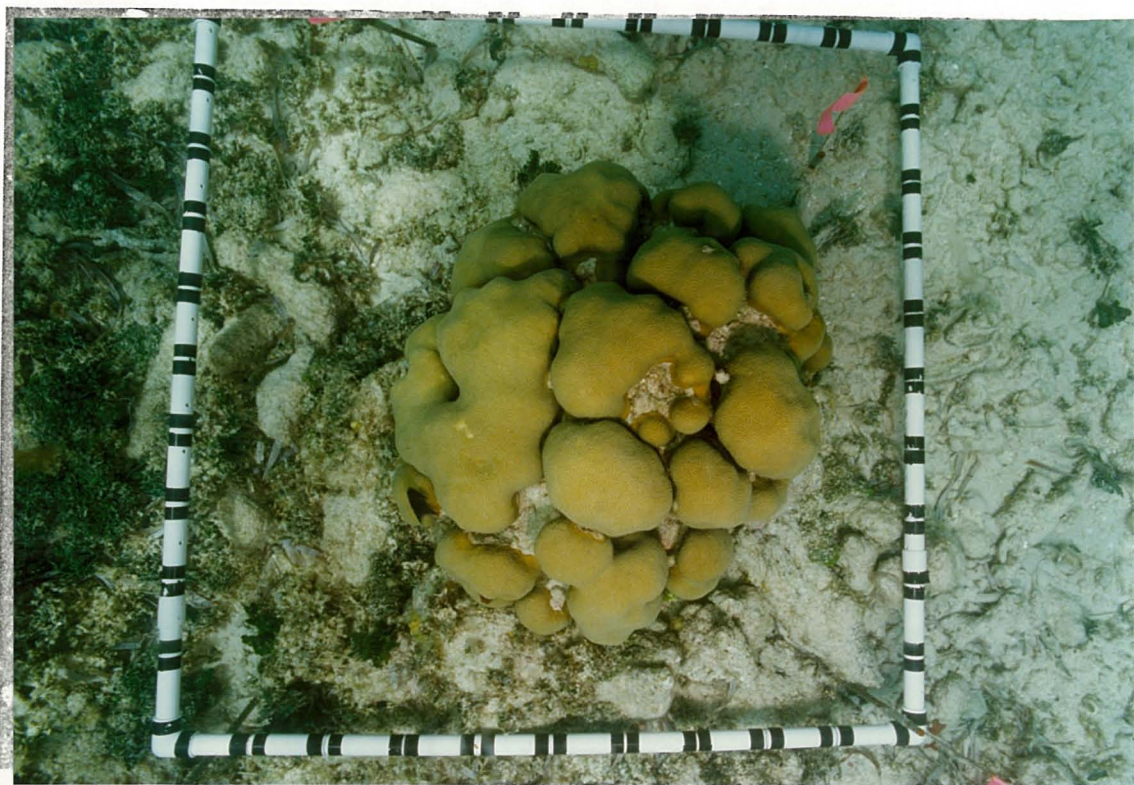
Photoquadrat (9): Montastrea annularis with small colonies of Agaricia agaricites, Diploria strigosa and Madracis mirabilis.

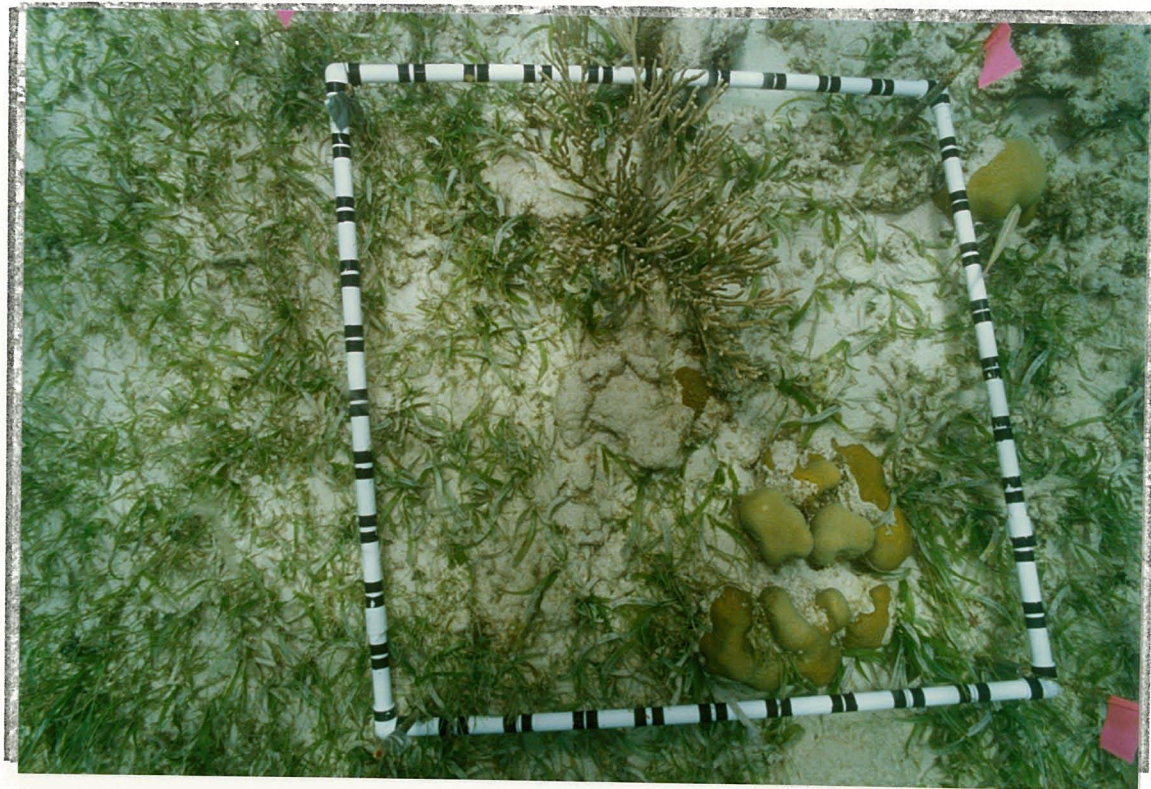
Photoquadrat (10): An original 1987 quadrat (#11) containing Montastrea annularis and two very small colonies of Diploria strigosa and Porites porites this photo taken 6-24-89.

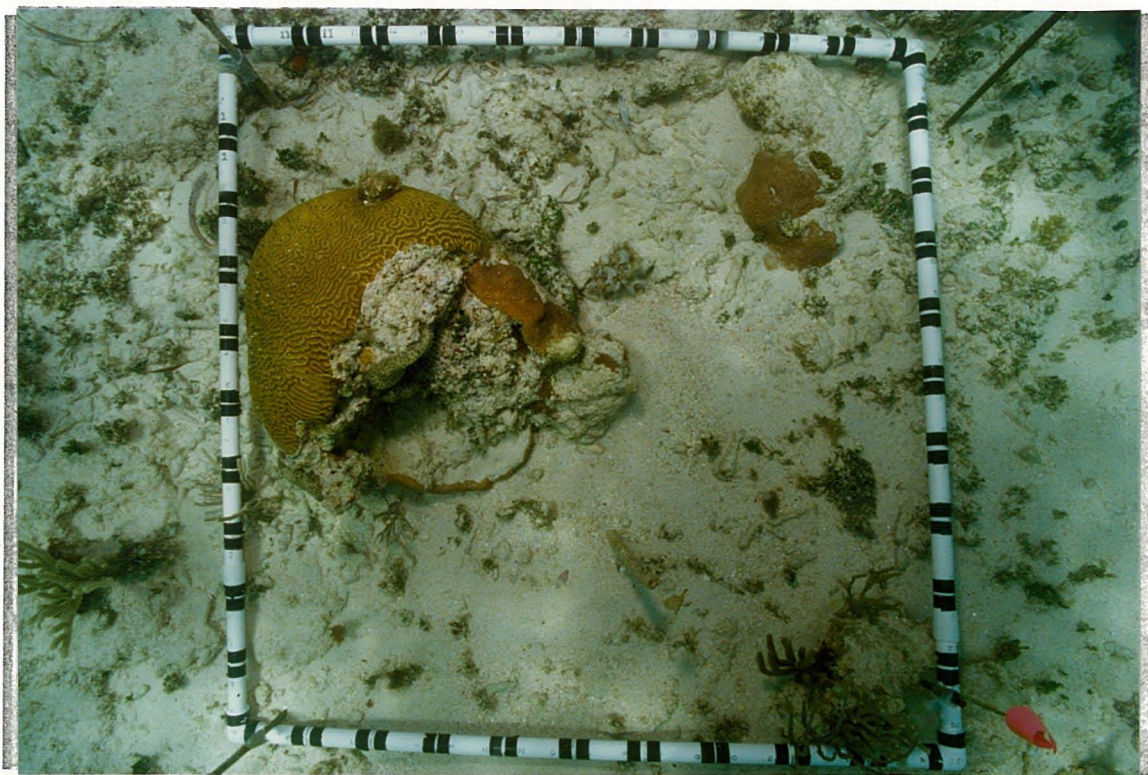
Photoquadrat (11): An original 1987 quadrat (#10) containing Montastrea annularis and Diploria strigosa with small colonies of Siderastrea siderea, Agaricia agaricites, Porites porites, and Madracis mirabilis. This photo taken 6-24-89 (listed in baseline report as #10).

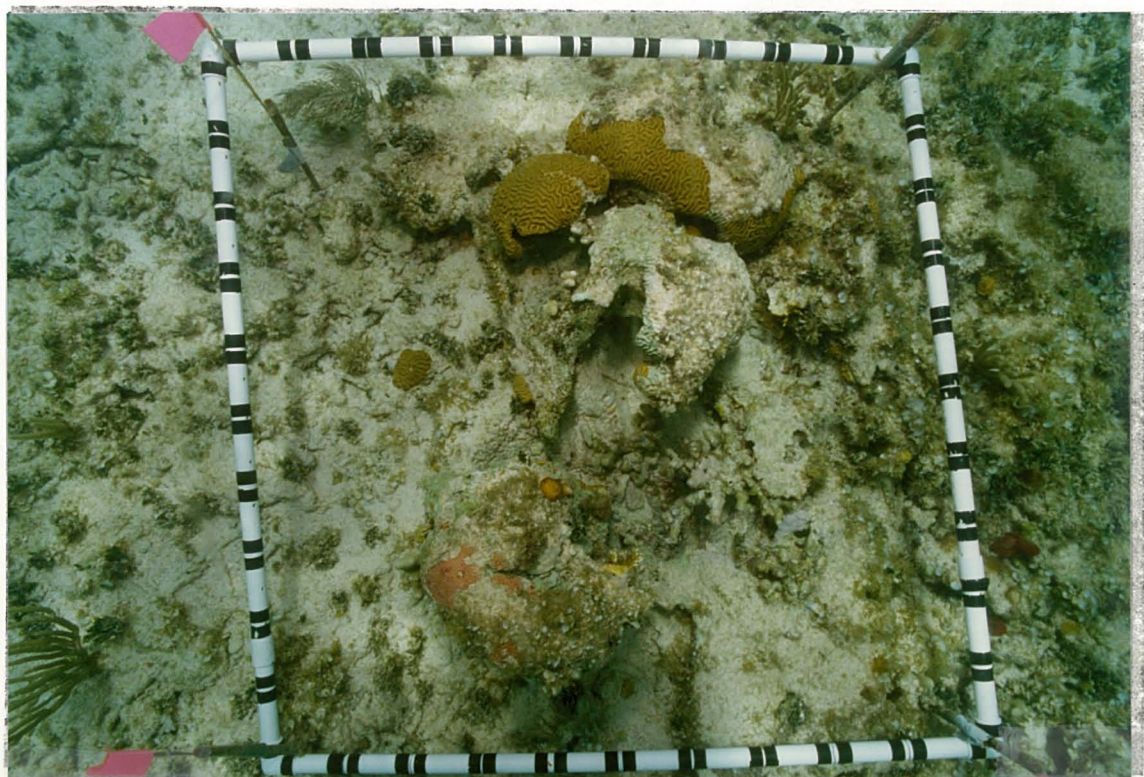
Quadrat 12 . Quadrat 12 is one of the original 1987 quadrats. It is dominated by D. strigosa and P. porites. Several other corals were observed in the quadrat but are difficult to identify on the photograph. These colonies will be routinely examined during the weekly diver observation. There are small colonies of M. alcicornis, S. siderea, A. agaricites, P. asteroides and D. strigosa. Examining photographs from 1987 show that there has been considerable decrease in the percent of live coral cover especially of the two dominant species.

Photoquadrat (12): An original 1987 quadrat (#12) containing Diploria strigosa with small colonies of Porites porites, P. asteroides, Siderastrea siderea, Millipora alcicornis and Agaricia agaricites. This photo taken 6-24-89.

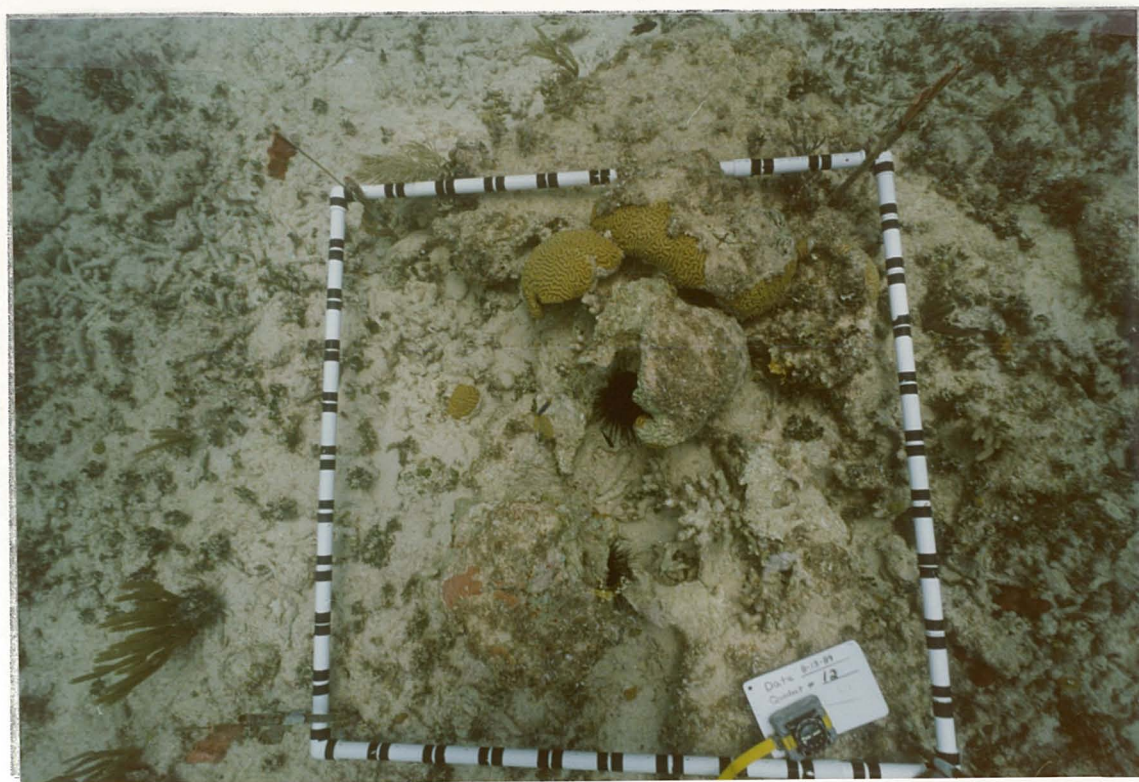
Photoquadrat (12): Same as above taken on 8-13-89.

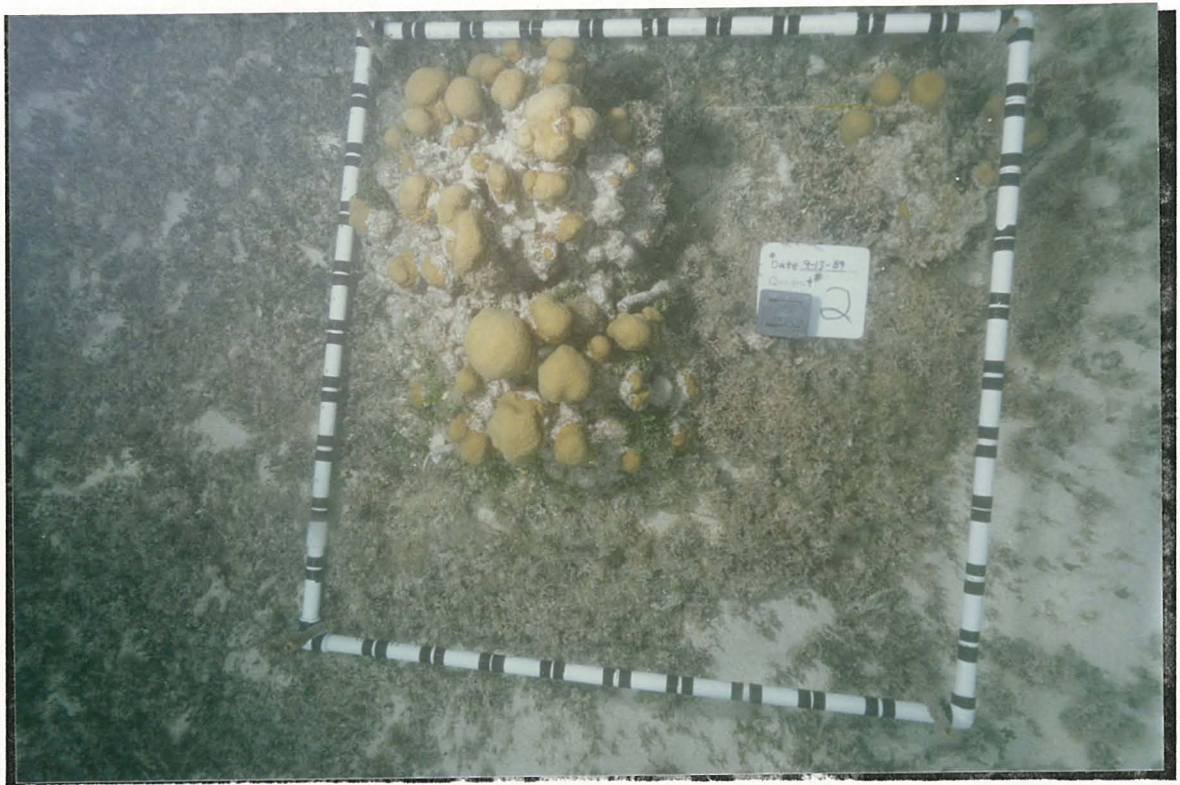
Quadrat 2. Photograph taken 9/13/89

Quadrat 2 site now buried under rubble.

Three new quadrats were selected to replace Quadrats 2, 6 and 11. They are being numbered 2a, 6a and 11a. These were photographed by Tonnemacher on 10/18/89. The three new quadrats photographs also appear in this report.

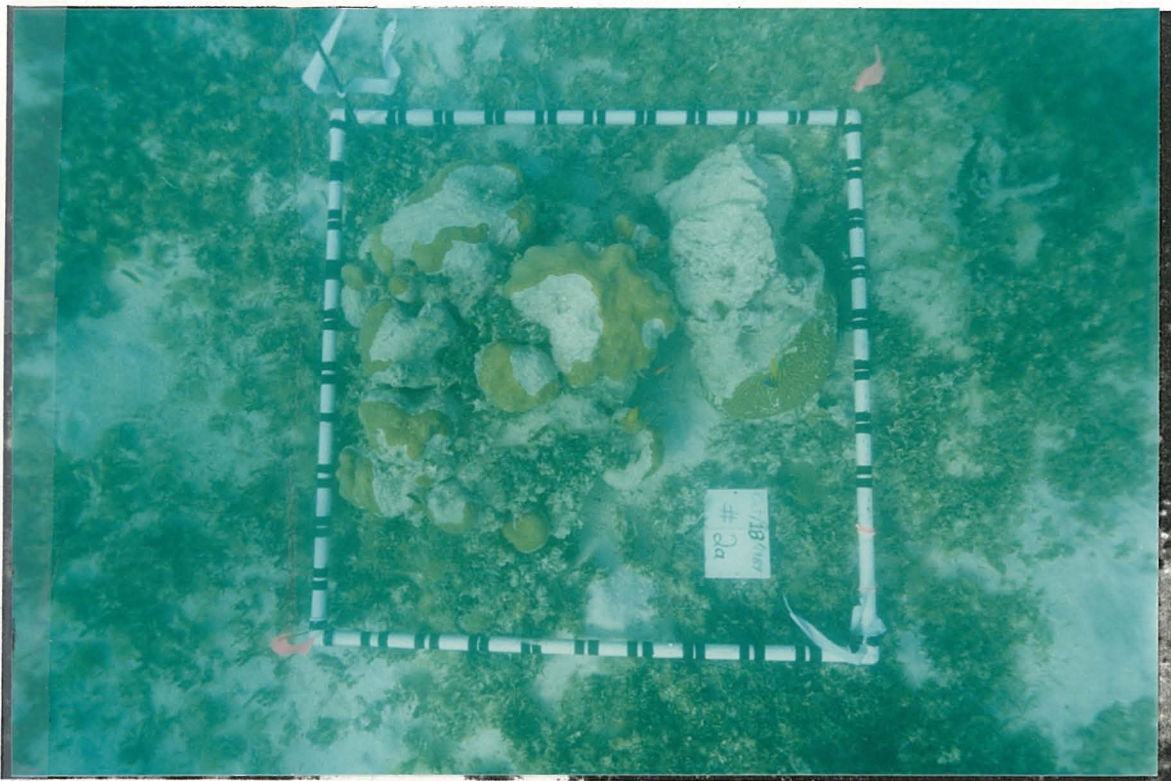
During the inspection on 10/14/89 it was noted that there was a noticeable filamentous green algal bloom in the area of quadrat 2a. The algae was identified as Chaetomorpha linum. It was only after the storm that this algae was observed here. The tremendous quantity of algae indicates a nutrient input entering the area.

Quadrat 2a. Photograph taken 10/18/89. New site selected to replace 2.

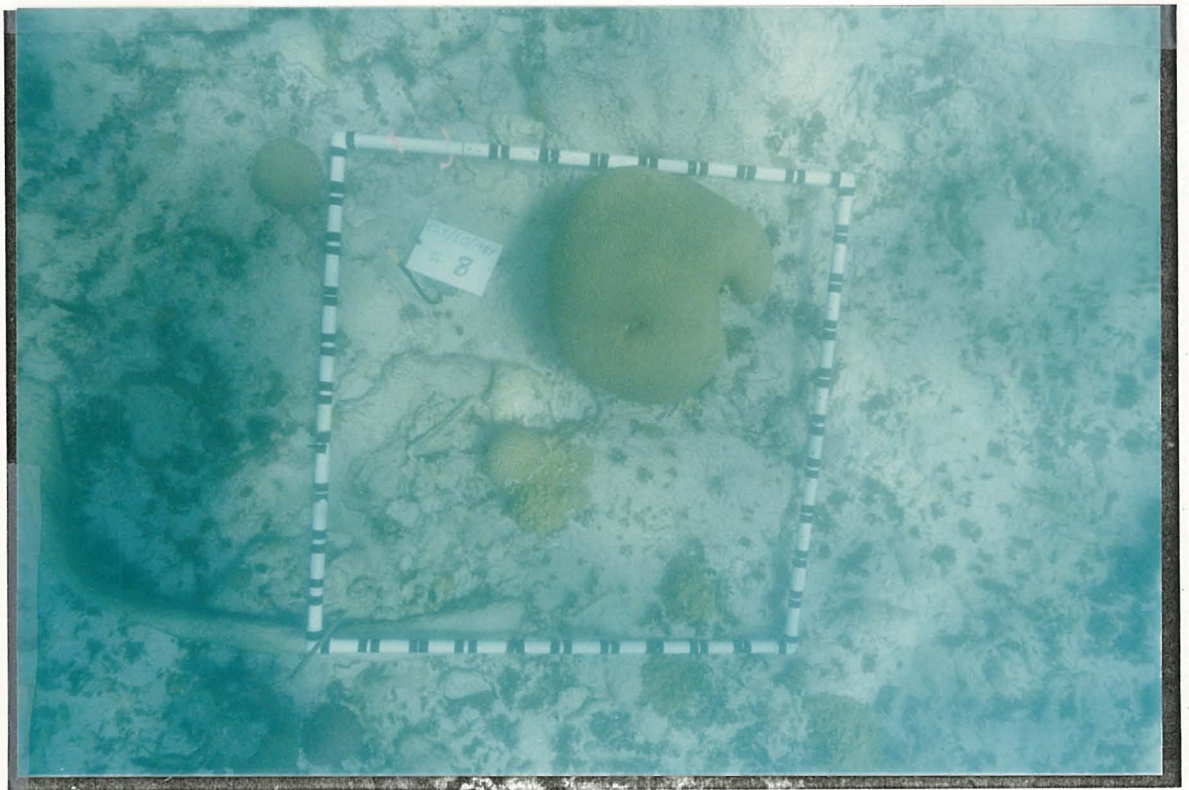
Quadrat 8. Photographed 10/10/89. No visible damage noted.
