Water Quality Monitoring Project / Third Port, St. Croix

/  
Baseline Report

July 5, 1989

## Water Quality Monitoring Project / Third Port, St. Croix Progress Report

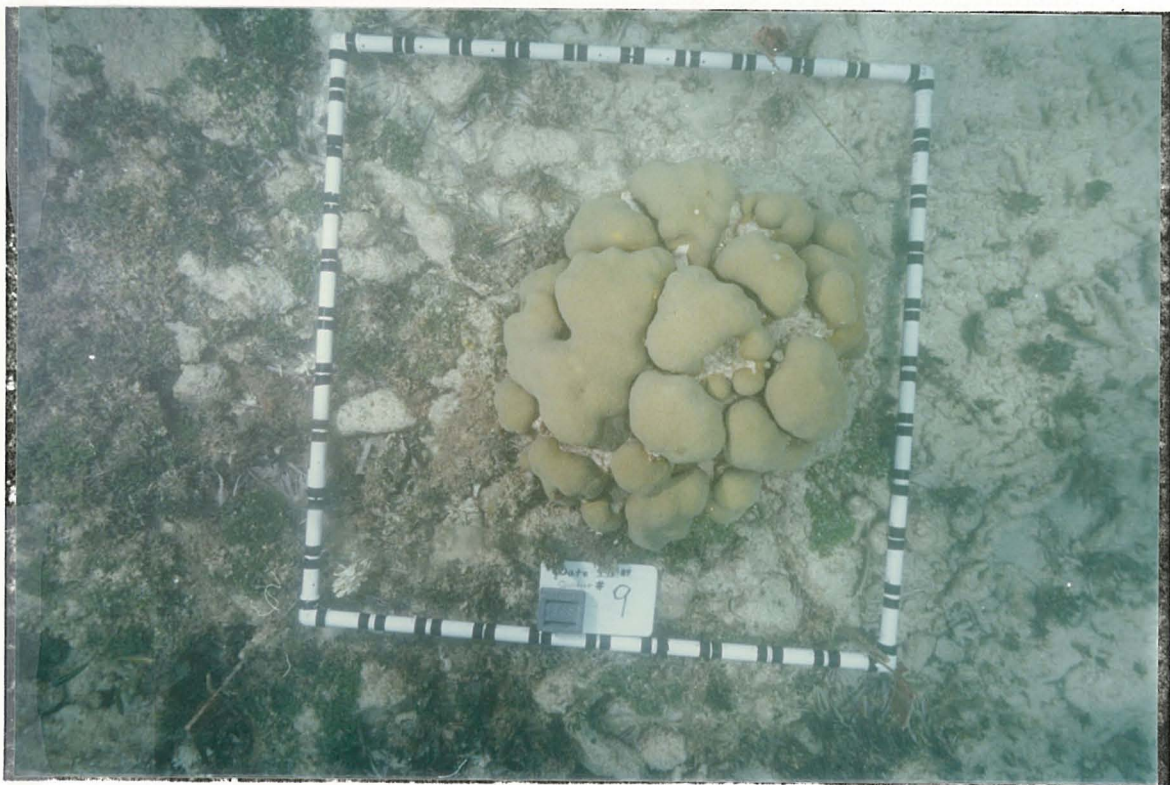
Quadrat 9. Photographed 9/13/89.

| Quadrat 9 | The entire head of <u>M. annularis</u> was broken off and moved approximately .25m to the south and slightly tilted on its side. |

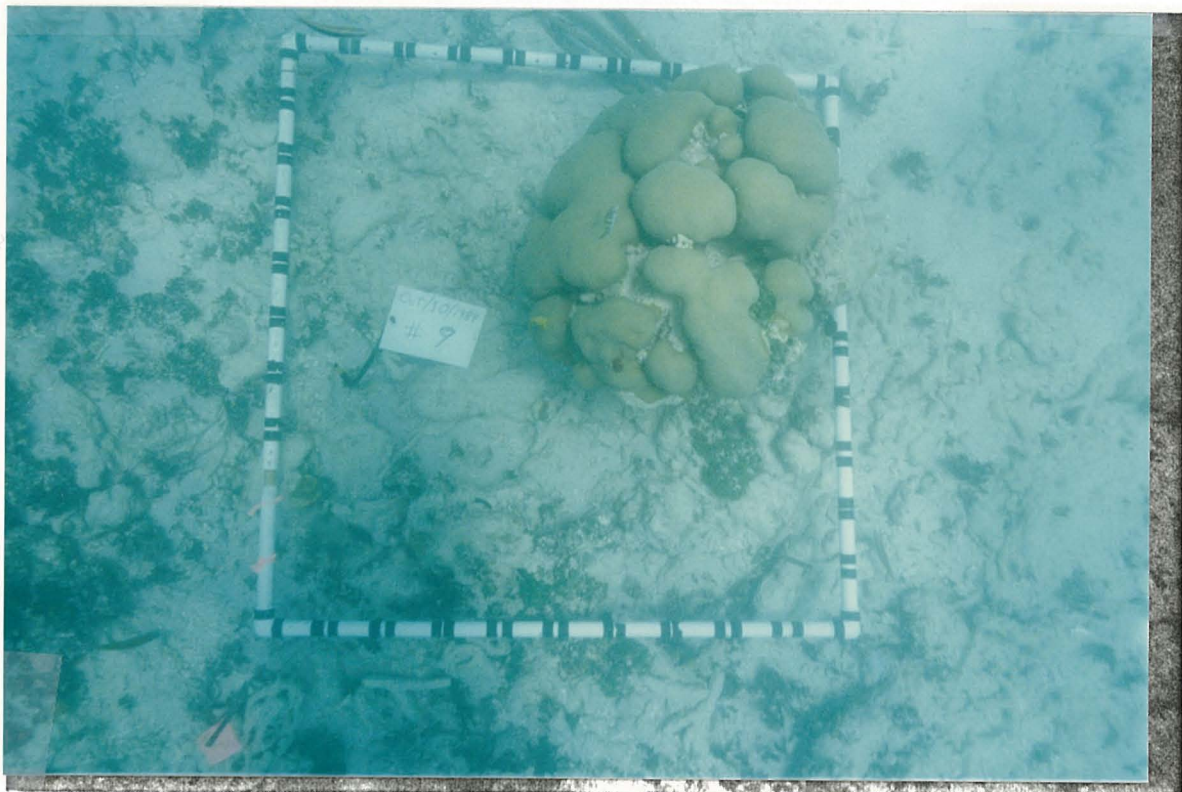
Quadrat 9. Photographed 10/10/89. Entire head was broken off and rested on its side approximate .25m to the south. Will continue to be used for analysis.
