CIRCULATION, WATER QUALITY  
AND ENVIRONMENTAL RESOURCES  
OF PERSERVERANCE BAY, ST. THOMAS

Final Report

Prepared for: Department of Conservation and Cultural Affairs  
Division of Natural Resources Management  
Government of the Virgin Islands

November 1977

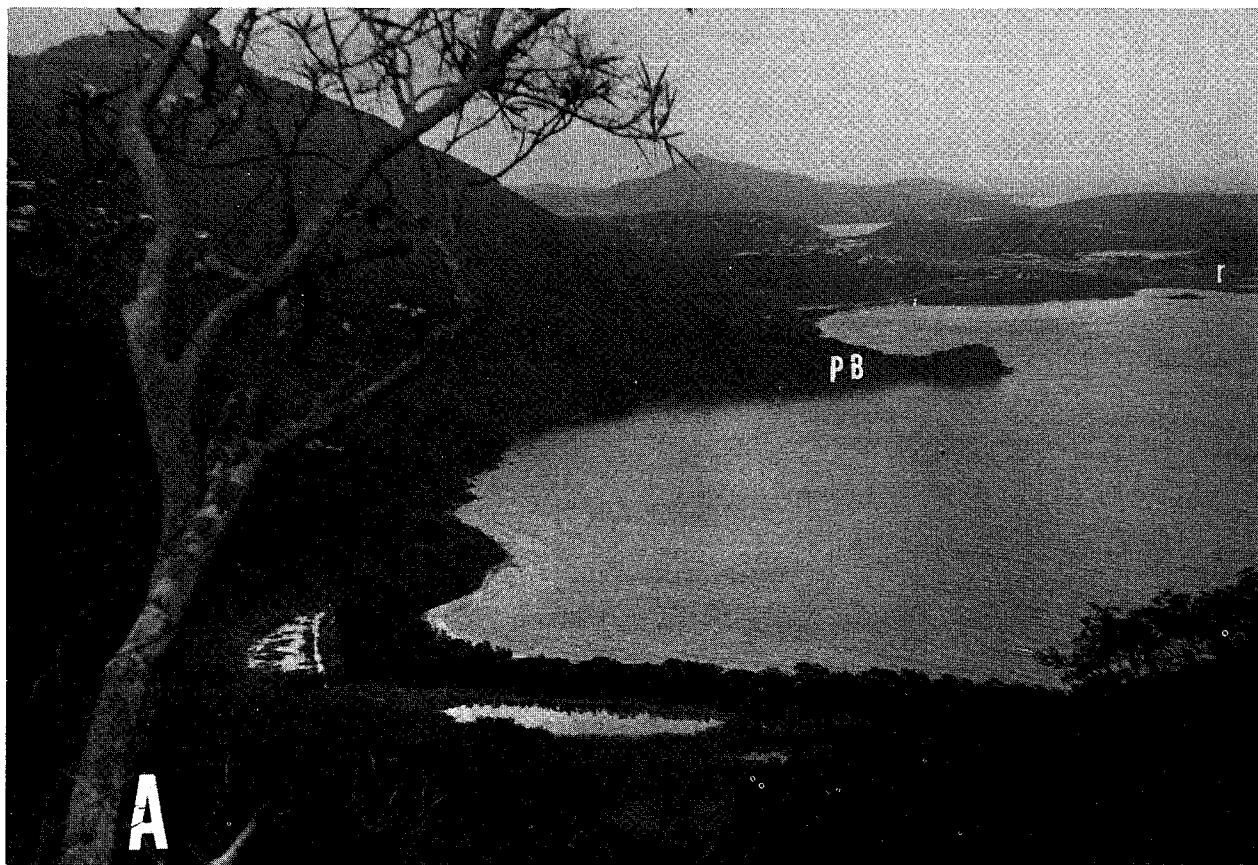
3A. General view of Perserverance Bay looking east toward Black Pt. (BP) and the airport runway (r). Hawk Hill lies to the left. Salt ponds, foreground, are rich in wildlife. They are threatened by impacts of development on steep slopes of the watershed.

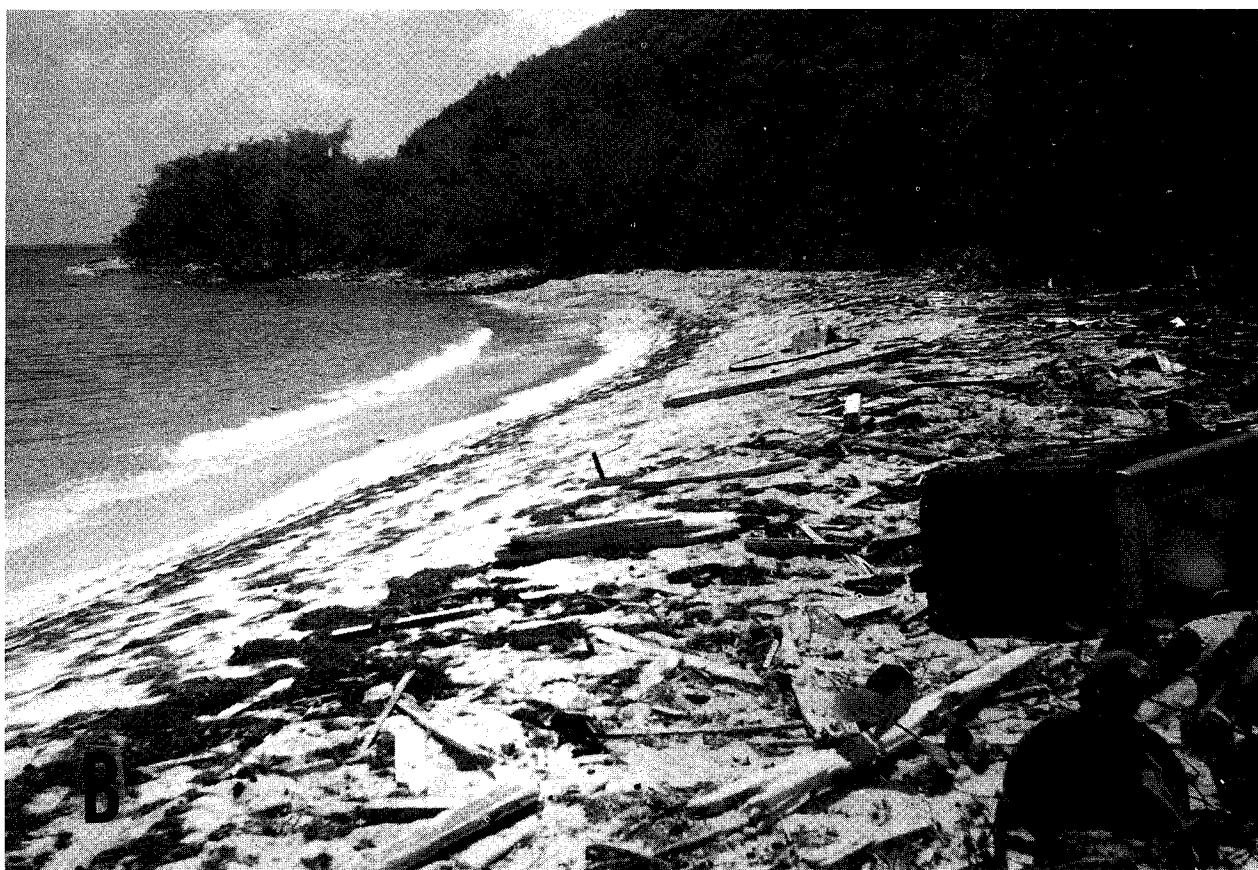
3B. Beach at the western head of Perserverance Bay is strewn with trash and debris distributed from passing ships and formerly from a municipal dump near the airport. The littoral current which converges along the shore is a virtual trap for floating debris.

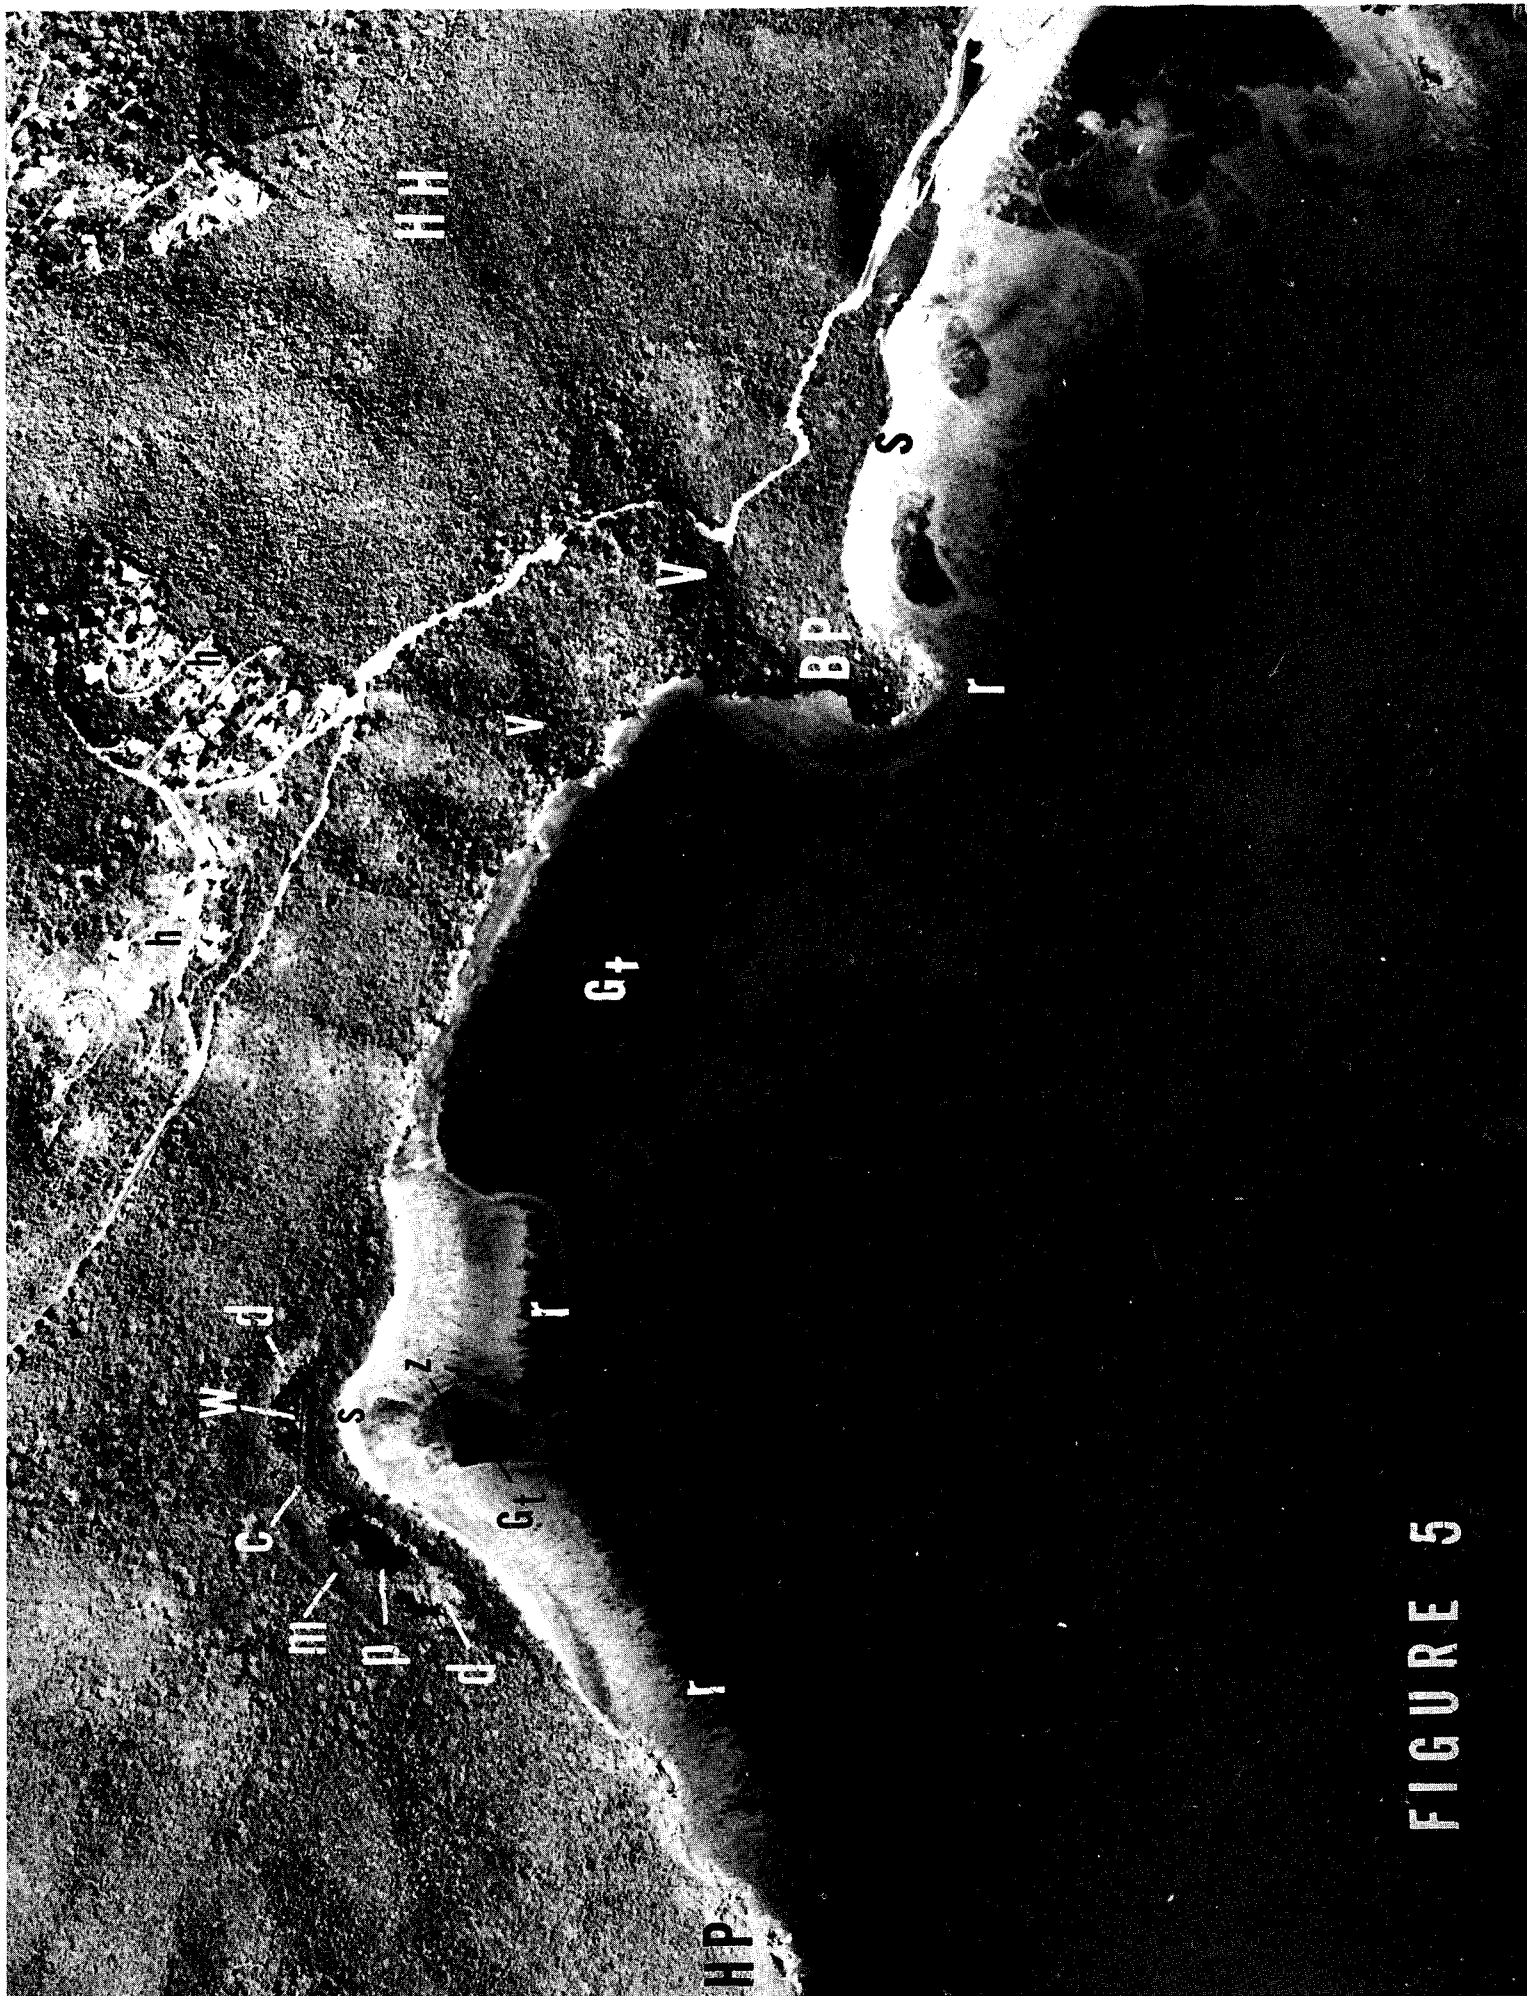
FIGURE 5

From an eye-in-the-sky of an aerial camera having a 15cm (6 inch) focal length, many environmental features are discernable that cannot be seen on the ground. Such features include turbid plumes, submerged vegetation boundaries and wave refraction which are not represented on charts and maps. When aerial photographs Figure 5, next page. Aerial photograph of Perserverance Bay and its drainage basin taken by NOS, Nov. 15, 1976. For description, see text.

The most conspicuous cultural features are the roads and houses (h) that cluster upper slopes of the drainage basin, near Bonne Esperance and Fortuna Hill (not displayed). Close inspection of the salt pond area reveals a causeway between the ponds (c) and a former drainage ditch across East Pond (w). Landward, ruins of a former plantation are nearly hidden by trees near (x). Submerged debris off the beach is visible near point (z).

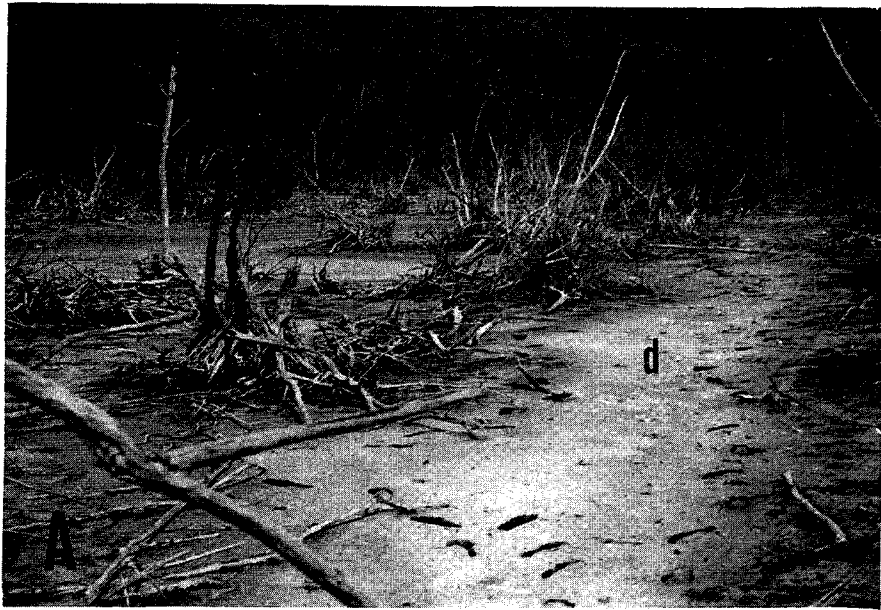
Figure 8A. Floor of East Pond during the dry season, March, 1977, showing shallow drainage channel leading to right (d). Note dead red mangroves.

The salt ponds fill shallow pan-like basins. The West Pond is flat-floored for a width of 87m (291 feet) while the East Pond is dissected for a width of 42m (140 feet) (Figure 8A). The central floor of East Pond is dissected by a shallow channel about 12cm below the average level of the pond floor. Presumably this is a former drainage channel leading to the bay at the extreme east end of the barrier ridge. The channel appears on 1947 aerial photography and therefore is at least 30 years old. Water depths in the ponds vary with the amount of precipitation and evaporation. During the study period, January-October 1977, depths in East Pond ranged 0 to 43 cm while in West Pond they ranged 2 to 55 cm.

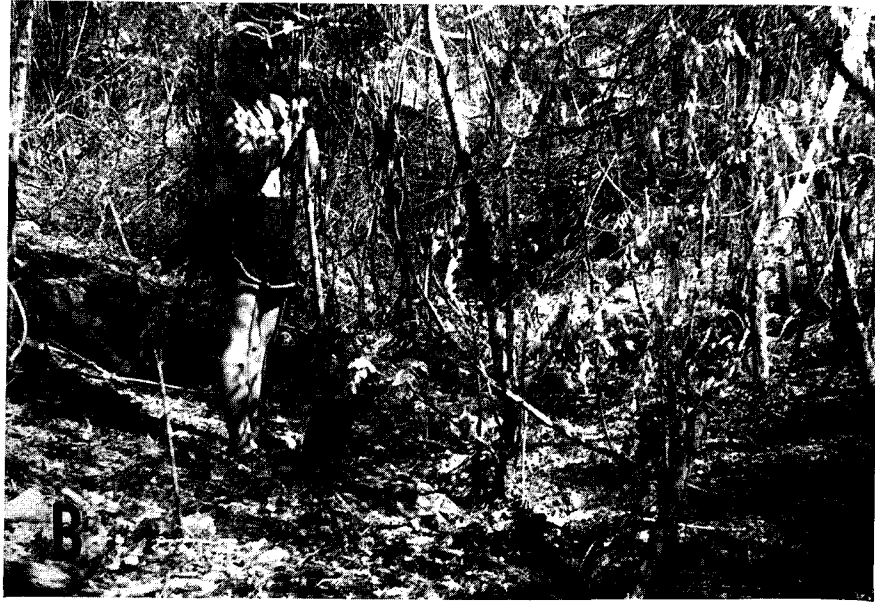
Figure 8B. Former drainage channel leading from East Pond to the bay through brush at extreme east end of ponds. Floor of channel lies 1.6 m (5.5 feet) above mean low water and carries water only during extreme floods from the land or storm tides from the bay.

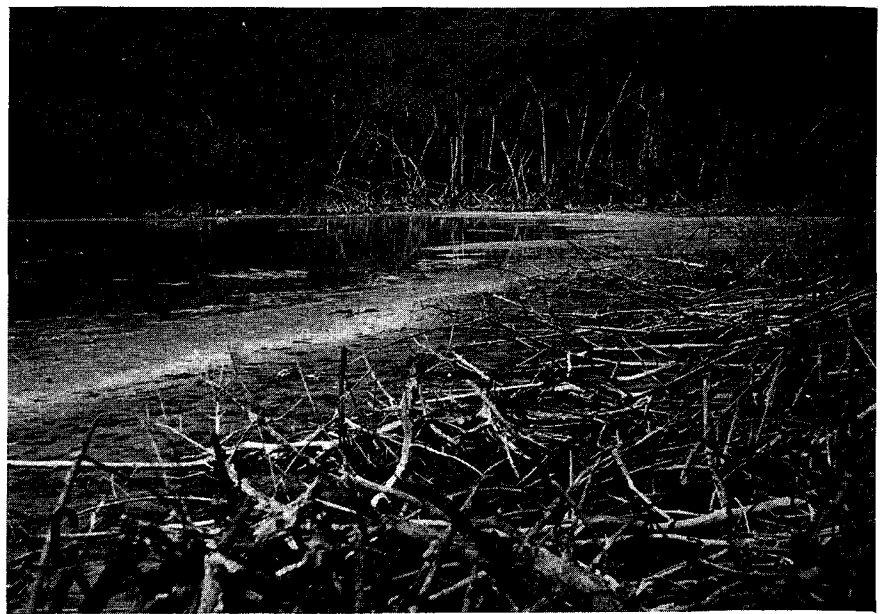
Figure 8C. Zone of dead red and black mangroves along edge of West Pond. Mangroves suffer from sedimentation of the pond floor and resulting high salinity during periods of drought, March, 1977, a time of very low water in the ponds.

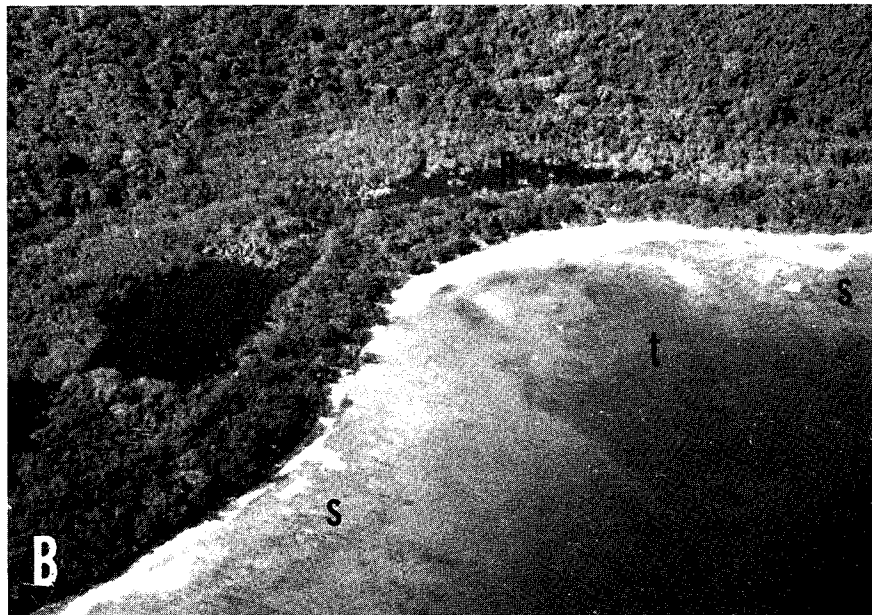
Figure 10B. Aerial view of main beach and western head of Perserverance Bay, October 9, 1977. Littoral drift which is driven from breaker zones on shoals (s) converges off the beach and partly flows seaward through a trough (t). The salt ponds (p) behind the shore act as natural catchments for silt and buffer the bay and its reefs against extreme runoff and sediment discharge from the land.

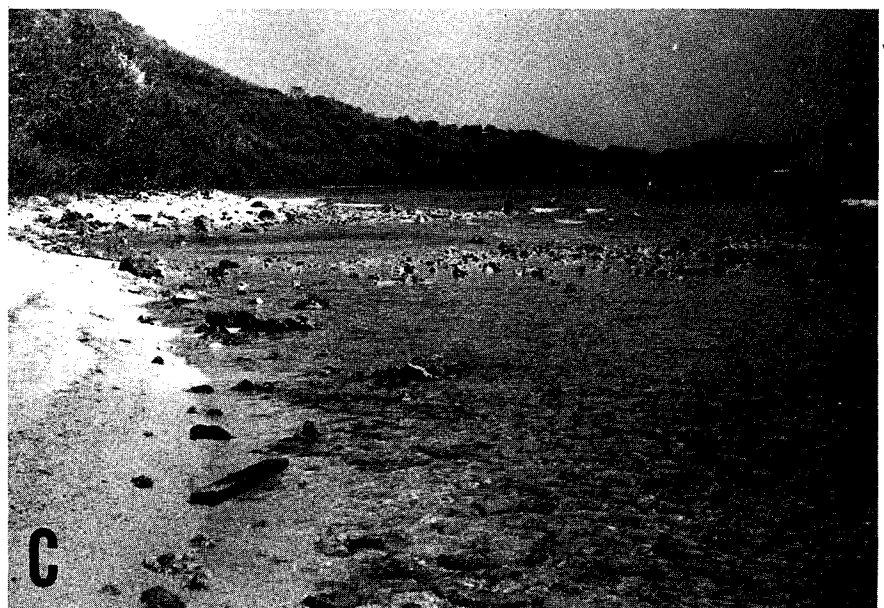
Figure 10C. Nearshore platform covered with coral debris near the west bay head. Waves breaking on this platform drive a littoral current into the bay head.
