# CARIBBEAN HYDRO-TECH, INC.

Re: Four Winds Test Well Logs

Enclosed you will find copies of a description of a shallow PVC sump ("WO Well") installed and well logs for test holes drilled on Four Winds Plaza Partnership Property (Four Winds Shopping Center) by Caribbean Hydro-Tech, INC. (CHT) during 1992.

Re: Meeting at Tutu "Splash and Dash" Car Wash

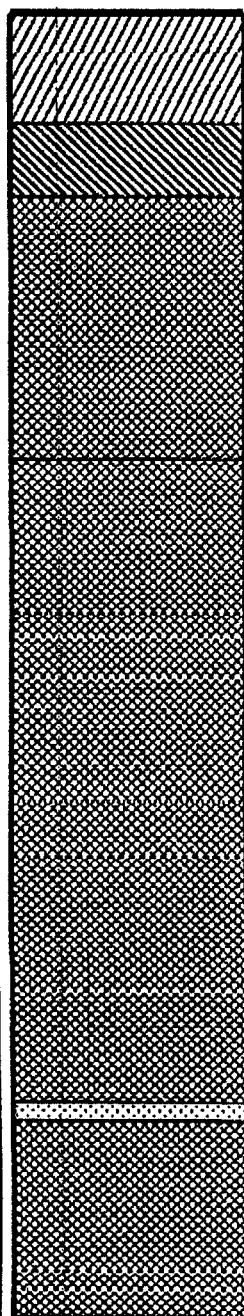
# WELL AND DRILLING LOG DEEP TEST HOLE 1

| depth | lithology | fractures | water bearing |
| 0 - 8 | green, claylike and fill | none | moist |
