Historic Structure Report  
**The Steeple Building**  
**Christiansted National Historic Site**  
*Final*

# **The Steeple Building**

## **Historic Structure Report**

May 2024

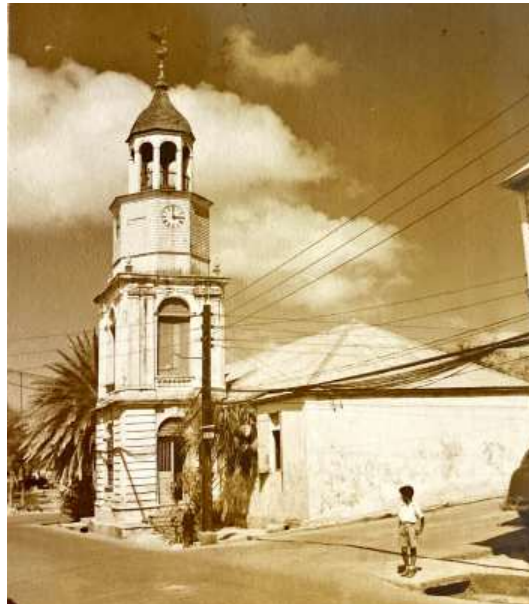
In 1953, architect Frederik C. Gjessing conducted observations of the Steeple Building as part of this overall review of the Christiansted site (see Figure 2–15, Figure 2–19).<sup>99</sup> The existing condition of the Steeple Building was considered fair to poor due to a variety of factors. The north and south walls of the main body of the building were deteriorated, the stucco scaled, and the material of the wall exposed. Water damage appeared to be the cause of this deterioration due to a lack of gutters on these walls. Architect Gjessing recommended chipping and repointing of the walls, particularly the lower part of the south wall. The interior walls of the building were stucco with the exception of the tower, which was painted. Two continuous cracks indicated a failure of masonry. One was in the west gable and the other on the second tier of the tower’s south wall. Considerable surface deterioration was observed on the tower, both inside and out. It was noted that recent repairs were implemented at the east end of the building. The interior pine tongue-and-groove floor boards suffered from termite damage, while the tongue-

FIGURE 2–15. Figure 13. Tower and west corner of the Steeple Building in 1953 with hairline cracks visible in end wall. Photo: Frederik C. Gjessing, *Condition Reports of Historic Buildings*, 1953, photo 1.

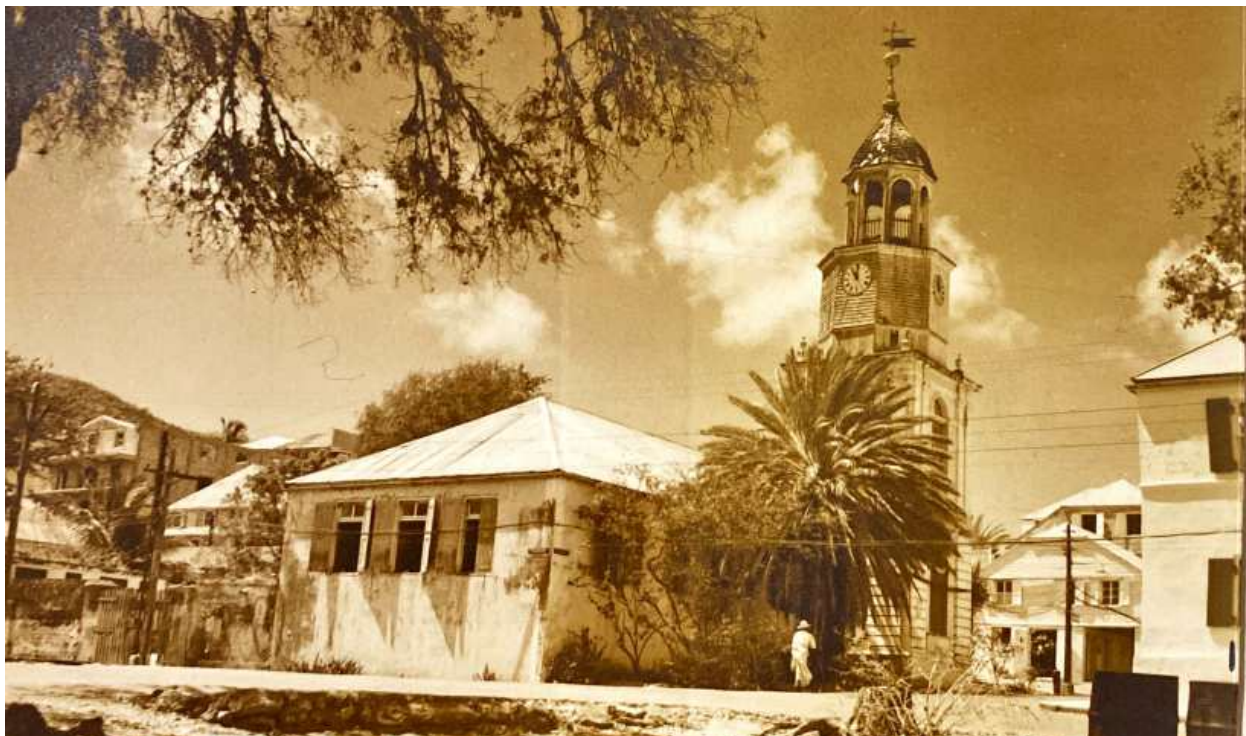
FIGURE 2-19. North corner of the Steeple Building and wall around rear yard in 1953. Photo: Frederik C. Gjessing, Condition Reports of Historic Buildings, 1953, photo 2.

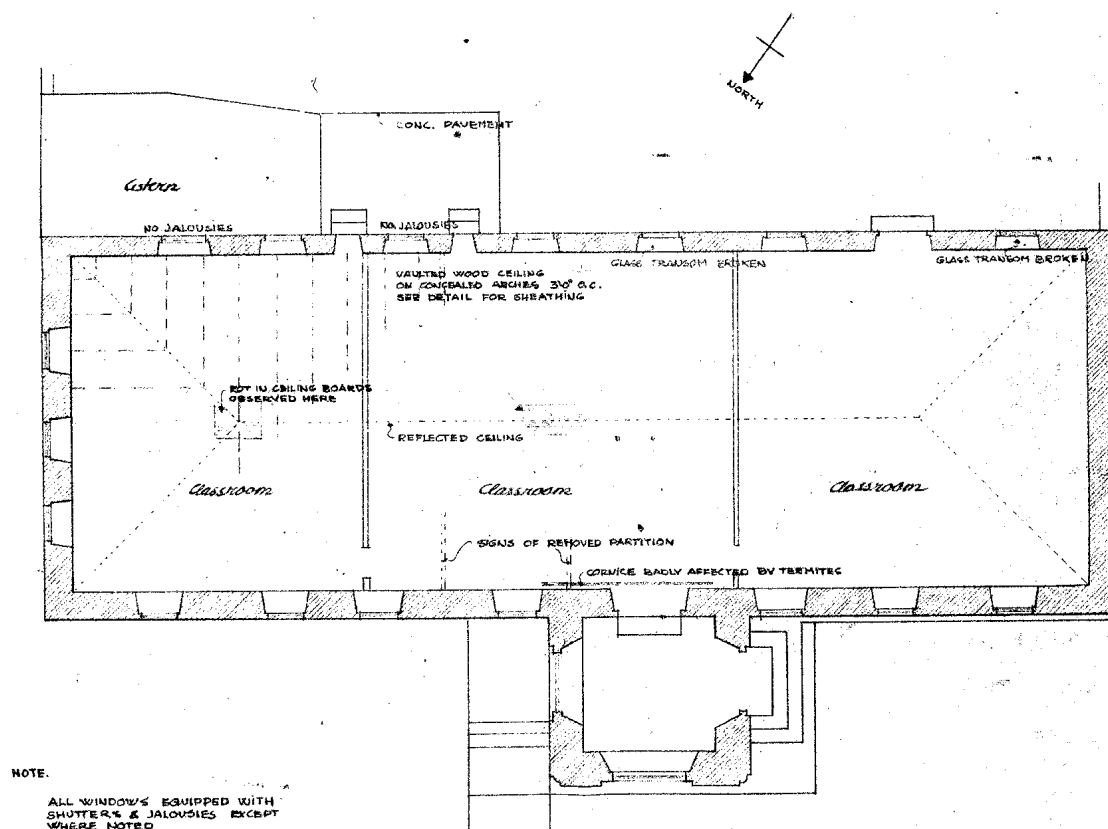
and-groove boards of the ceiling showed areas of rot due to roof leaks. Signs of former partitions that had previously been removed were evident on the north side of the building, near the entrance to the steeple (Figure 2–20).<sup>100</sup>

FIGURE 2-20. Plan of Steeple Building with notes on existing conditions as observed by Frederik C. Gjessing in 1953. Frederik C. Gjessing, Condition Reports of Historic Buildings, 1953.

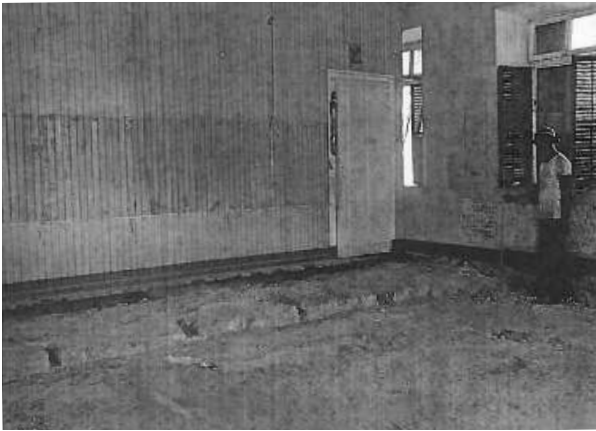
FIGURE 2-21. Interior of the Steeple Building during the 1956 investigations looking northwest toward one of the temporary partition walls. Photo: Frederik C. Gjessing, Preliminary Survey Report, photo 10.

The physical investigation documented in architect Gjessing’s 1956 preliminary survey report required the removal and demolition of some of the existing fabric of the Steeple Building (Figure 2-21, Figure 2-22). The existing wood flooring and interior classroom partitions were removed and horizontal bands were chipped along the walls. Vertical stripes

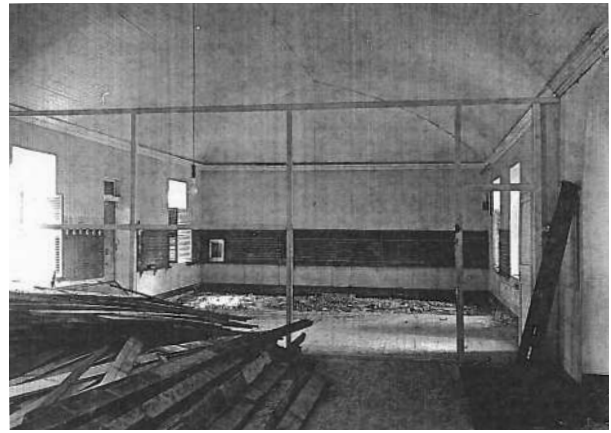
FIGURE 2-22. Interior of the Steeple Building during 1956 investigations looking southwest where one of the temporary partitions was removed. Photo: Frederik C. Gjessing, Preliminary Survey Report, photo 7.

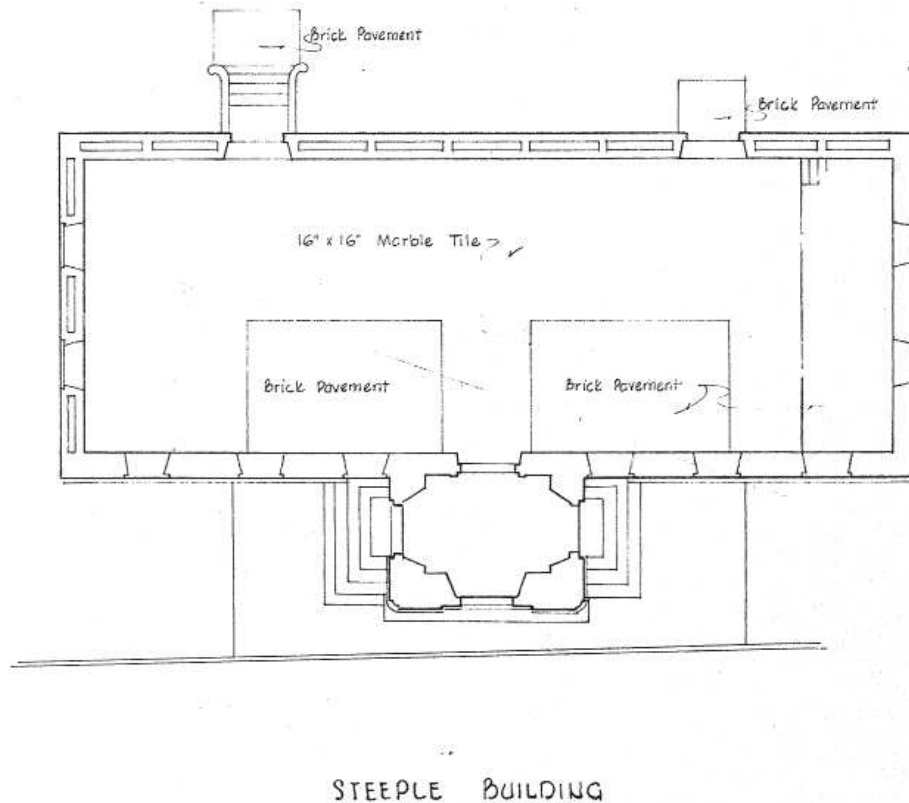
FIGURE 2-27. 1965 floorplan of the Steeple Building noting flooring materials, cropped by the author (Drawing No. NPS-CHRI 399 3004).

pavement on the north side of the building (Figure 2–27).<sup>133</sup> In 1965, it was noted that the sand bed of the floor was improperly tamped and rolled in two localized areas of the building. As a result, approximately 15 of the marble tiles were cracked. The majority of the cracking occurred when the museum exhibit materials were unloaded into the building. Because the condition was localized, the repair of the sand bed and replacement of tiles was achieved.<sup>134</sup>

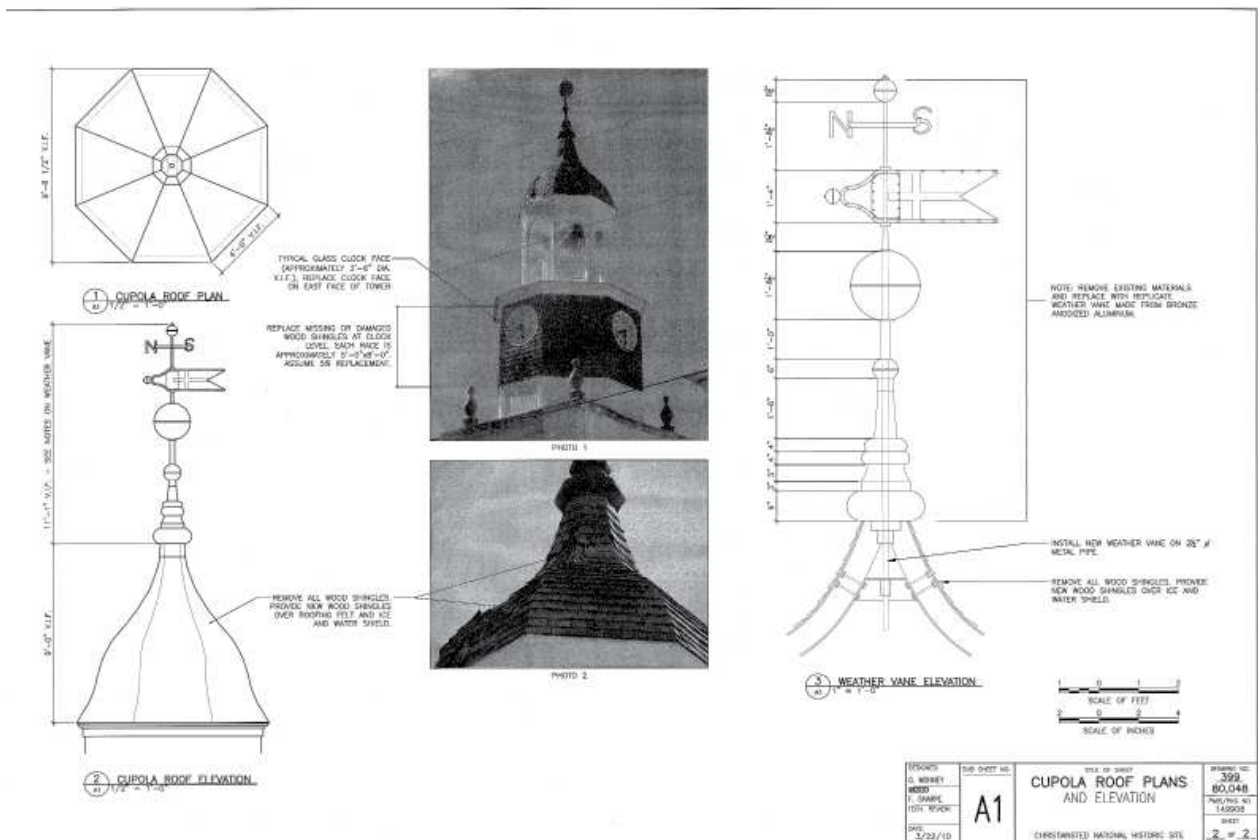
FIGURE 2-60. Plan for cupola and weathervane repair after damage caused by Hurricane Omar in 2008. Drawing: Denver Service Center, Technical Information Center, Drawing No. CHRI 399 80048.

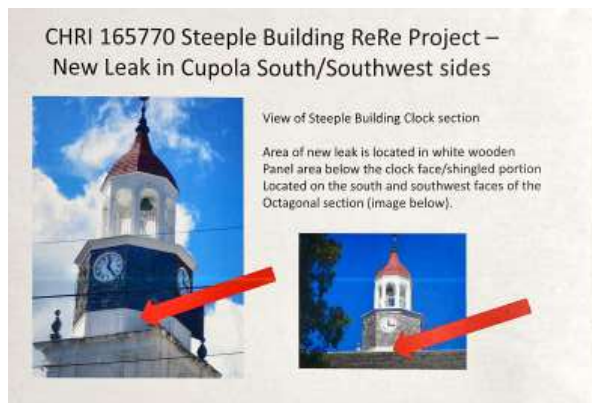
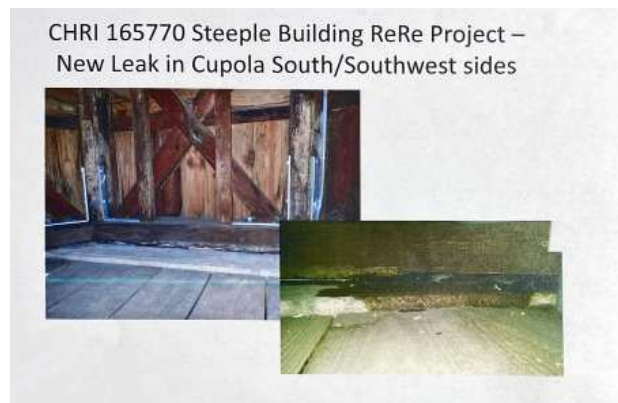
FIGURE 2-63. Photographs taken in 2017 by the National Park Service staff showing the location of a newly identified leak in the cupola. Source: National Park Service, Christiansted National Archives.

significant leak was discovered in the steeple tower below the octagonal drum (Figure 2–63).<sup>239</sup> This leak allowed water to infiltrate into the woodwork and masonry of the tower and the main body of the building.

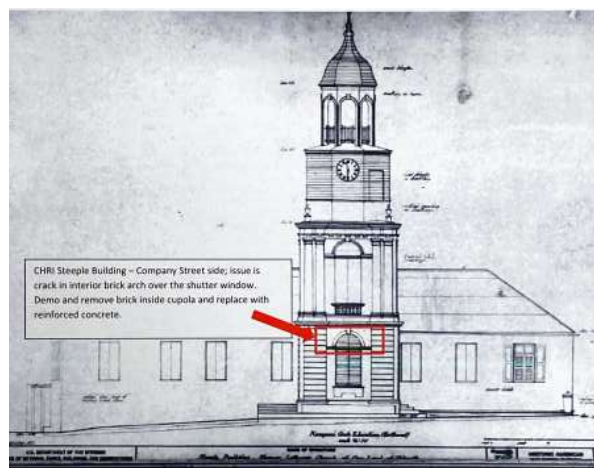
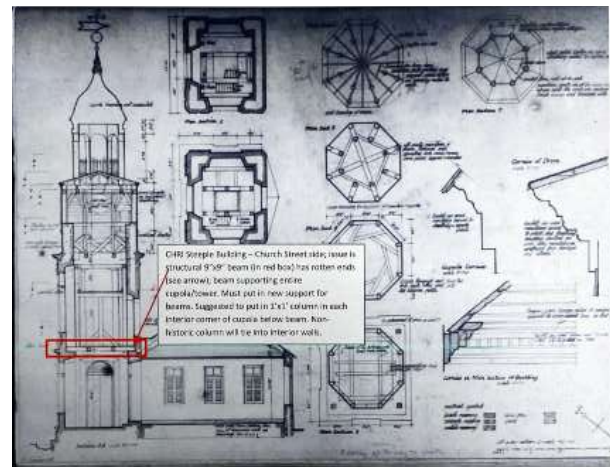
FIGURE 2-64. Front and east side elevations with notes identifying the location of the rotten structural beam. Notes added to copies of HABS plan drawings in 2017 by CMGC Building Corp. Drawings: National Park Service, Christiansted National Historic Site Archives.

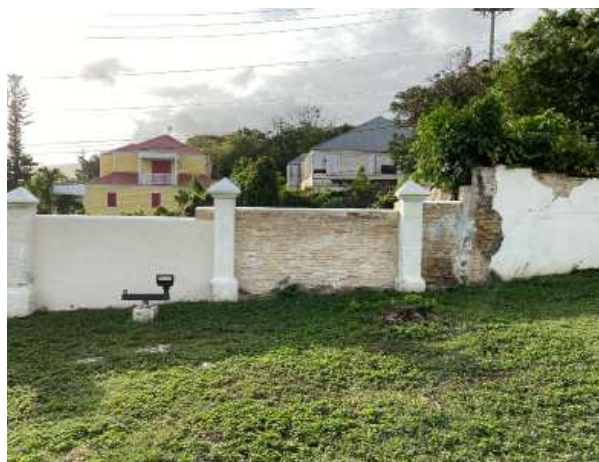
FIGURE 2–67. Photograph of the rear yard wall with repairs completed, as evident by the new bricks and stucco finish on portions of the wall at left and more weathered portions of the wall at right, taken February 2022. Photograph by the author.

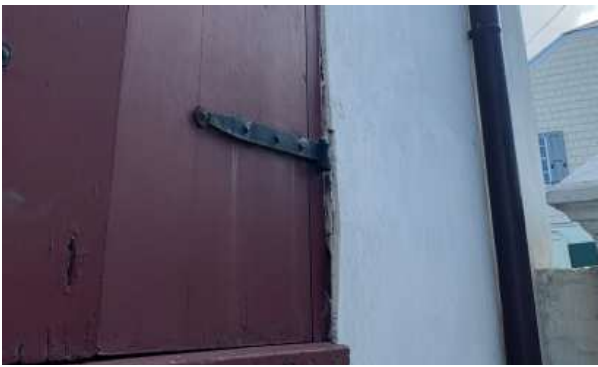
FIGURE 3-3. Bulging on northeast wall.

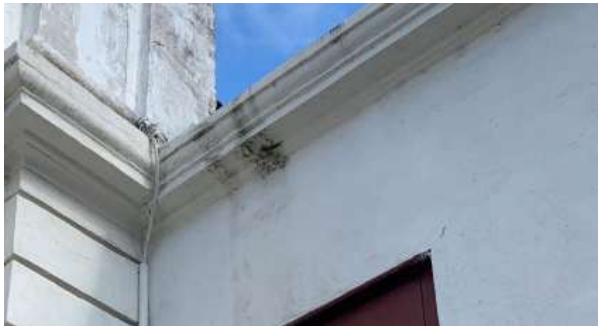
FIGURE 3-4. Staining on northwest wall.

repair work that HPTC performed prior to the site visit. Most of the staining present on this elevation is found near the cornice, where it appears that blockages in the gutter system cause water to overflow onto the wall below (Figure 3-4). This is along the cornice but primarily on the leftmost edge above Window 3.

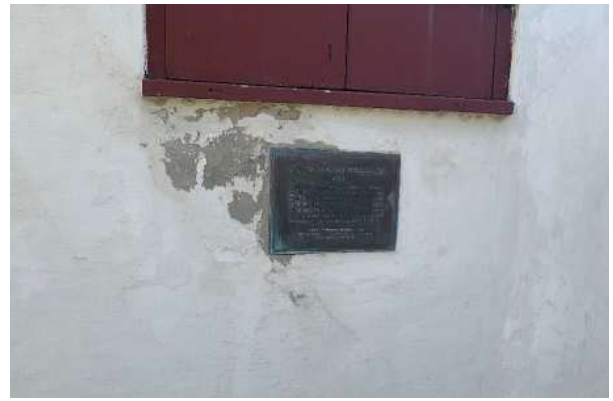
Plaster damage is present under Window 1 surrounding an NPS plaque (Figure 3-5). In this location, paint is peeling and pieces of plaster are separating and falling off the wall. The plaque is made from bronze and exhibits a typical copper patina. Otherwise, it appears in good condition.

FIGURE 3-5. Plaster damage.

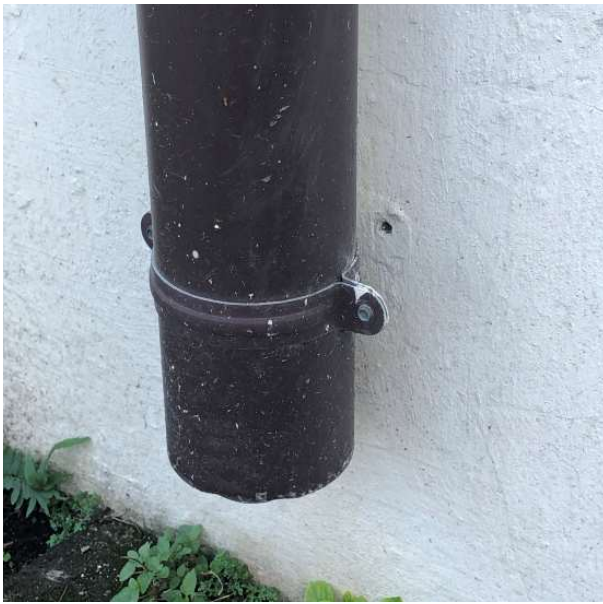
Based on observations while on site, it appears that the rain leader and fasteners on this façade were either replaced or moved from the original installation locations. There are four locations adjacent to the leader where open holes are present. First, approximately 1'-0" above the ground on the right side of the leader there is an open 1/4"-diameter hole in the wall (figure 3-7).

FIGURE 3-7. Wall penetration.

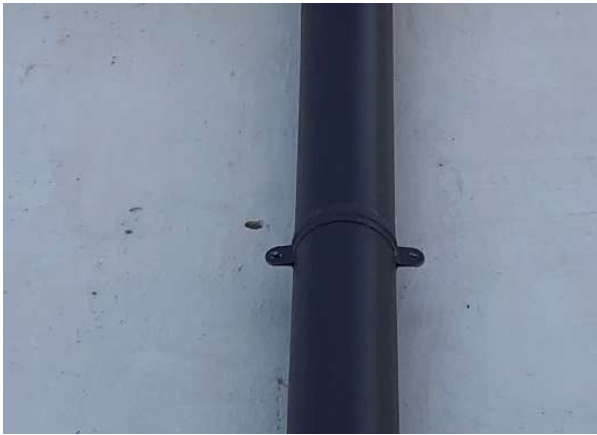
FIGURE 3-8. Wall penetration.

the leader there is an open 1/4"-diameter hole. There also appears to be a patched hole located at the same height on the left side of the leader (Figure 3-8).

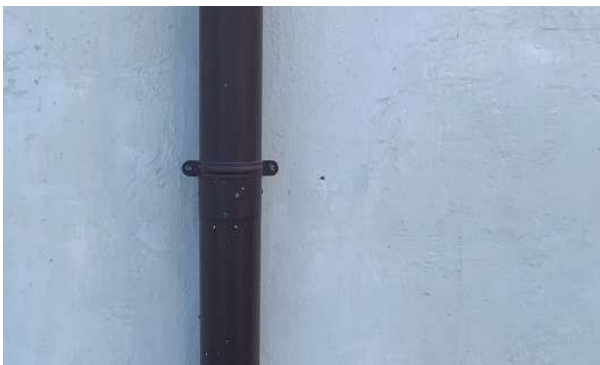
FIGURE 3-9. Wall penetration.

Third, a set of 1/4"-diameter open holes is located on either side of the leader approximately 8'-8"

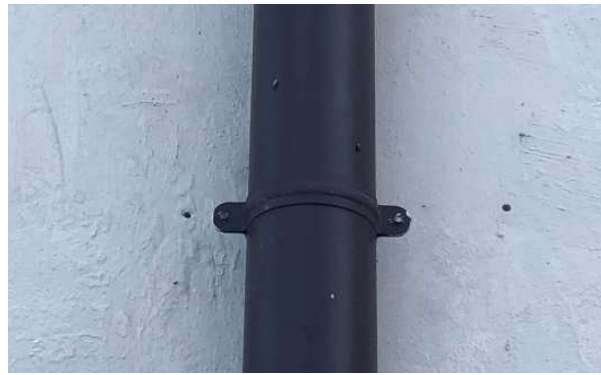
FIGURE 3-10. Wall penetration.  
above ground (Figure 3-9).

Fourth, a larger 1/2"-3/4"-diameter hole is located on the left side of the leader. The exact height of the hole was unable to be measured but appeared 12'-0"-13'-0" above the ground (Figure 3-10).

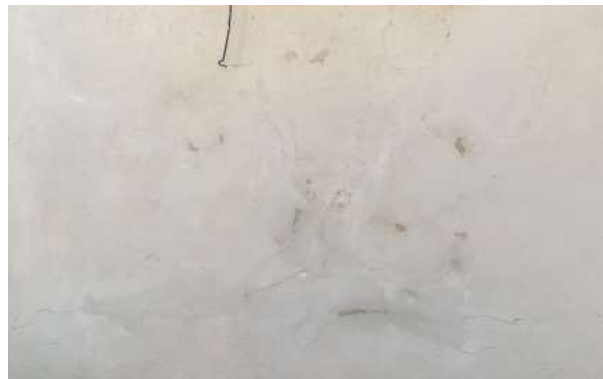
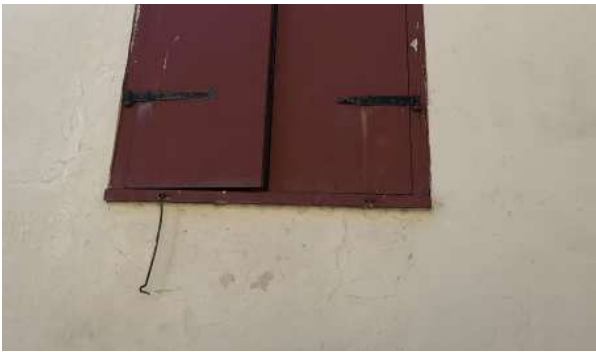
The first series of cracks is located under Window 6 at the lower left edge of the wall (Figure 3-11 and Figure 3-12). These five cracks are adjacent to a previous patching job. The cracks are approximately 1/16" wide and range from about 9" to 1'-2" in length. It is likely that these cracks are connected as a part of a larger system.

FIGURE 3-11. Cracks under window 6.

FIGURE 3-12. Cracks around Window 6.

However, since the site visit used only surface-level observations, the full extent was unable to be determined due to a previous patch.

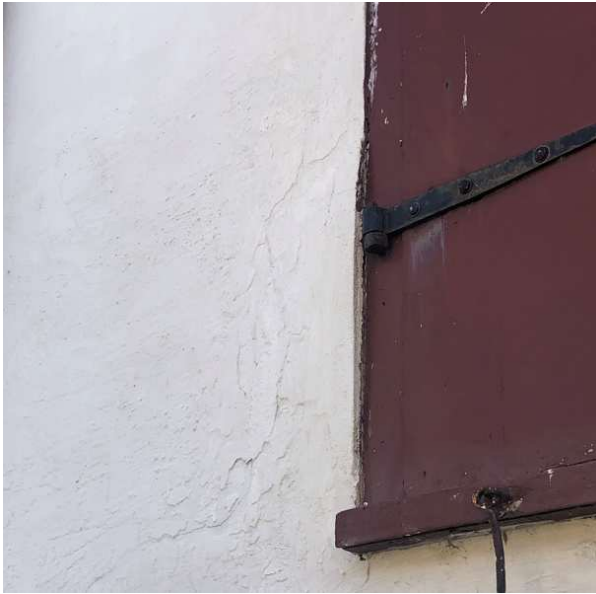
FIGURE 3-13. Bulging in plaster left of Window 6.

The second series of cracks is located slightly higher up the wall in a small location. They are directly below and to the left of Window 6 (figure 3-13). These cracks also appear approximately 1/16" wide and range from about 1'-0" to 3'-0" in

locations, first to the left of Window 6 (Figure 3-13). Bulging was also present under Window 5 (Figure 3-16).

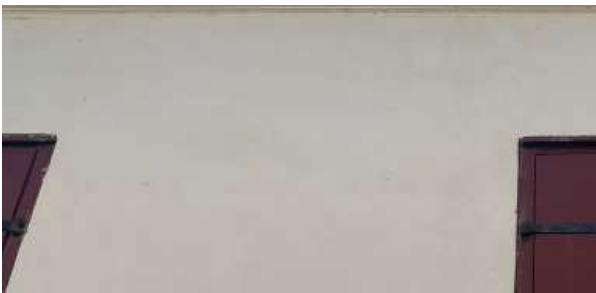
FIGURE 3-14. Cracking between Windows 5 and 6.

The third series of cracks is located at the top edge, running between Windows 5-6 (Figure 3-14). At the surface, these cracks also appear approximately 1/16" wide. However, a similar set of cracks is in the same location on the interior. This likely indicates through-wall cracking caused by settlement issues, as will be discussed in the structural section.

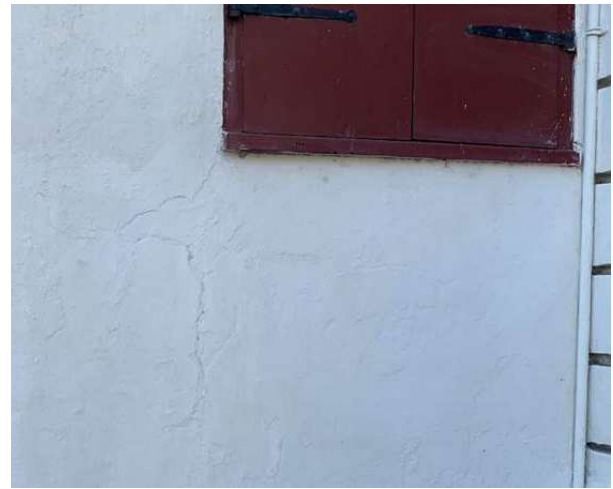
FIGURE 3-15. Cracking under Window 4.

The fourth series of cracks is located underneath Window 4 (Figure 3-15). Like the other cracks on this elevation, they appear approximately 1/16" wide and range from about 1'-0" to 3'-0" in length.

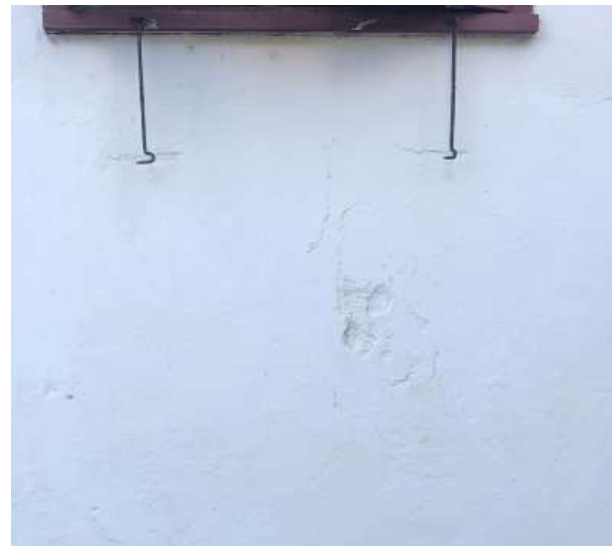
FIGURE 3-16. Bulging in plaster under Window 5.

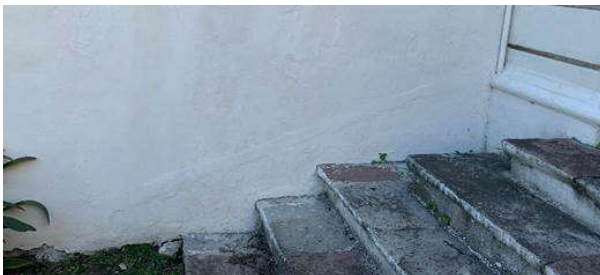
FIGURE 3-18. Remnant of former knee wall.

As previously mentioned, repairs were made to the exterior of the building by HPTC before the site visit was conducted. These repairs consisted primarily of crack repair, reapplying plaster, and repainting. However, many iterations of previous repair efforts have also occurred and can still be observed. On the lower right corner of the elevation, there is evidence of the removal of a potential knee wall that sat adjacent to the steps leading up to the Door C (Figure 3-18).

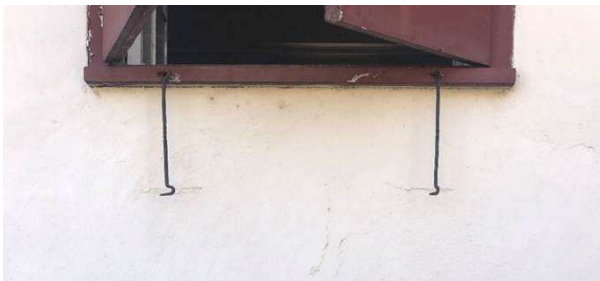
FIGURE 3-19. Grooves cut by shutter hooks.

The swinging shutter hooks under both Windows 5 and 6 on this elevation have cut grooves into the plaster (Figure 3-19). Window 4 does not have shutter hooks and, therefore, does not cut grooves into the plaster.

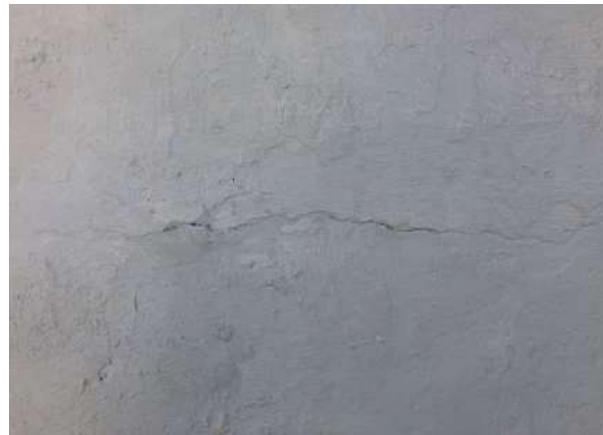
FIGURE 3-20. Crack on northeast façade.

Overall, the northeast façade (facing Hospital Street) seems to be in good condition. The most prominent issue found was a large crack on the bottom left section of the wall, roughly 1'-11" from the edge and 4'-7" above the ground (Figure 3-20). This crack measures approximately 1/8" wide and 4'-0" long.

The night before the site visit on December 13, 2021, a heavy rain came down on Christiansted. The morning after, when visiting this location, evidence of water was seen coming out of this crack. The surrounding wall had mostly dried from the rain; however, underneath this crack a

noticeably damp section could be seen and felt. This seems to indicate water was coming out of the crack from the interior of the wall.

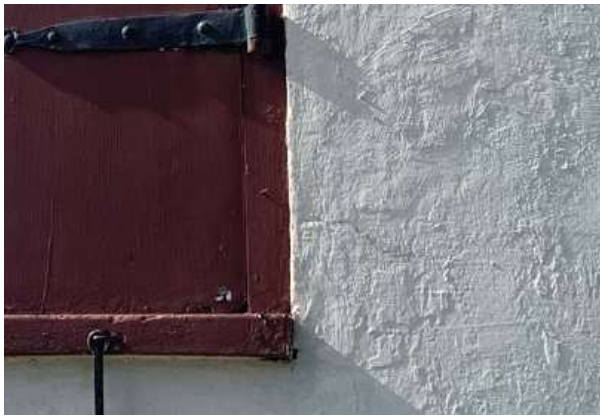
FIGURE 3-21. Small crack near Window 8.

A smaller crack, roughly 6" in length, was also observed adjacent to Window 8 in the bottom right corner (Figure 3-21). This crack appeared to be patched over and was not leaking water in the same manner.

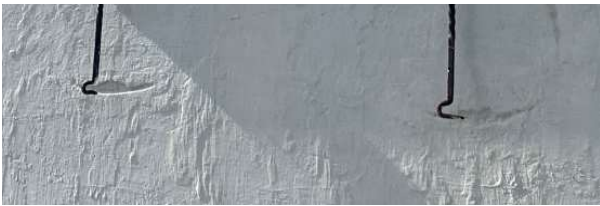
FIGURE 3-22. Grooves cut by shutter hooks.

The grooves cut into the plaster by the swinging shutter hooks were also observed under both Window 7 and 8 (Figure 3-22).

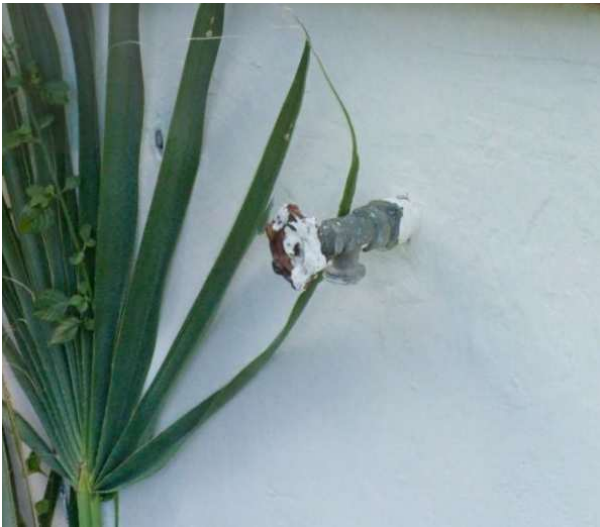
FIGURE 3-23. Penetration near water spigot on southeast façade.

Penetration on this elevation is located under Window 10 and is approximately 1/2"–3/4" in diameter. Its origin is not known, but it is in close proximity to the existing water spigot (Figure 3-23).

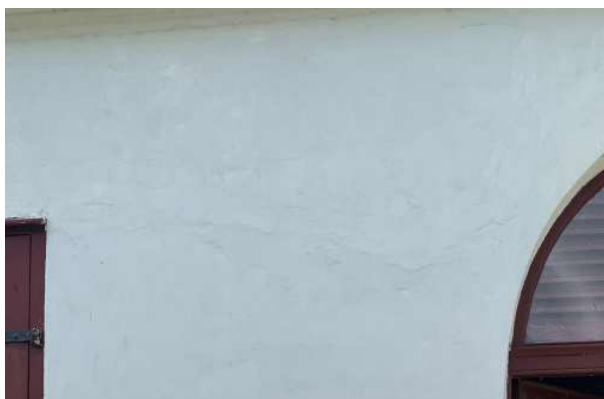
FIGURE 3-25. Patched crack near Door E.

directly adjacent to this crack also seem to be recently repaired, indicating that it was part of a larger crack system (Figure 3-25). In fact, the other side of Door E also showed signs of a patched crack that matched an interior set. The likely cause of these cracks is also settlement issues, as will be discussed in the structural section.

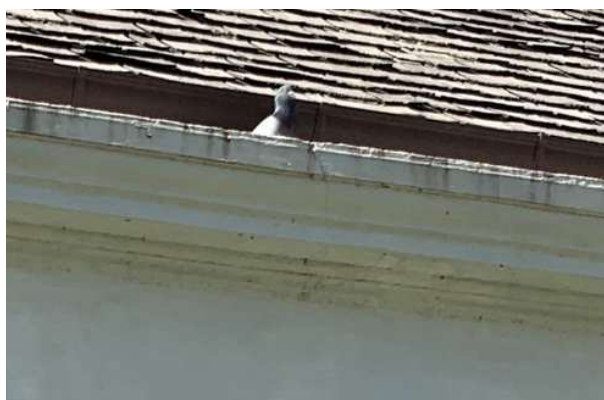
FIGURE 3-26. Crack in cornice near Door D.

The second visible crack is in the cornice near Door D (Figure 3-26). At the surface it appears relatively small, 1/8" in width. However, evidence of a connected crack running toward the door opening can be seen in an adjacent patch (Figure 3-27). Settlement is again the likely cause.

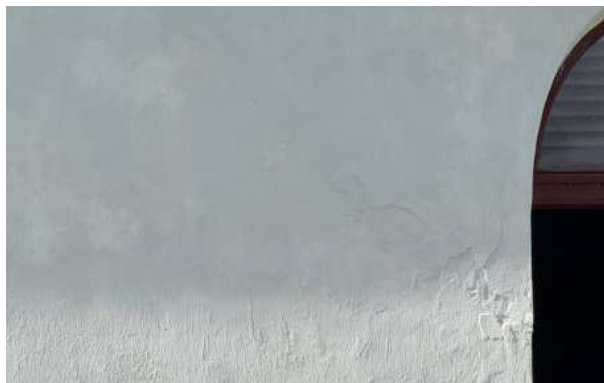
FIGURE 3-27. Patched crack near Door D.

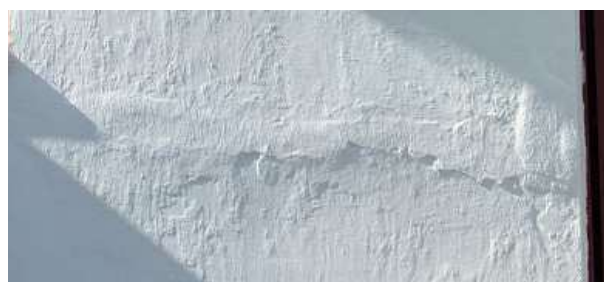
FIGURE 3-28. Patch at lower left side of Door E.

Other examples of potentially larger cracks that may have been repaired are found on the lower left side of Door E and a series of patches under Window 9 (Figure 3-28 and Figure 3-29).

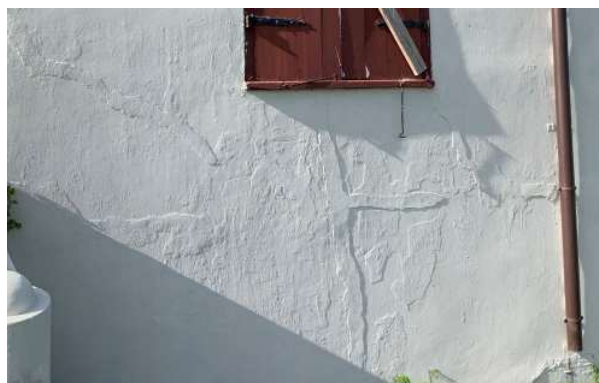
FIGURE 3-29. Series of patches under Window 9.

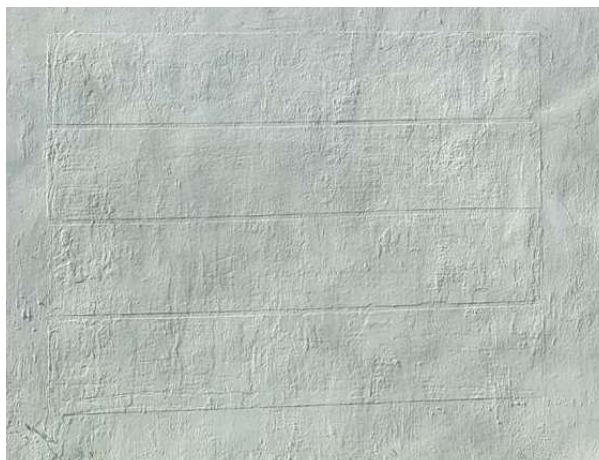
FIGURE 3-30. Series of four rectangles shaped into the plaster.

into the plaster in the middle of the wall (Figure 3-30). Each rectangle measures approximately 1'-4 1/2" tall by 7'-8 1/2" wide. The reason for these rectangles is unknown, though they could have been training examples during the HPTC efforts.

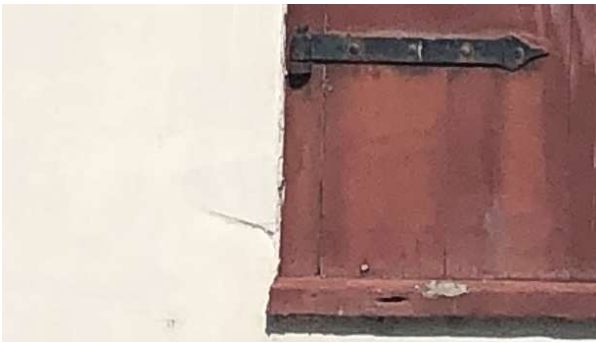
FIGURE 3-31. Crack near the lower left corner of Window 11.

Overall, the southwest façade (facing Church Street) is in good condition. Very few of the issues seen in other parts of the exterior are present here. The only real visible instance of damage is a crack near the lower left corner of Window 11 (Figure 3-31). This crack is approximately 1/8"-1/4" wide and runs roughly 6" in length.

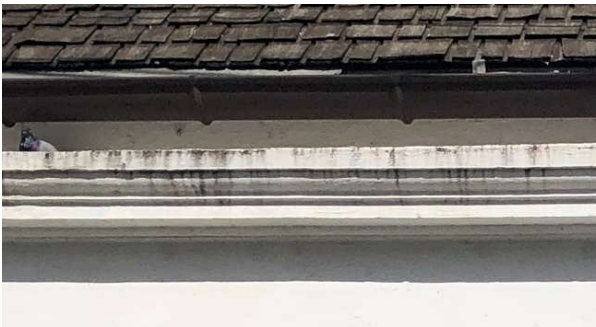
FIGURE 3-32. Staining along the cornice.

Staining along the cornice, likely caused by water runoff from the gutters, also exists (Figure 3-32).

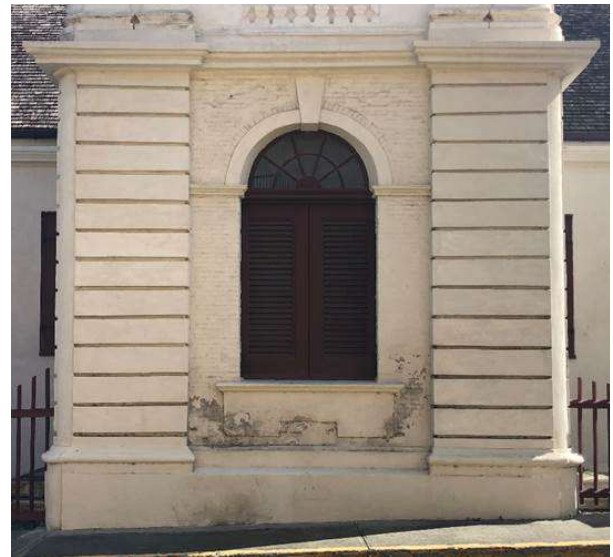
The northwest façade of the steeple tower is in good condition. Starting at the first tier, some paint is peeling off the window base and surrounding

FIGURE 3-33. Northwest elevation, first tier.

brick (Figure 3-33).

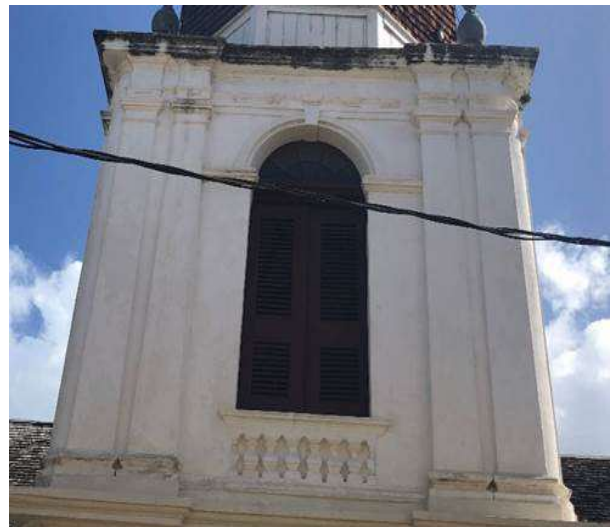
FIGURE 3-34. Northwest elevation, second tier.

At the second tier, heavy black soiling is at the top of the cornice and parts of the pilasters (Figure 3-34). The staining appears to be gypsum buildup.

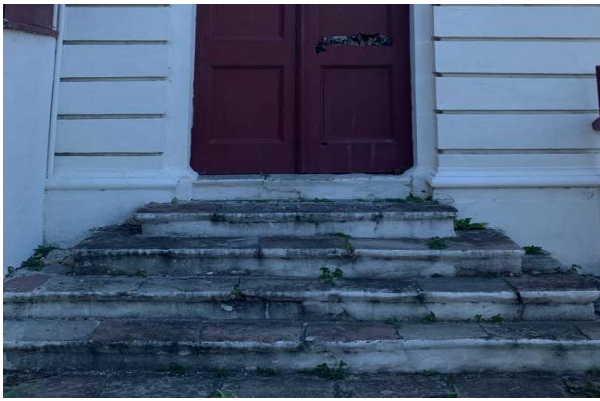
The northwest façade of the steeple tower is in overall fair to poor condition. Starting at the first tier, some vegetation is growing in the steps leading up to Door C (Figure 3-35). A crack over 1/2" wide runs directly under Door C. A section of Door

FIGURE 3-35. Steps leading up to Door C with missing section.

C is missing from the middle panel of the right northwestern leaf.

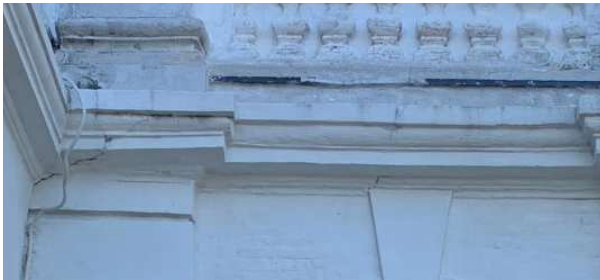
FIGURE 3-36. Cracks in cornice of northeast elevation.

At the top left corner, another crack extends through the cornice (Figure 3-36). This crack is over 1/2" at its widest. A smaller crack, about 1/8", runs through the cornice in the center of the elevation and extends up into the second tier.

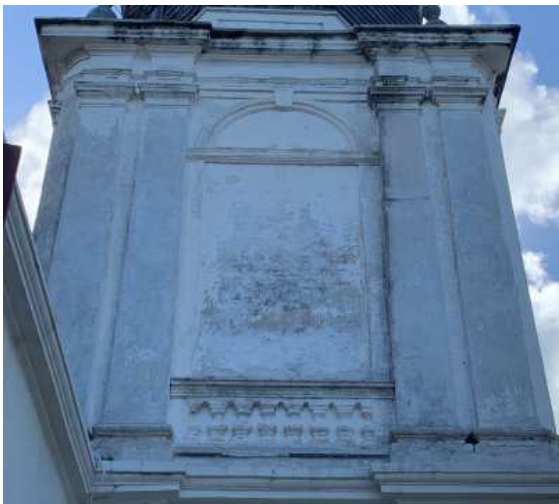
FIGURE 3-37. Northeast elevation, second tier.

The second tier has extensive paint and plaster damage (Figure 3-37). Several series of cracks are

also present throughout both sets of pilasters and in the blind arch.

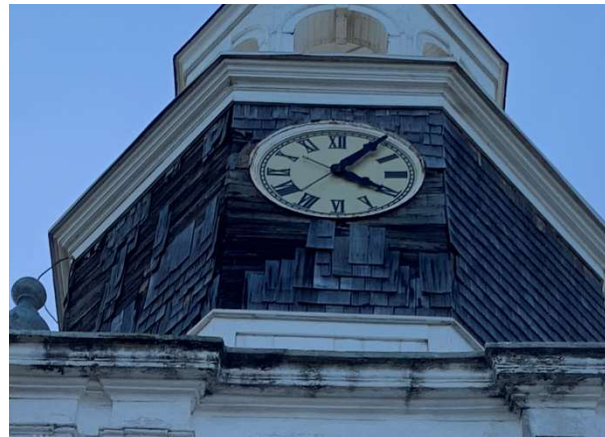
FIGURE 3-38. Northeast elevation, third tier.

Approximately half of the wood shingles are missing from both the east and northeast elevations at the third-tier level (Figure 3-38). The cupola appears to be in good condition with no major problems present.

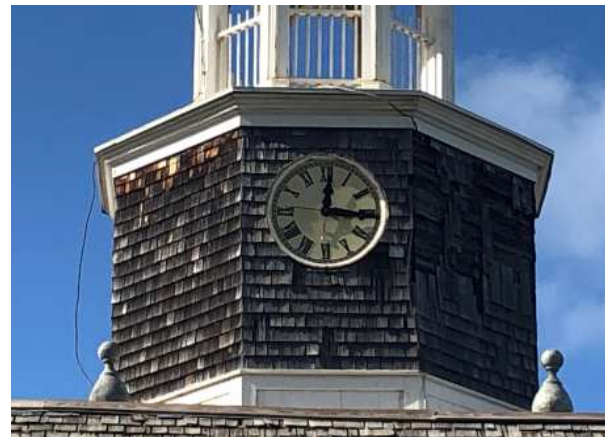
FIGURE 3-39. Southeast elevation, third tier.

The southeast facade of the steeple tower was difficult to assess because there was no roof access during the site visit. Also, only the third tier and cupola are present at this elevation. With that in mind, the third tier appears to be in good to fair condition (Figure 3-39). As was mentioned, the east face is missing roughly half its shingles. The southeast face appears to be missing only a couple of shingles and the west wall seems completely intact.

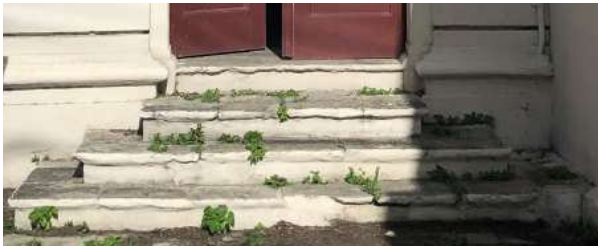
The southwest elevation of the steeple tower is in overall good condition. Starting at the first tier, some vegetation is growing in the steps leading up to the building (Figure 3–40).

FIGURE 3–40. Steps to Door B on southwest elevation.

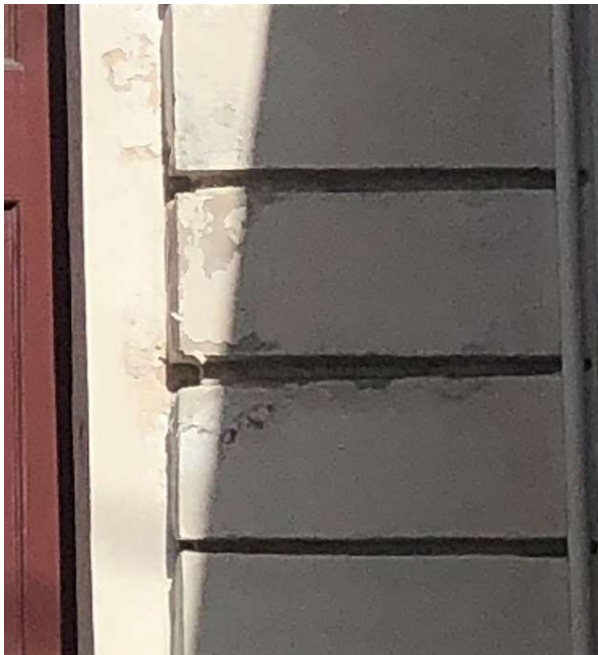
Plaster damage is located about halfway up the wall southwest of Door B (Figure 3–41).

FIGURE 3–41. Plaster damage southwest of Door B.

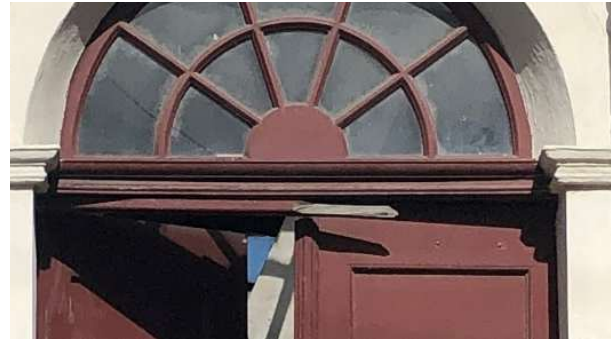
A section of the door frame appears to be broken at the top of Door B (Figure 3–42).

FIGURE 3–42. Broken door frame, Door B.

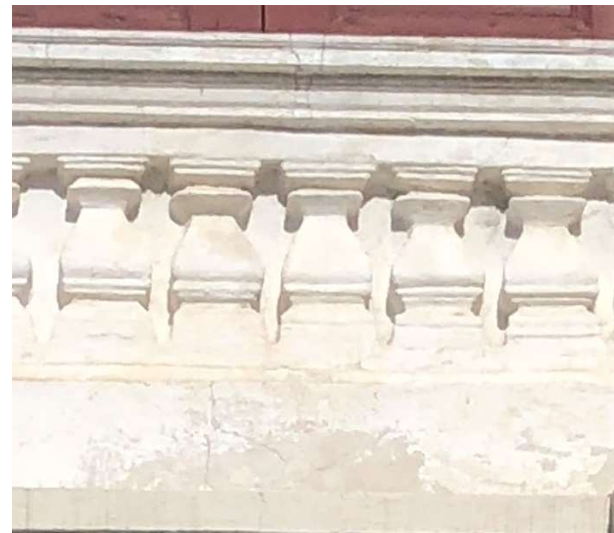
At the second tier, there appears to be cracks both above Window 15 and in the balustrade beneath it (Figure 3–43).

FIGURE 3–43. Cracking in balustrade below Window 15.

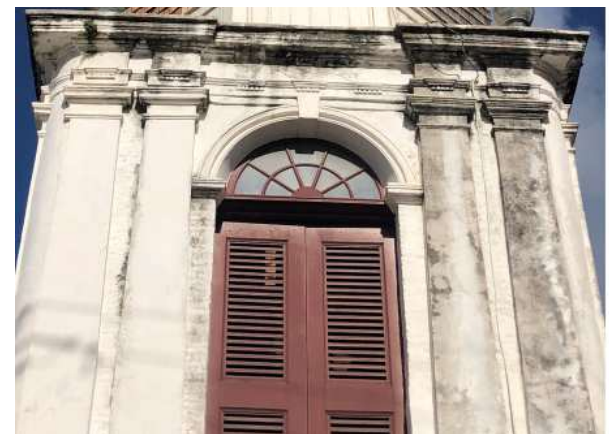
Plaster damage can also be seen on the southeastern pair of pilasters approximately three quarters up the wall (Figure 3–44). The gypsum soiling can also be seen along the pilasters and at the cornice.

FIGURE 3–44. Southwest façade, second tier.

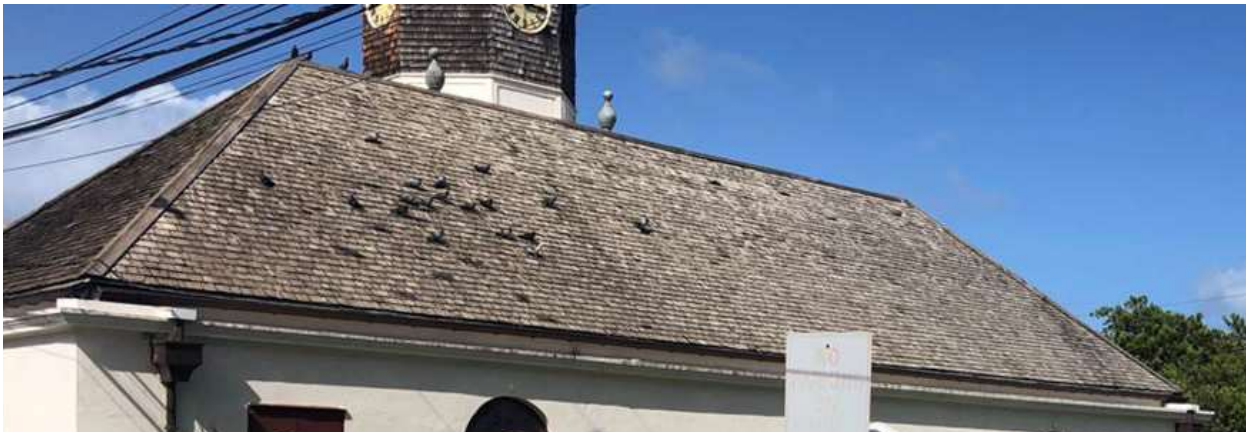
FIGURE 3-45. Roof.

The roof is a wood-framed hipped roof covered in wood shingles. It appears to be in good condition and was replaced in 2017 (Figure 3-45).

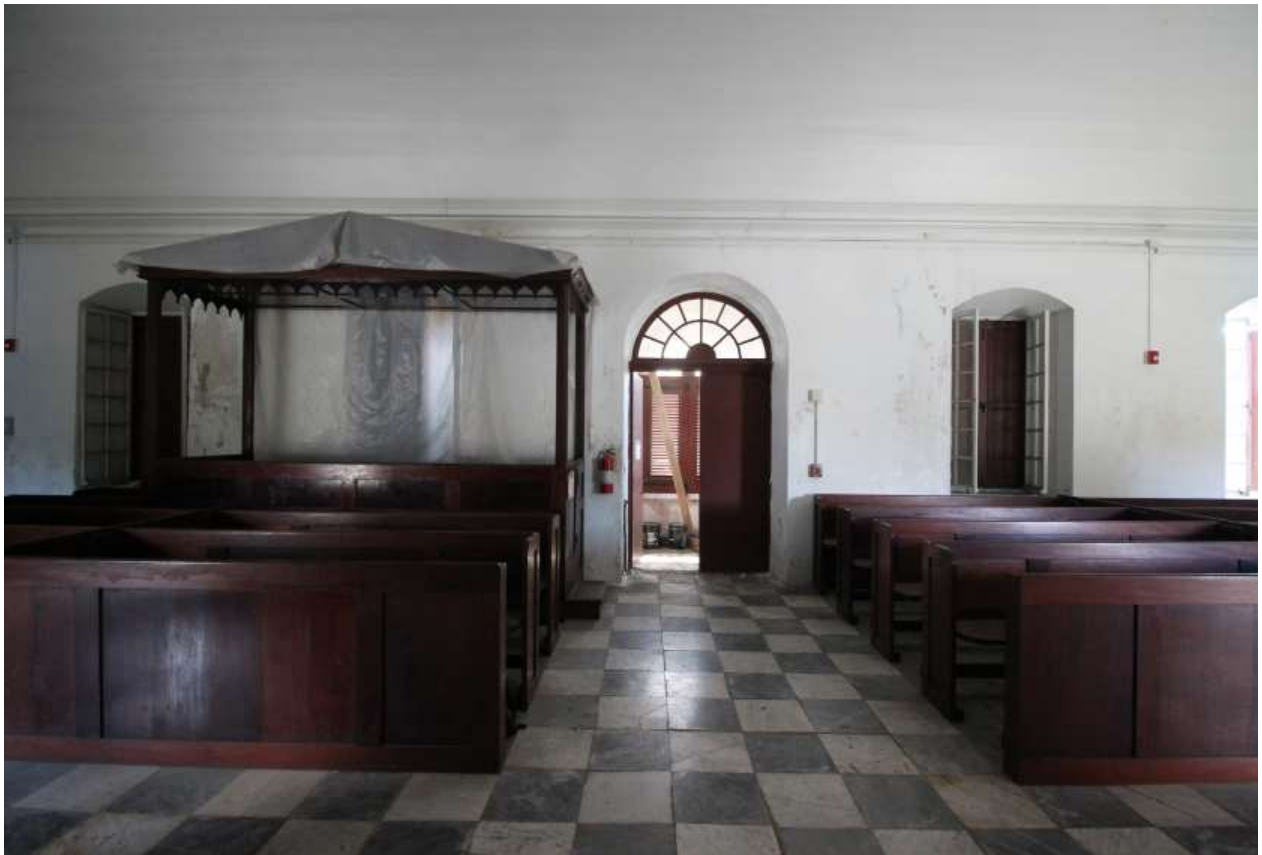
Overall, the northwest wall is in poor condition. The different types of issues can be broadly grouped into three categories: plaster deterioration, cracks, and staining. (figure 3-47)

FIGURE 3-47. Interior looking Northwest.

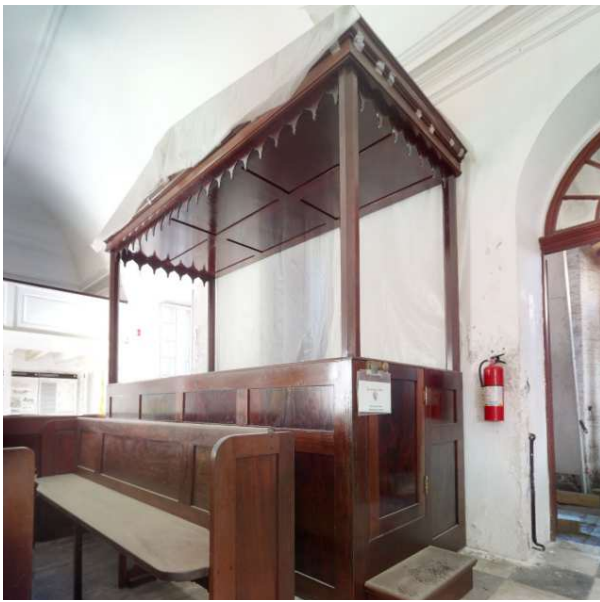
FIGURE 3-48. Governor's box covered by plastic.

Significant plaster damage was found throughout the wall. In fact, the section of the wall behind the governor's box (by Window 3) was completely covered in plastic in an apparent effort to protect the replicated structure (Figure 3-48).

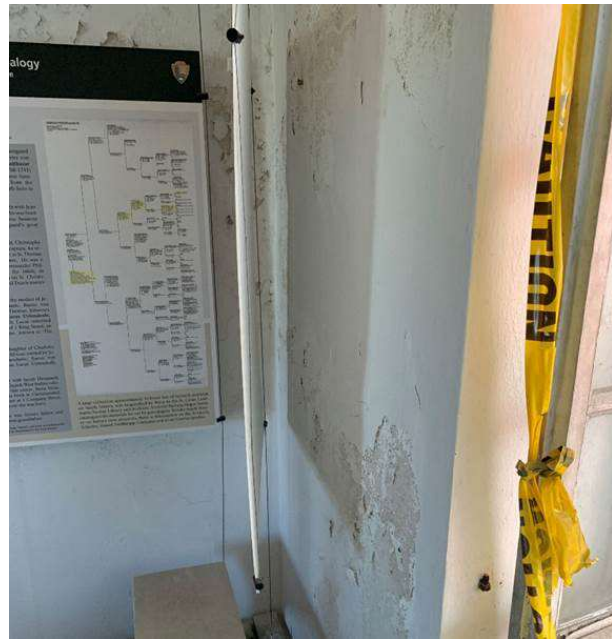
On the left side of this wall, plaster is actively failing behind the display boards (Figure 3-49). This damage continues up the wall on the top side of the mezzanine as well (Figure 3-50). This type of deterioration is also present around the opening of Window 1 (Figure 3-51). The same condition extends through to the opening of Window 2 and on toward Window 3 (Figure 3-52 and Figure 3-53). The full extent of the damage around Window 3 could not be seen due to the plastic. However, it appears to be as substantial as in the other locations.

FIGURE 3-49. Plaster failure behind display boards.

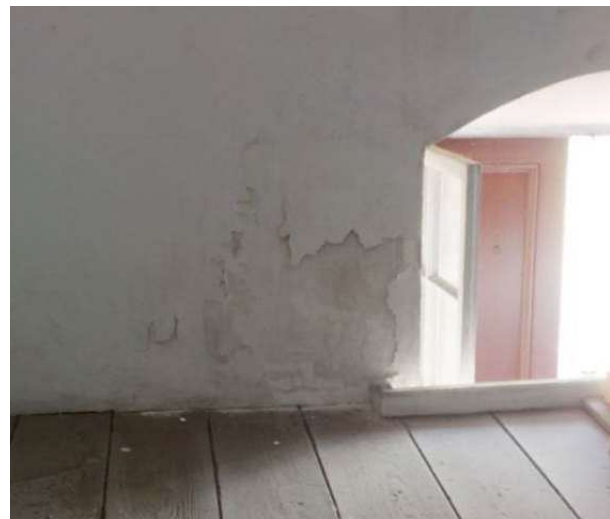
FIGURE 3-50. Plaster damage above mezzanine.
