Historic Structure Report  
**The Steeple Building**  
**Christiansted National Historic Site**  
*Final*

# **The Steeple Building**

## **Historic Structure Report**

May 2024

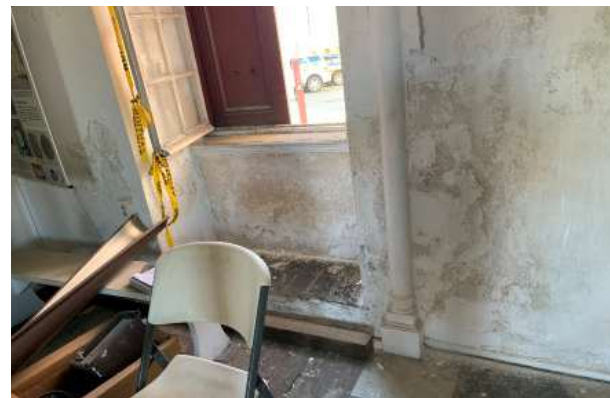
FIGURE 3-51. Plaster damage around Window 1.

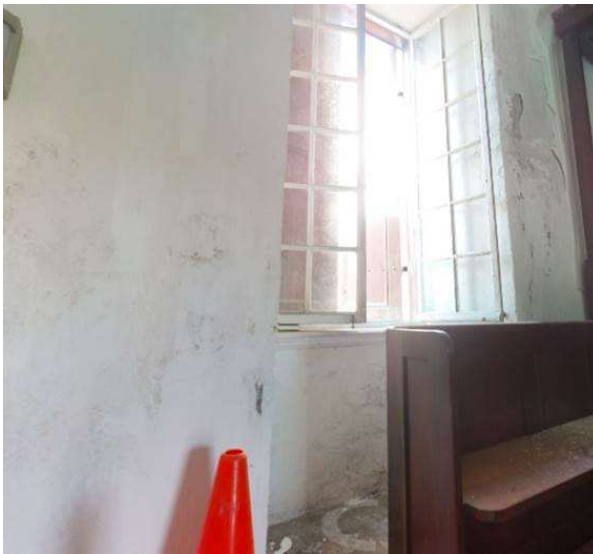
FIGURE 3-52. Plaster damage around Window 2 toward Window 3.

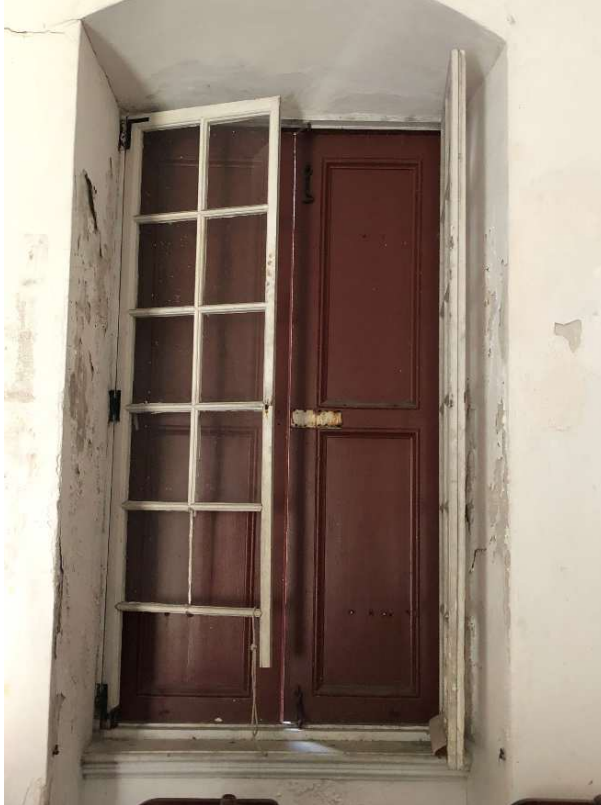
Plaster damage is visible around Window 4, though it is most severe on the left half of the opening. The plaster around Window 5 appears to be relatively intact, but failure does arise again around the opening of Window 6 on the left side. The remaining section of the wall between Window 6

FIGURE 3-57. Plaster around Window 6.

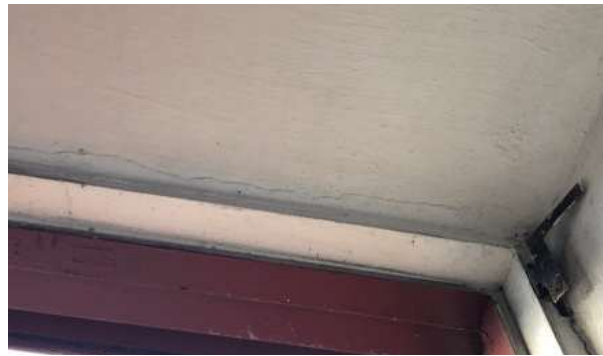
The majority of the cracking in the interior of the building appears in close proximity to window and door openings. Two significant cracks are present around Window 1 (Figure 3-58). The first crack is located at the underside of the arched

opening, running the length of the window. The second crack derives from a rusted anchor that was imbedded in the wall. Both cracks appear relatively small in size, approximately 1/16"–1/8" in width.

FIGURE 3-58. Crack above Window 1.

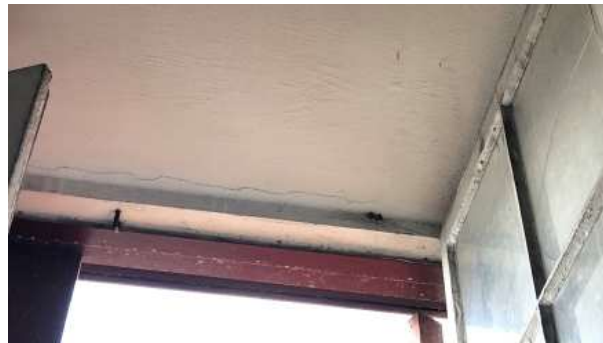
Similar cracking was found around Window 2 (Figure 3-59). A roughly 1/16"–1/8" crack is present, running the length of the arched opening.

FIGURE 3-59. Crack above Window 2.

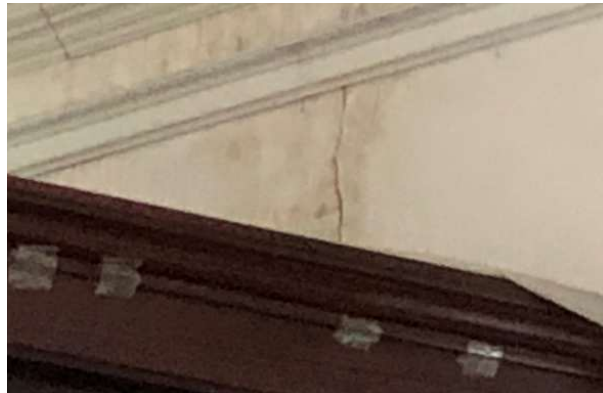
FIGURE 3-60. Crack above Window 3.

Another crack can be seen above the plastic of the governor's box. This crack runs from the ceiling trim to the arched opening of Window 3 (Figure 3-60). As this location could not be reached, the full extent of the crack could not be measured. However, it appears to be fairly large and had several stains emanating from it.

The second stain location appears to be coming from the crack located above the governor's box. These stains also seemed to be caused by water leaking from the crack.

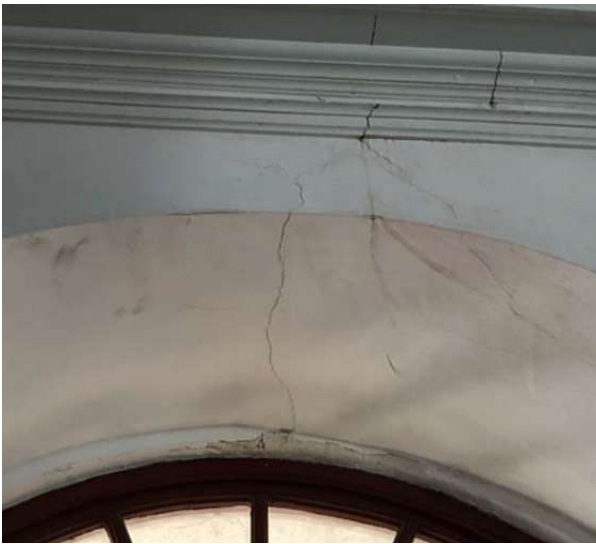
FIGURE 3-61. Crack above Door A.

of Door A (Figure 3-61). This crack runs through the ceiling trim (starting roughly at the spring point) and down toward the arch, branching in two directions.

Similarly, the third set of stains, located above the arched opening of Door A, also seems to originate from water coming into the building from the crack above it.

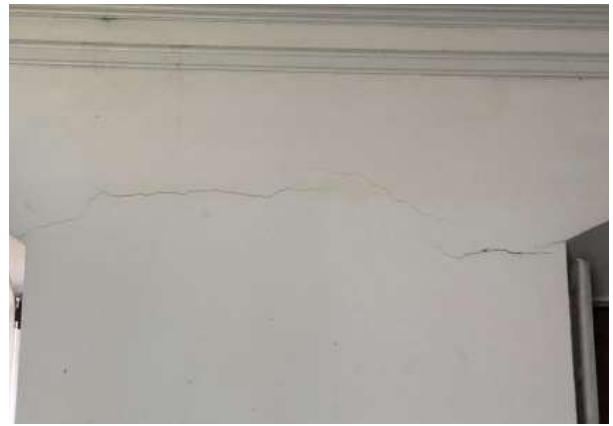
FIGURE 3-63. Cracks between Windows 5 and 6.

mentioned previously in the exterior section under Main Block – Northwest Elevation – West (Figure 3-63). These cracks start near the spring point for the arched opening of both windows and run toward the center of the wall.

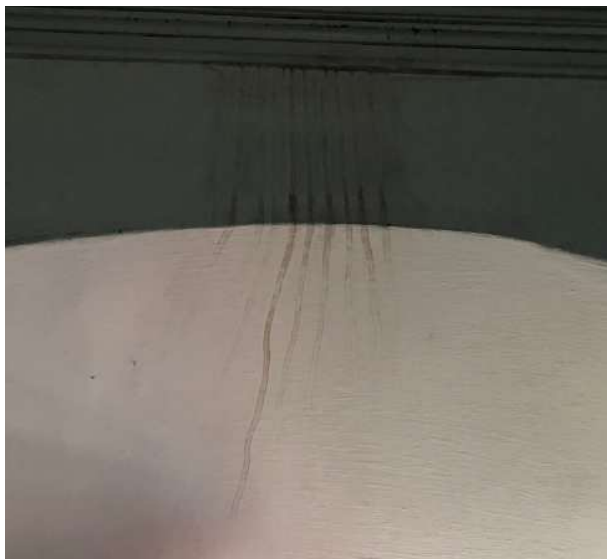
FIGURE 3-65. Stain above Window 2.

Four primary staining locations are found on the northwest interior wall. The first location is at the arched opening of Window 2, where the stain appears to have been caused by different streams of water flowing down the wall from a crack behind the ceiling trim (Figure 3-65).

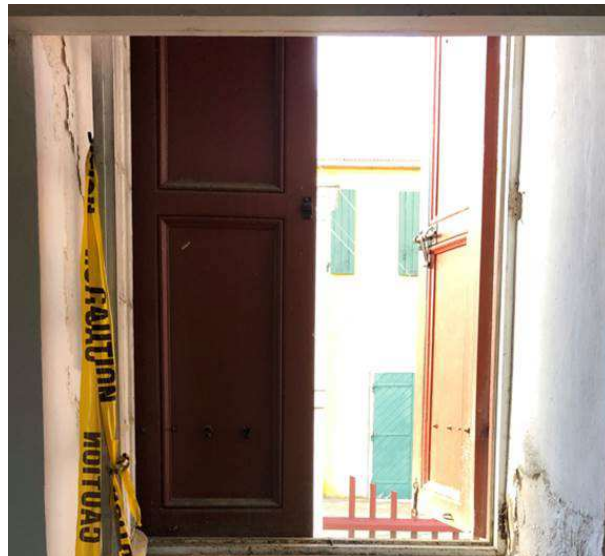
FIGURE 3-67. Missing half of Window 1.

None of the windows in the Steeple Building are completely watertight. However, certain windows are able to provide better protection than others. The right (northwest) half of Window 1, including the sash and glass, appears to have been fully removed (Figure 3-67). In fact, a section of plaster appears to have been taken out of the wall when that window was removed.

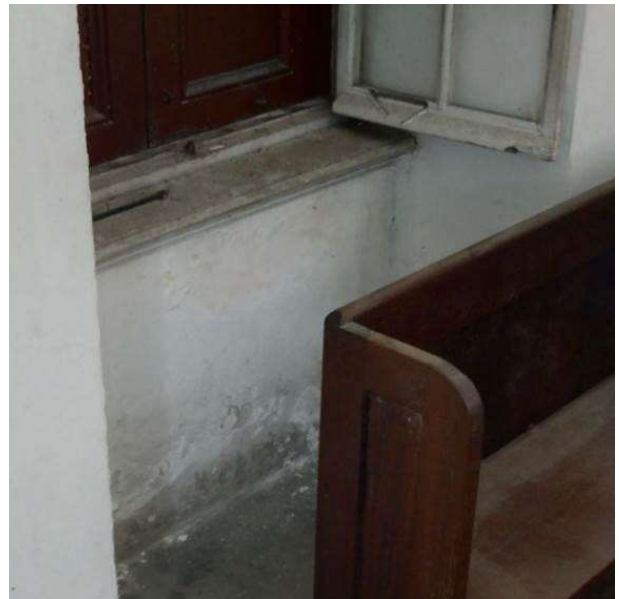
FIGURE 3-70. Plaster damage under Window 8.

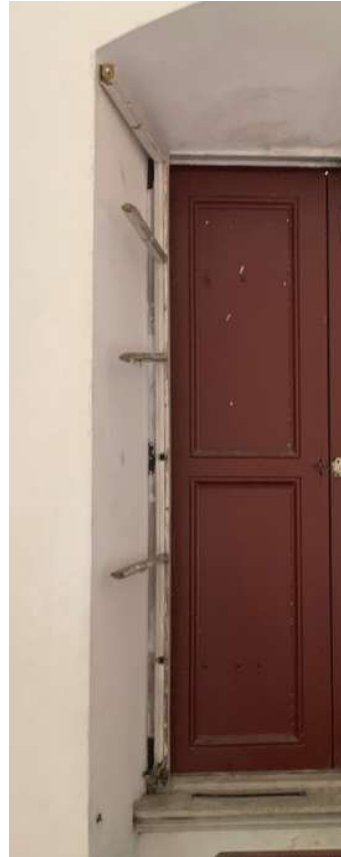
The left sash of Window 8 is also damaged and missing several components. The glass panes and wood muntins appear to have been broken off for the majority of the window (Figure 3–72).

FIGURE 3–72. Broken left half of Window 8.

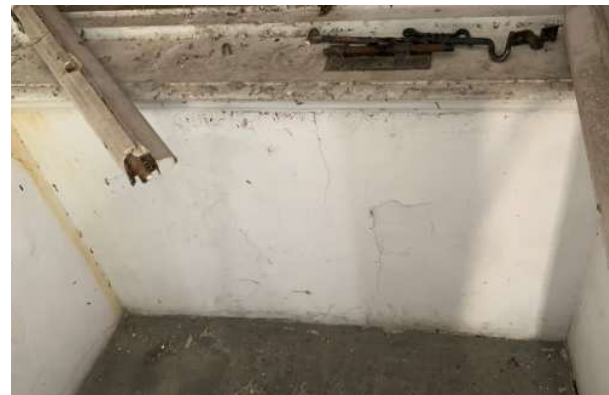
Along the lower edge of the wall from Window 9 through to the opening of Door D is another series of cracks (Figure 3–73). The cracks appear to be similar in width, though they are connected to patches of missing plaster.

FIGURE 3–73. Cracks under Window 9.

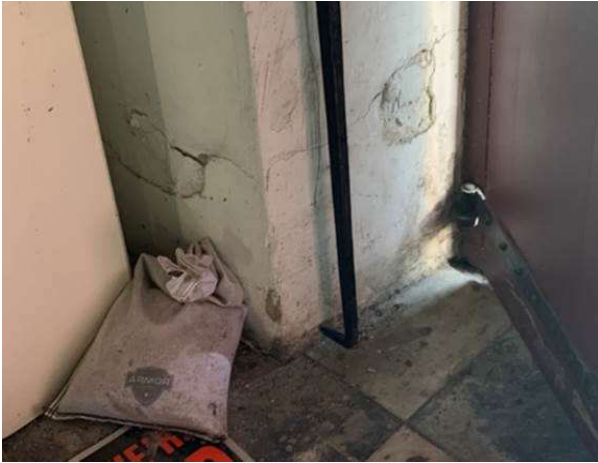
Door D also has cracks on the underside of the arch and on the right side of the opening (Figure 3–74, Figure 3–75, and Figure 3–76). The side crack appears to originate from the door bracket attached to the wall and runs the length of the opening.

FIGURE 3-74. Cracks to the left of Door D.

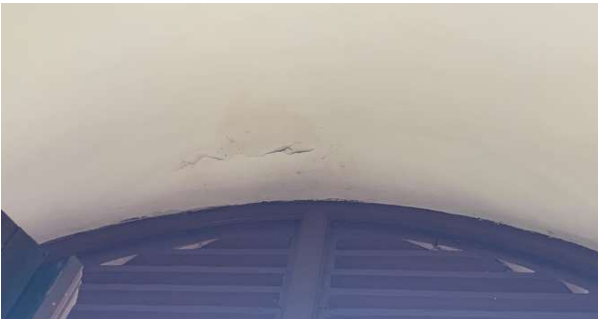
FIGURE 3-75. Crack above Door D.

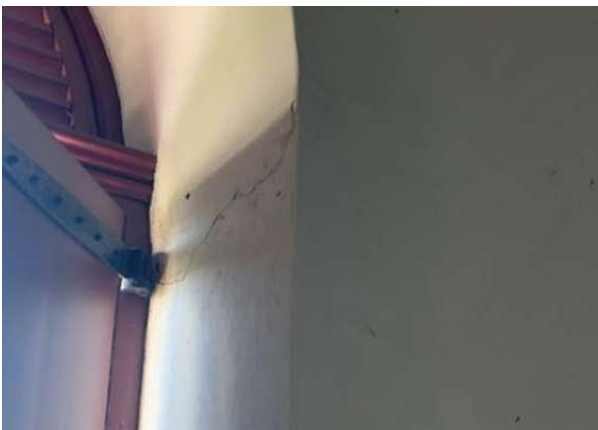
FIGURE 3-76. Crack to the right of Door D.

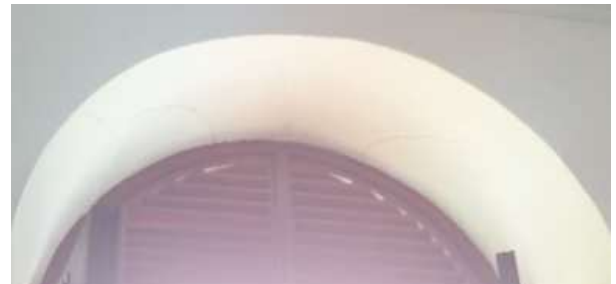
Two cracks also exist at the underside of the arch in the Door E opening (Figure 3-78).

FIGURE 3-78. Cracks above Door E.

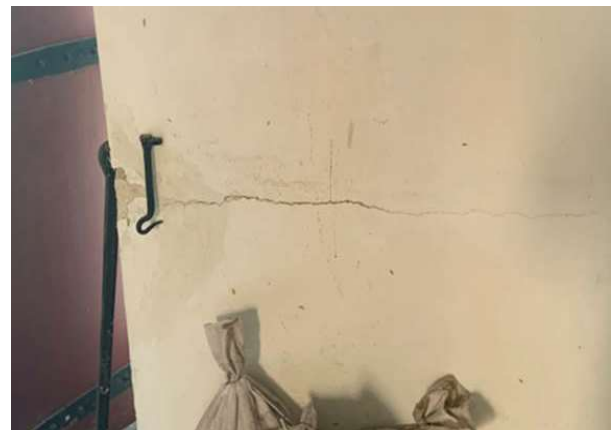
On the lower right of the door opening is a large crack that extends several feet along the wall (Figure 3-79). This crack appears to start where the bolts that used to hold the doors closed are attached to the wall.

FIGURE 3-79. Cracks to the right of Door E.

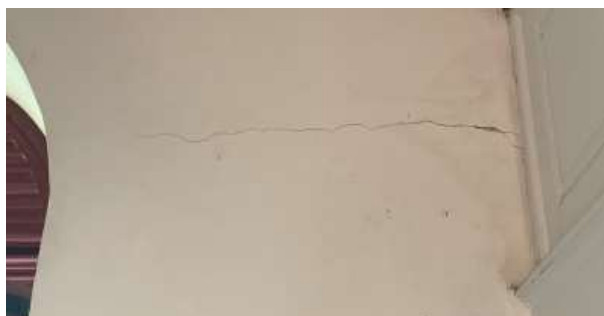
FIGURE 3-80. Crack running from Door E to Window 10.

A large crack runs horizontally from the spring point of the arch in Door E to Window 10 through the mezzanine (Figure 3-77 and Figure 3-78). Once the crack intersects with the opening of Window 10, a large chunk of the wall can be seen missing and the crack continues toward the center of the window (Figure 3-80).

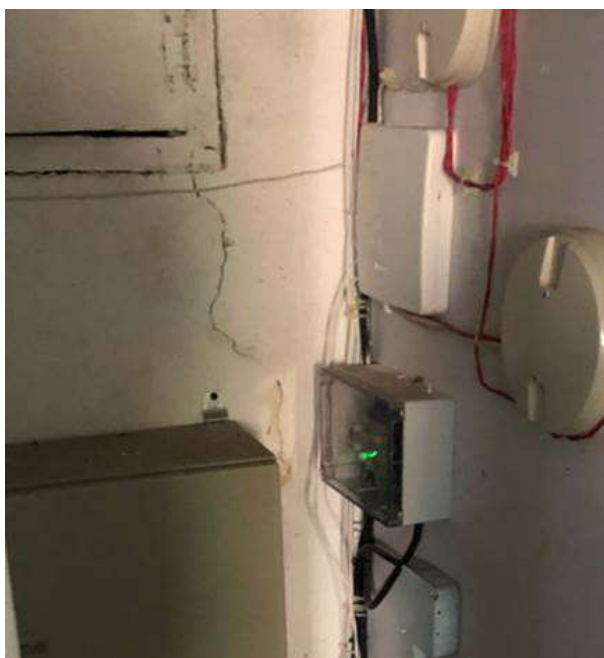
FIGURE 3-81. Crack below access hatch.

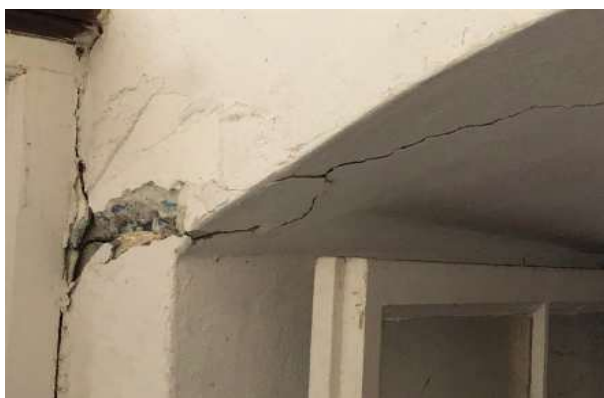
FIGURE 3-82. Crack at Window 10.

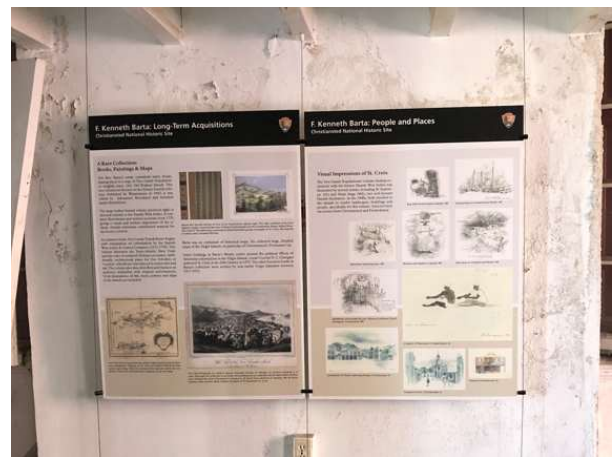
Significant plaster damage exists throughout the wall. Around the opening of Window 11, plaster and paint are peeling away from the wall (Figure 3-85). This same condition continues down the wall behind the educational posters toward Window 12 (Figure 3-86).

FIGURE 3-86. Plaster damage behind educational posters.

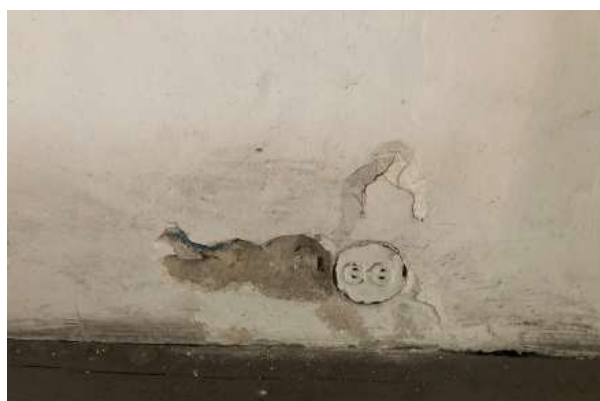
Above the mezzanine, near the left corner, a section of plaster is missing directly next to an electrical outlet (Figure 3-89). This condition is also seen near the other two outlets at this level. The second instance of missing plaster is between Windows 11 and 12 (Figure 3-90 and Figure 3-91). The third, most severe, instance is located between

FIGURE 3-89. Plaster damage at left outlet.

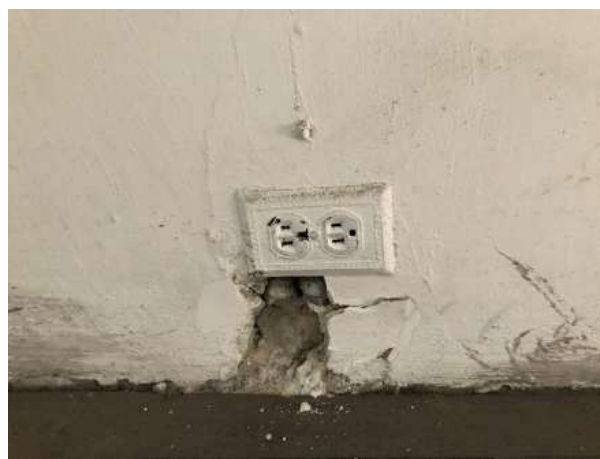
FIGURE 3-90. Plaster damage at middle outlet.

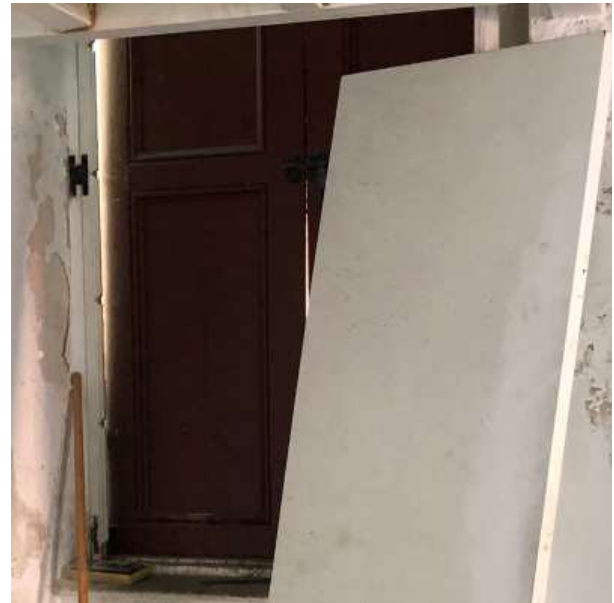
Window 11 is missing both halves of the assembly (Figure 3-93).

FIGURE 3-93. Missing Window 11.

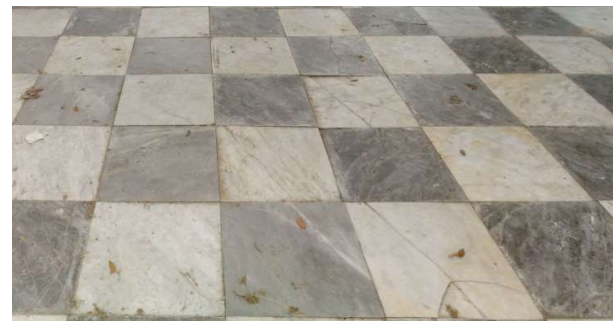
FIGURE 3-94. Cracked and chipped black and white marble tiles.

roughly 1'-5" x 1'-5" black and white marble tiles (Figure 3-94). A large percentage of these tiles (estimated 15%–20%) are either broken, cracked, or chipped in some manner. In addition, the entire floor is uneven, with tiles at different heights. The likely cause for this is discussed in the structural report (Appendix E).

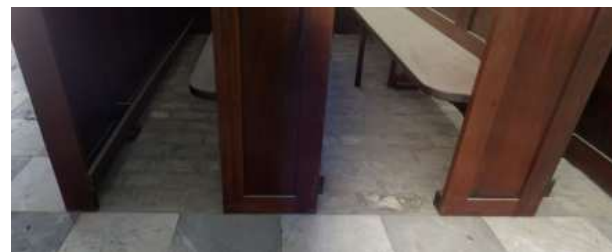
FIGURE 3-95. Brick Flooring.

(Figure 3-95). This type of flooring does not have the same cracking issues as the tiles due to the nature of construction. However, this also made it difficult to discern whether differential settlement had taken place, as the floor was very uneven to begin with.

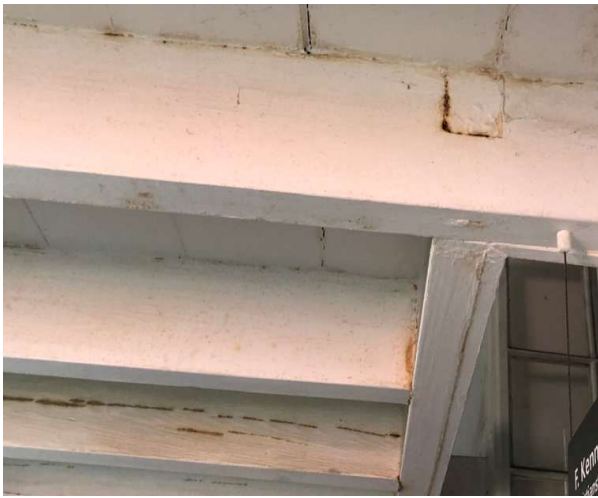
FIGURE 3-98. Rust stains under mezzanine.

Overall, the mezzanine appears to be in good condition. The columns are all intact and the wood framing looks to be in generally good order. There are, however, rust stains on the paint of the framing, likely coming from the nails and fasteners exposed to water in the humid environment (Figure 3-98).

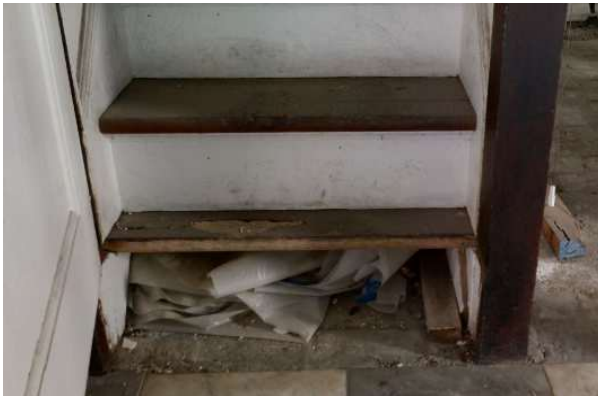
FIGURE 3-99. Broken first step of mezzanine.

The finished floor is in good condition and does not show serious signs of deterioration. The stairs are also in good condition, with the exception of the first step, which is split lengthwise along the grain (Figure 3-99).

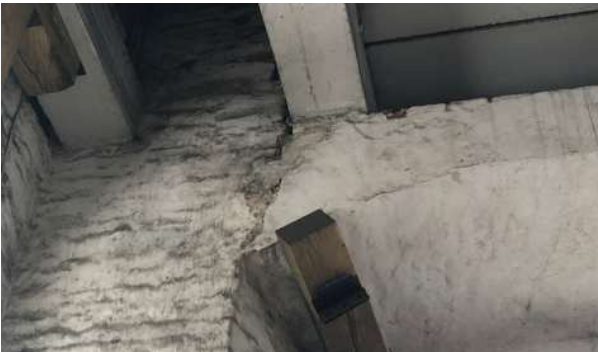
FIGURE 3-100. Large crack above Window 13.

The largest and most prominent issue on this wall is a crack located at the top corner of the arched opening for Window 13 (Figure 3-100). This crack is so severe that an additional structural support is needed to ensure the arch does not fail.

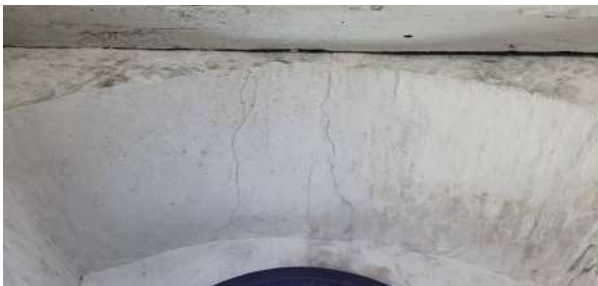
FIGURE 3-101. Cracks above Door C.

At the top of the arched opening for Door C is a series of cracks (Figure 3-101). These cracks appear roughly 1/8" in width and run the length of

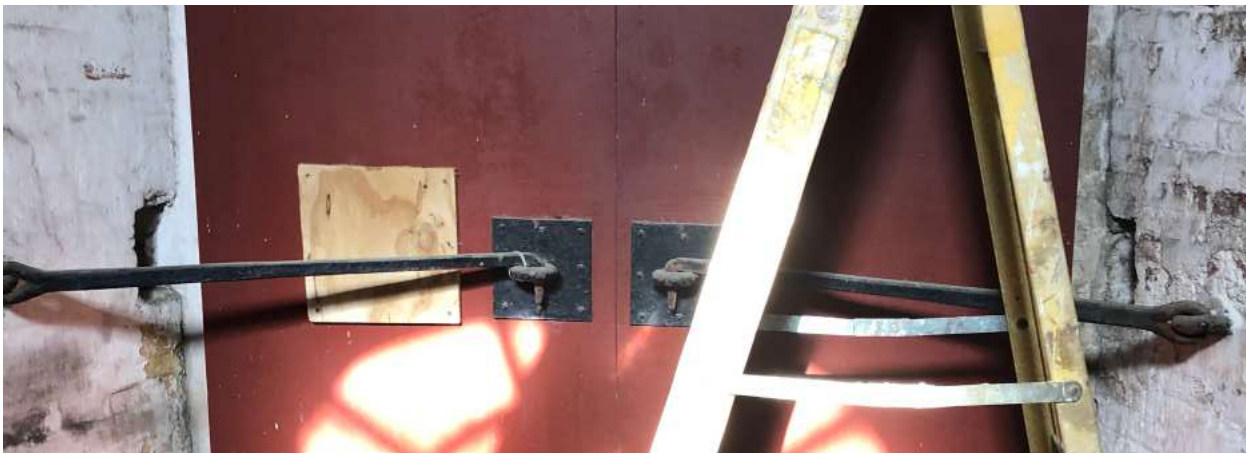
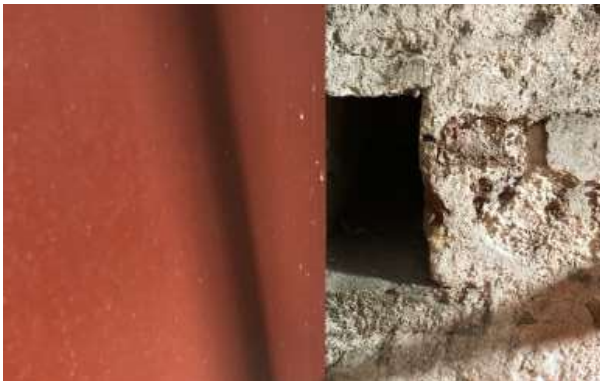
FIGURE 3-103. Empty pockets from past door hardware flank Door C.

Open cavities are on either side of Door C where previous door brackets were once located (Figure 3-102 and 3-103).

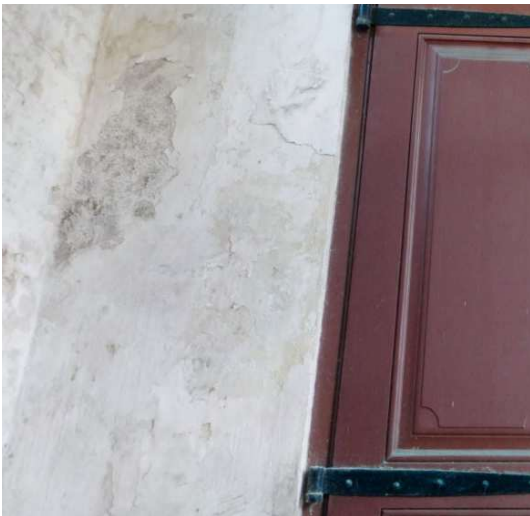
FIGURE 3-104. Plaster failure adjacent to Door A.

Patches of plaster failure on the left side of Door A are the primary condition issue on the southeast wall (Figure 3-104).

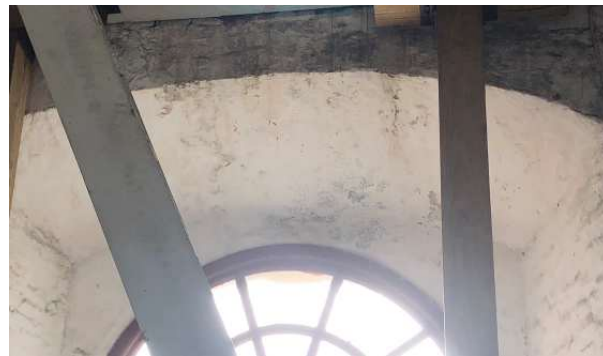
FIGURE 3-105. Crack and paint peeling above Door B.

A small crack (1/16" in width) and some paint peeling are present at the top of the arch above Door B (Figure 3-105).

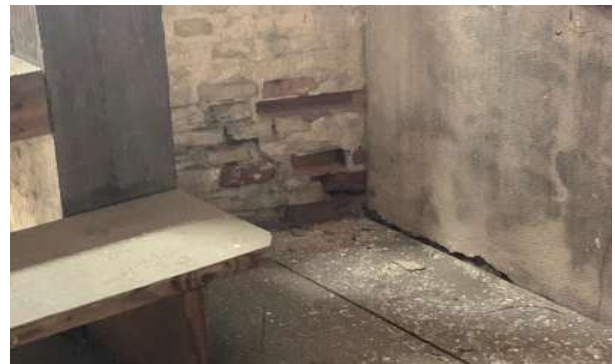
On the lower left side of the window opening, several bricks are either missing or have deteriorated (Figure 3-106). A similar condition also exists on the right side of the opening (Figure 3-107).

FIGURE 3-106. Brick deterioration left side of second tier, northwest wall.

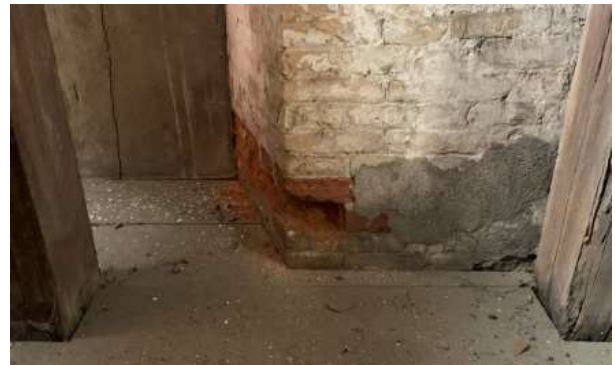
FIGURE 3-107. Brick deterioration right side of second tier, northwest wall..

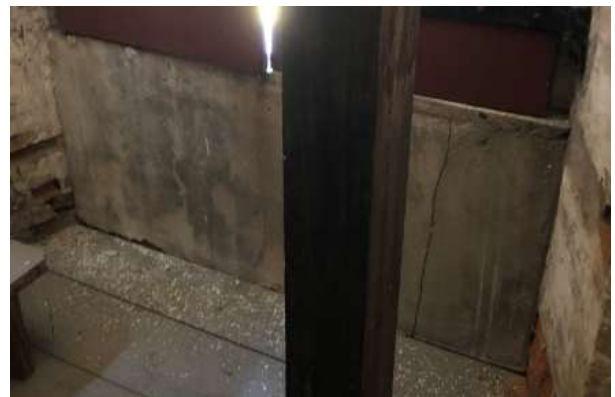
A series of cracks under Window 14 appears to be only in the surface plaster and the cracks are approximately 1/8" in width (Figure 3-108).

FIGURE 3-108. Cracks under Window 14.

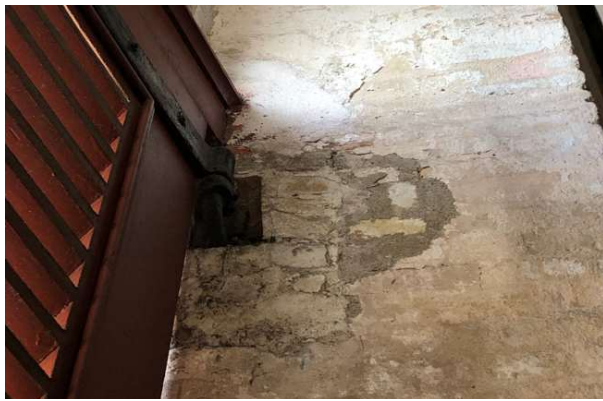
The wall around the top right bracket holding the shutters for Window 14 appears to have been patched more recently (Figure 3-109). The wall

FIGURE 3-109. Repaired bracket on right side of window 14.

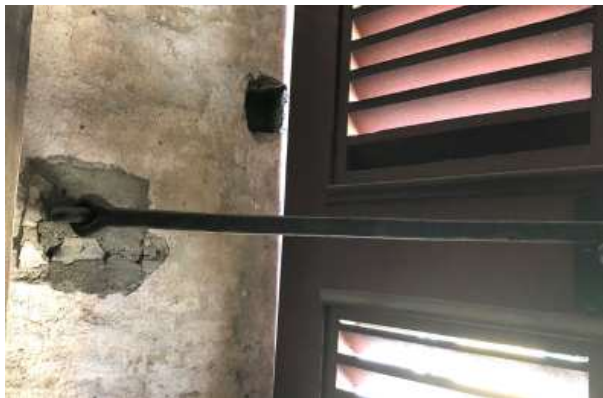
section around the middle bar that holds the shutters closed on the left side also appears to have been patched, and there appears to have once been a middle bracket that is no longer in use (Figure 3-110). Slots for the anchorage still remain on both sides of the wall.

FIGURE 3-110. Repaired bracket on left side of window 14.

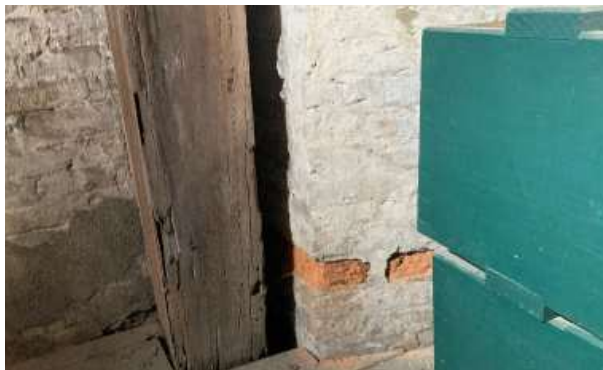
FIGURE 3-111. Brick deterioration left side of second tier, northeast wall.

On the lower left side of the masonry opening, two bricks have partially delaminated (Figure 3-111).

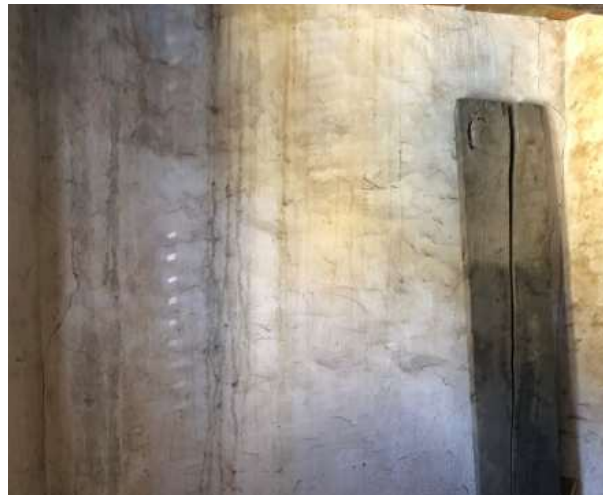
FIGURE 3-113. Water staining on northeast wall of second tier.

A series of stains extends down the horizontal wall from the level above (Figure 3-113). The origin of these stains appears to be water damage leaking through the plaster.

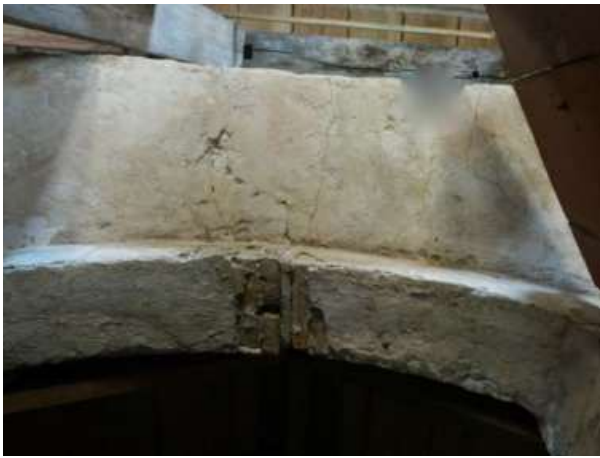
FIGURE 3-114. Crack over the arched opening of Door F.

The brickwork shows the same extent of wear as the other walls, but no areas of obviously failing brick are visible. The largest issue is a crack over the arched opening of Door F (Figure 3-114).

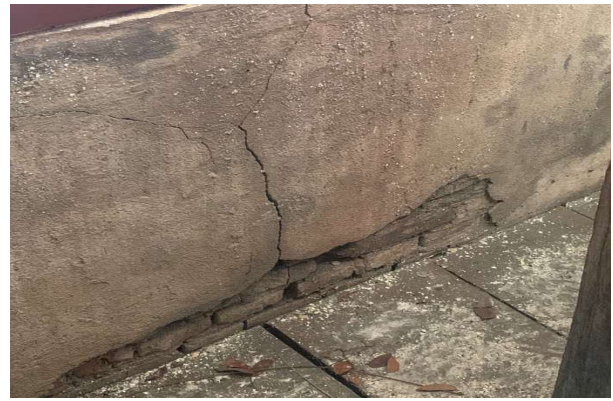
FIGURE 3-116. Series of cracks underneath Window 14.

A series of cracks under Window 14 appears to be in the surface plaster and partially in the brick behind (Figure 3-116). The cracks are approximately 1/8"–1/4" in width.

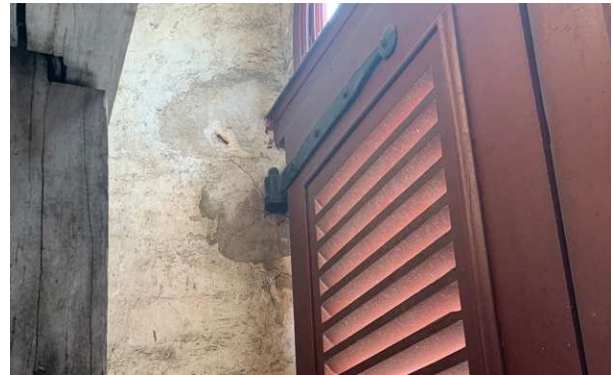
FIGURE 3-117. Top left patch Window 14.

The wall around the top left bracket holding the shutters for Window 15 appears to have been more recently patched (Figure 3-117). The wall section around the middle bar that holds the shutters closed also appears to have been patched (Figure 3-118). There also appears to have once been a

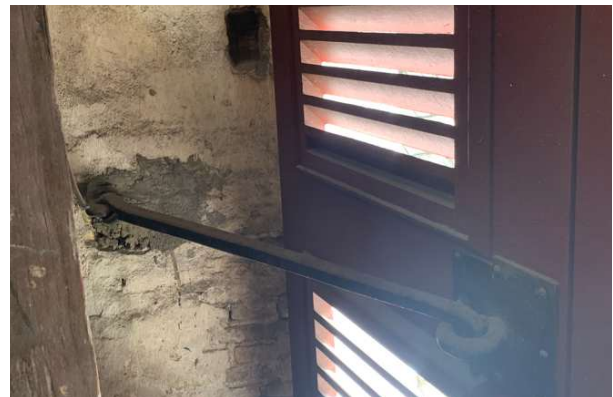
FIGURE 3-118. Middle left patch Window 14.

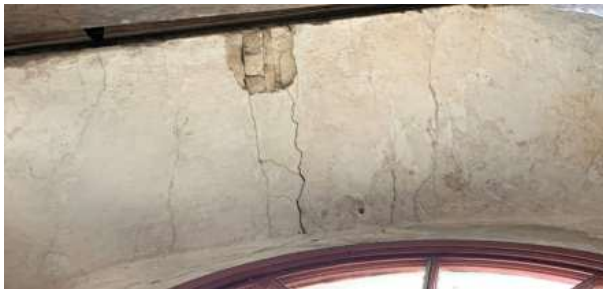
FIGURE 3-119. Series of cracks above Window 14.

A series of cracks above Window 14 appears to be only in a surface plaster and exposes the brick arch below (Figure 3-119). The cracks are approximately 1/8"–1/4" in width. An additional series of cracks is on either side of the window (Figure 3-120). These are also approximately 1/8"–1/4" in width and seem to extend to the backing brick wall as well. A section of the brick at the left corner of the arch is also cracked (Figure 3-122).

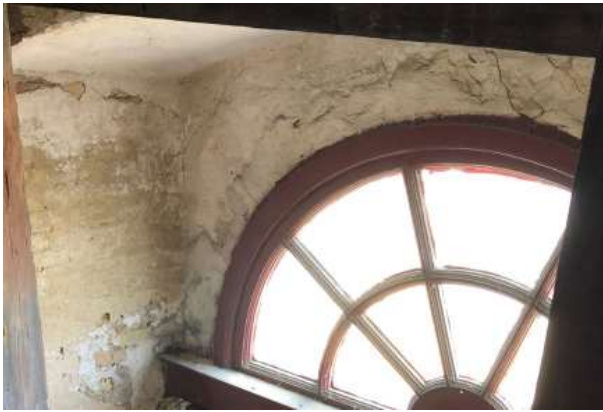
FIGURE 3-120. Series of cracks on either side of the window.

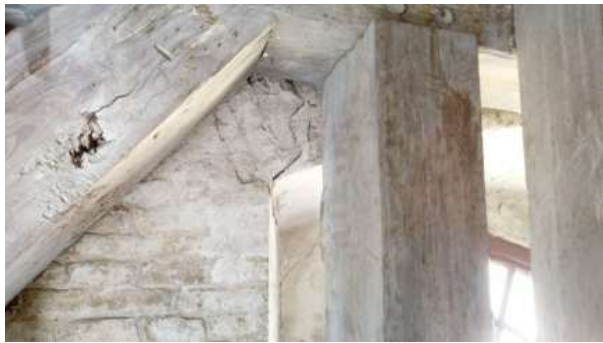
FIGURE 3-121. Crack on left side of arch southwest wall of second tier.

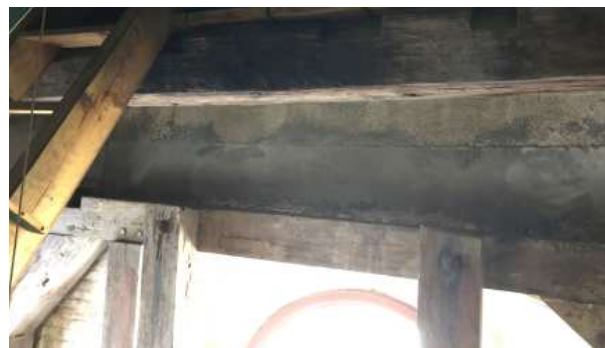
The lower half of the concrete wall above the masonry walls appears to have been patched or repaired during a previous project (Figure 3-122).

FIGURE 3-122. Concrete patch or repair on northwest wall of third tier.

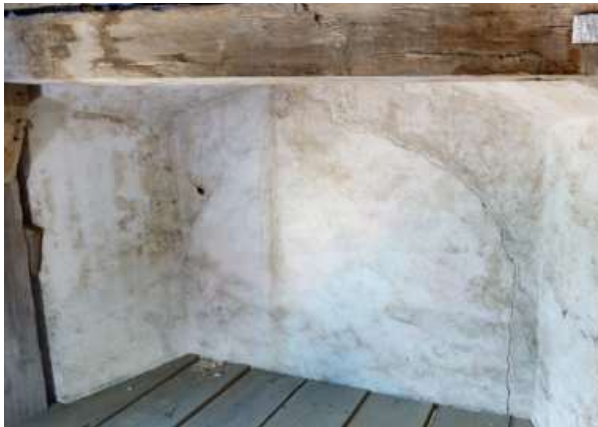
A series of cracks in the northeast wall appears to exist around the infill of a previous opening (Figure 3-123 and Figure 3-124). These cracks are approximately 1/8" in width and run down the length of the wall, extending down to the second tier below.

As can be seen in the previous figure, water staining appears to be coming from the cracks in the wall.

FIGURE 3-123. Series of cracks around infill on northeast wall of third tier.

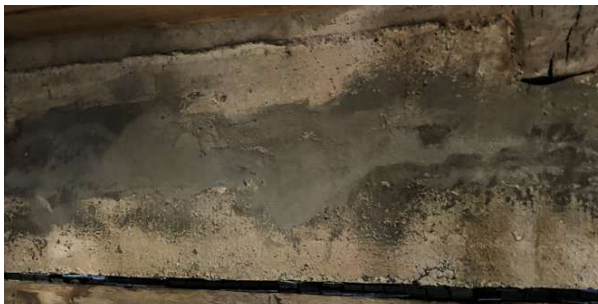
FIGURE 3-124. Concrete patch or repair on northeast wall of third tier.

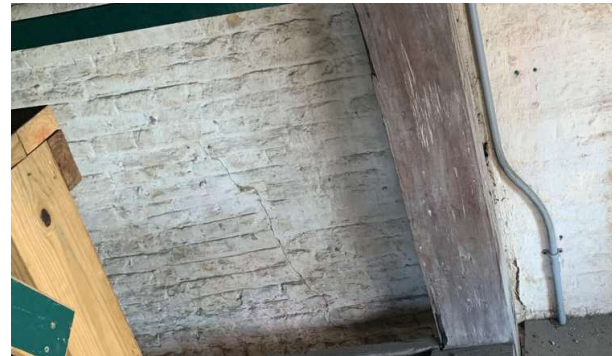
About 4'-0" from the right edge of the wall, a roughly 1/8"-wide crack runs through the brick (Figure 3-125).

FIGURE 3-125. Crack at right edge of southeast wall of third tier.

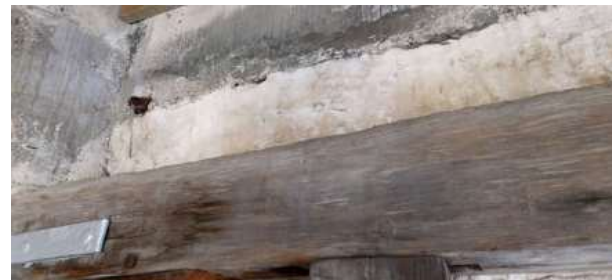
A series of cracks is also present in the concrete slab above the masonry wall (Figure 3-126). The cracked concrete appears to be in the initial slab. An additional concrete slab that matches the other walls appears to have been poured atop the original in this location (Figure 3-127).

FIGURE 3-126. Series of cracks in the concrete slab above the masonry wall on southeast wall of third tier.

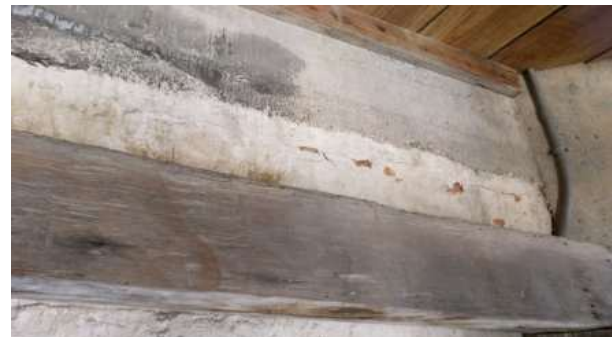
FIGURE 3-127. New concrete slab pour on southeast wall of third tier.

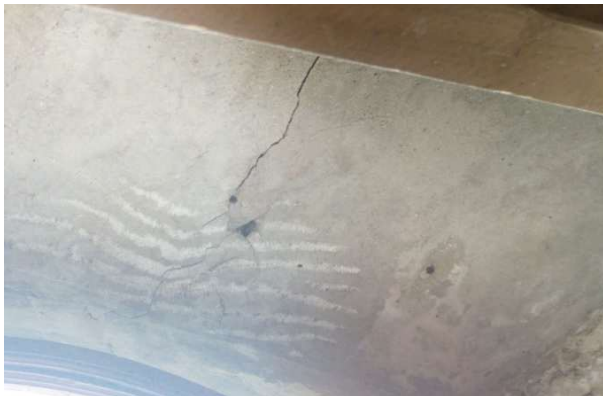
A series of cracks above the arch of Window 15 appears to be only in the surface plaster, and the cracks are approximately 1/16"-1/8" in width (Figure 3-128).

FIGURE 3-128. Crack along arch of Window 15 on southwest wall of third tier.

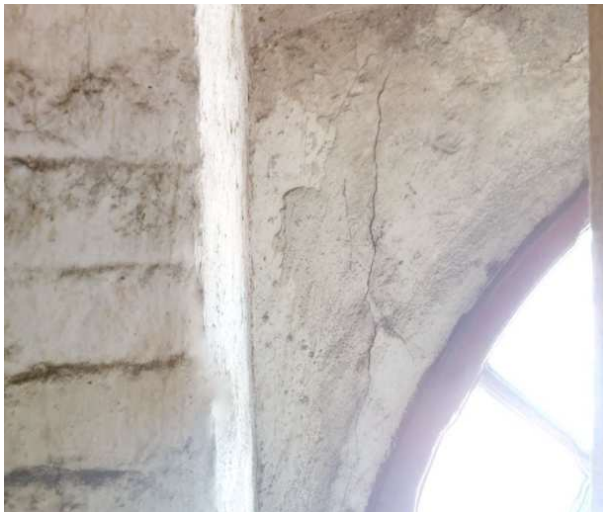
A crack also runs along the left side of Window 15 and is roughly 1/8" in width (Figure 3-129).

FIGURE 3-129. Crack along left side of Window 15.

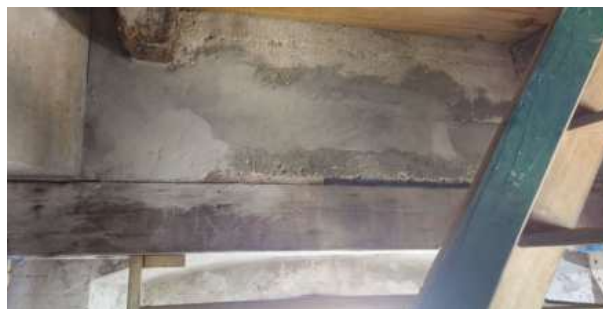
The concrete structure above the masonry walls appears to have been patched or repaired during a previous project (Figure 3-130).

FIGURE 3-130. Concrete patch or repair on southwest wall of third tier.

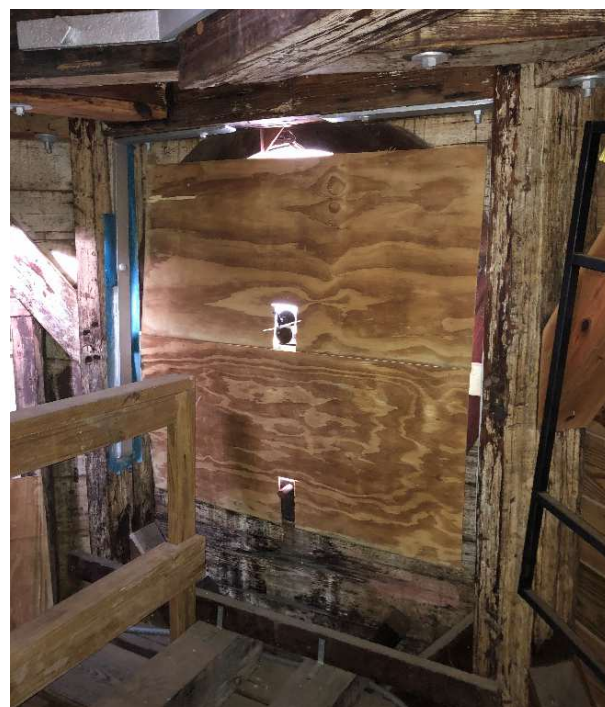
The northwest wall appears to be in fair to poor condition (Figure 3-131). The horizontal lumber seems to be older in age and is showing signs of weathering. The structural timber also appears to be older.

FIGURE 3-131. Northwest wall of fourth tier.

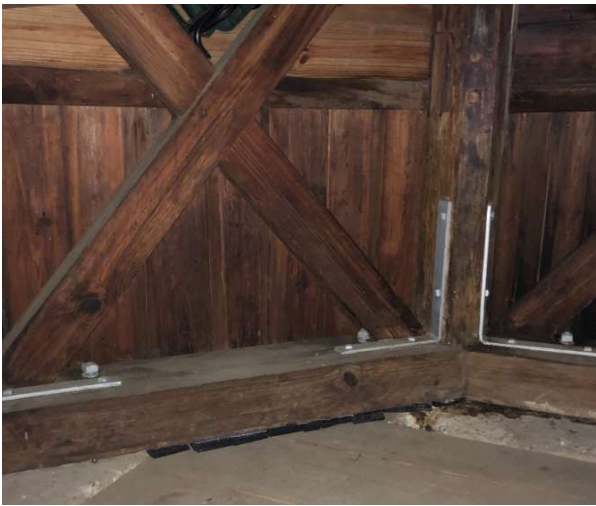
The north wall appears to be in good condition (Figure 3-132 and Figure 3-133). The horizontal lumber seems to be newer in age and does not show significant signs of weathering. The structural timber, however, does appear to be older, with the exception of the diagonal cross beam on the left side.

FIGURE 3-132. North wall of fourth tier.

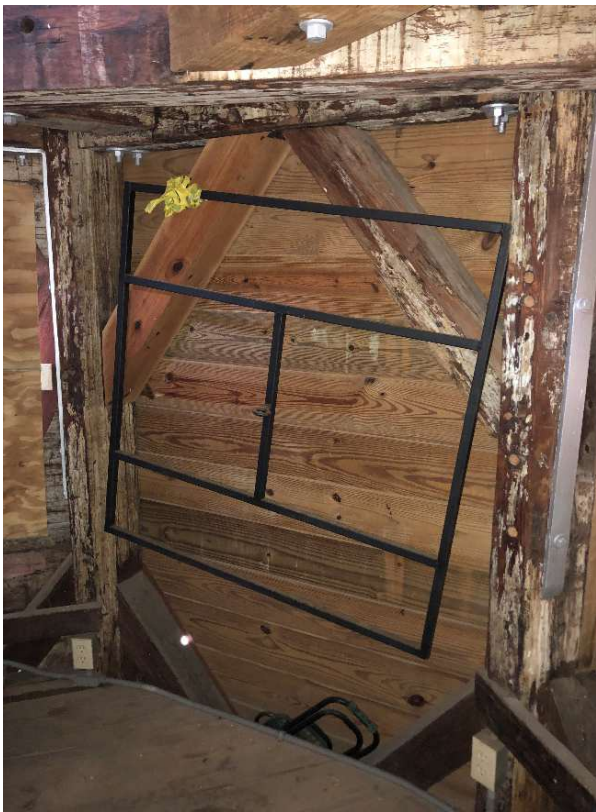
FIGURE 3-133. North wall of fourth tier.

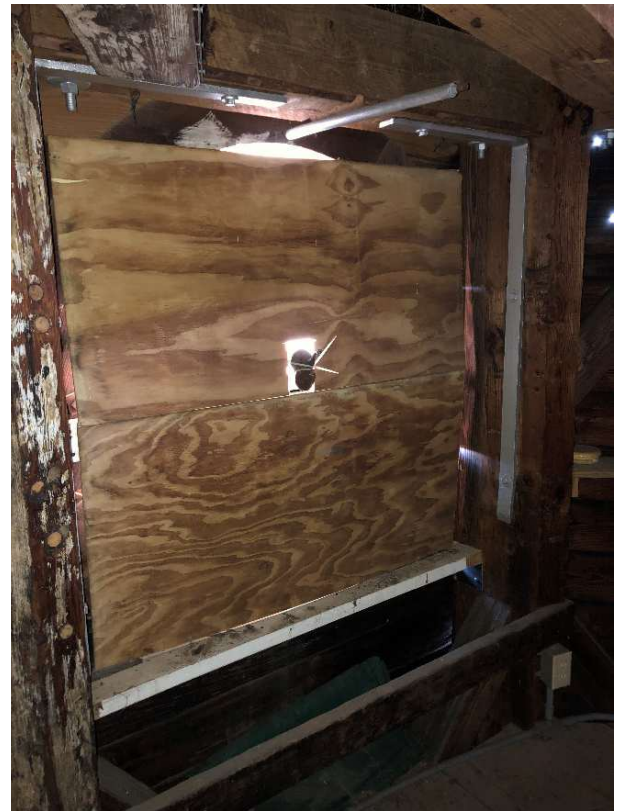
The northeast wall appears to be in fair condition (Figure 3-134). Some of the horizontal lumber seems to be older in age and is showing signs of weathering. The structural timber also appears to be a combination of old and new.

FIGURE 3-134. Northeast wall of fourth tier.

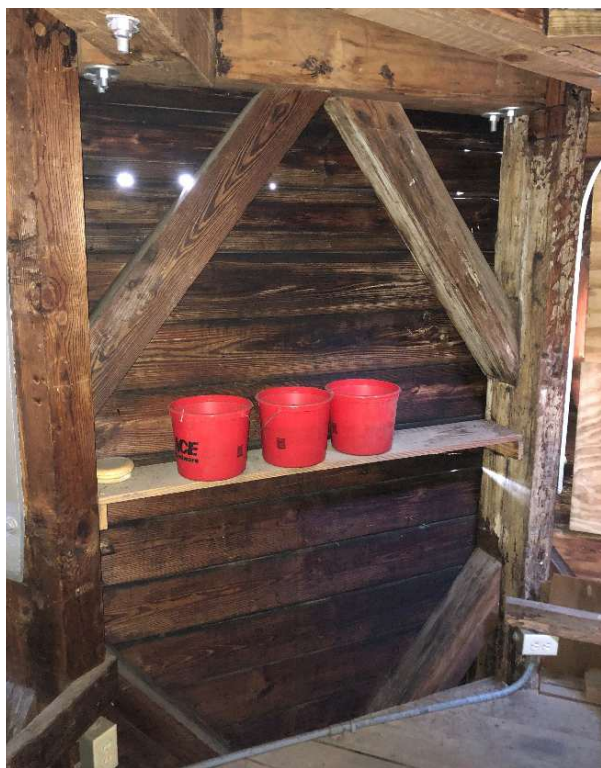
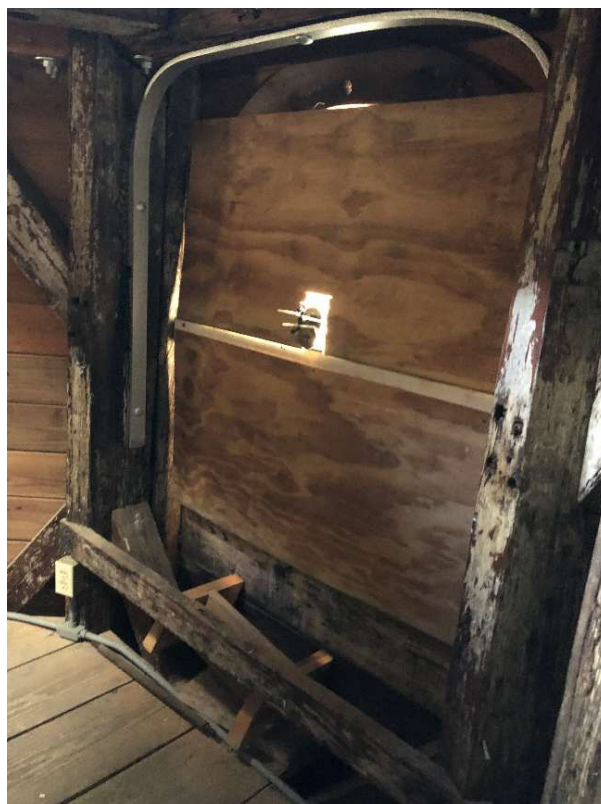
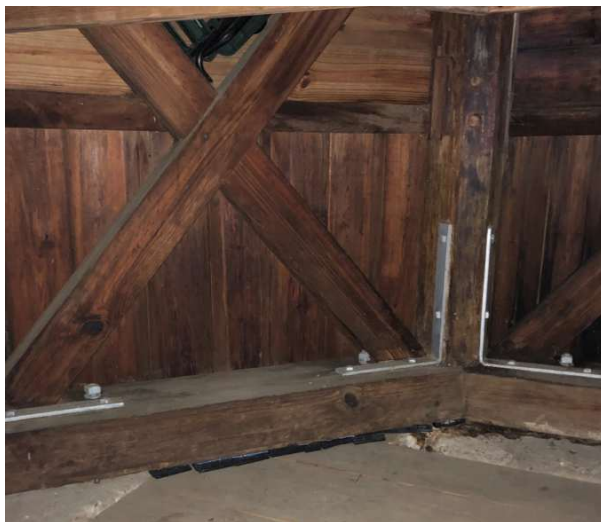
(Figure 3-135, Figure 3-136, and Figure 3-137). The horizontal lumber seems to be newer in age and does not show significant signs of weathering. The back of the wood, however, appears to be treated or stained with a darker color. The structural timber also appears to be a combination of old and new.

FIGURE 3-135. East wall of fourth tier.

FIGURE 3-137. East wall of fourth tier.

FIGURE 3-136. East wall of fourth tier.

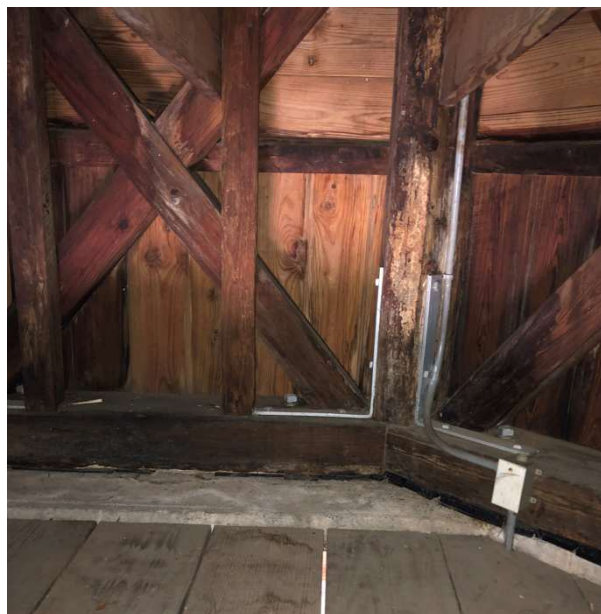
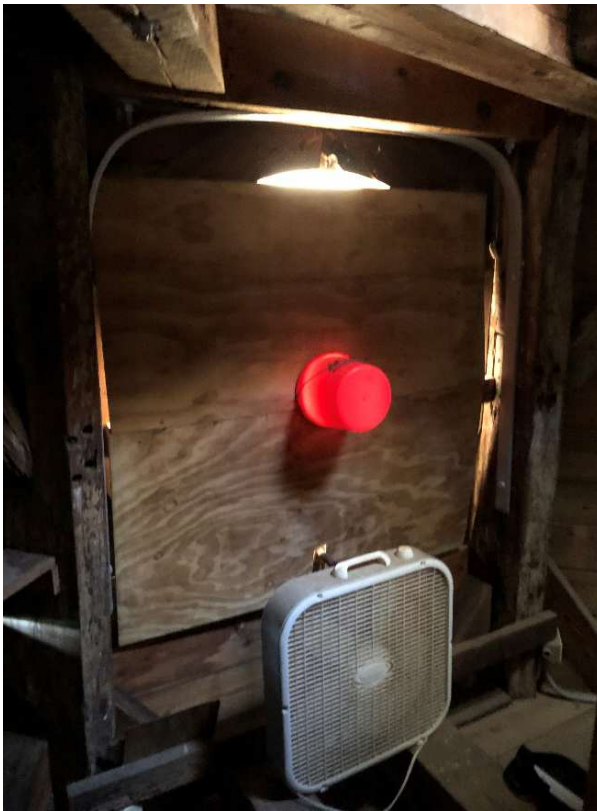
The southeast wall appears to be in good condition (Figure 3-138 and Figure 3-139). The horizontal lumber seems to be newer in age and does not show significant signs of weathering. The structural timber also appears to be a combination of old and new.

FIGURE 3-138. Southeast wall of fourth tier.

FIGURE 3-139. Southeast wall of fourth tier.
