Historic Structure Report  
**The Steeple Building**  
**Christiansted National Historic Site**  
*Final*

# **The Steeple Building**

## **Historic Structure Report**

May 2024

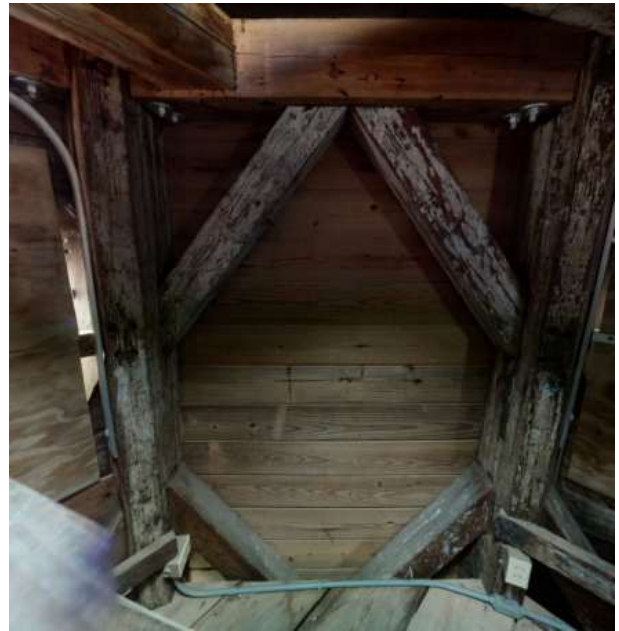
The south wall appears to be in fair condition (Figure 3-140). Some of the horizontal lumber seems to be older in age and is showing signs of weathering. The structural timber also appears to be a combination of old and new.

FIGURE 3-140. South wall of fourth tier.

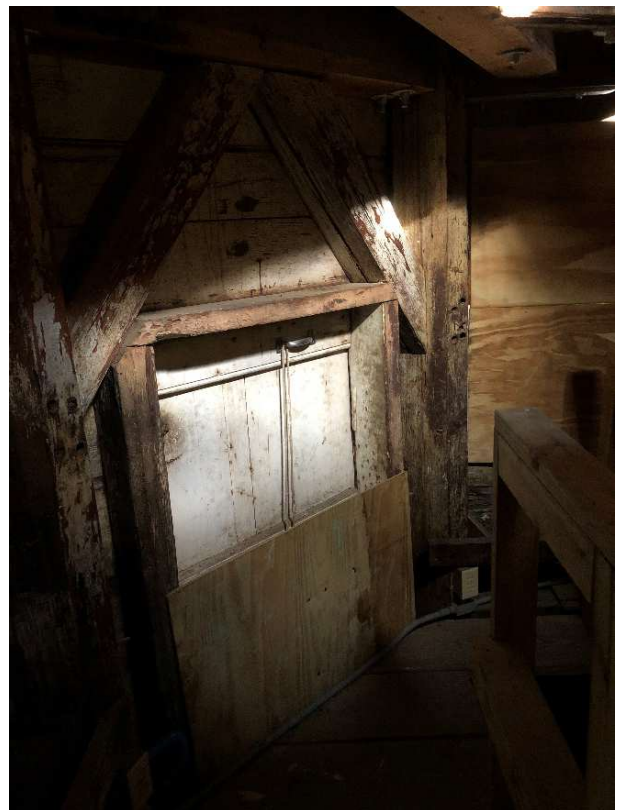
The west wall appears to be in fair to poor condition (Figure 3-141). The horizontal lumber seems to be older in age and is showing signs of weathering. The structural timber also appears to be older. The west wall also contains a hatch to allow access to the exterior.

FIGURE 3-141. West wall of fourth tier.

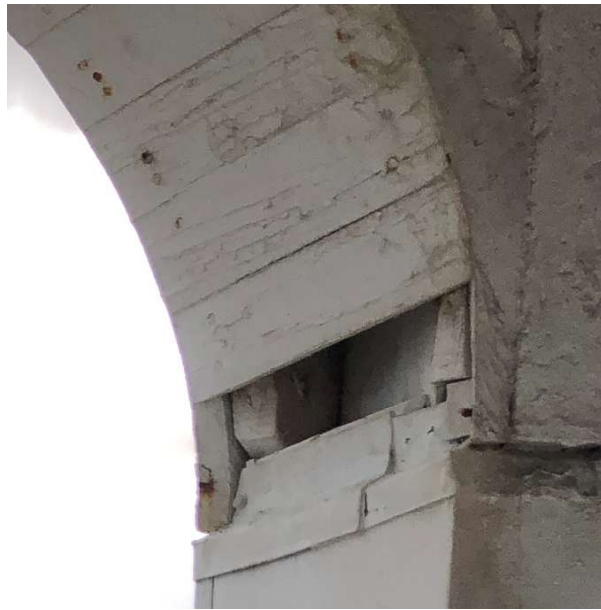
Overall, the cupola is in good condition. Despite being exposed to the elements, relatively few significant signs of deterioration exist. The most prominent issues present are rusting from fasteners and weathering of wood surfaces (Figure 3-143, Figure 3-144, and Figure 3-145).

FIGURE 3-143. Rusting of fasteners on cupola

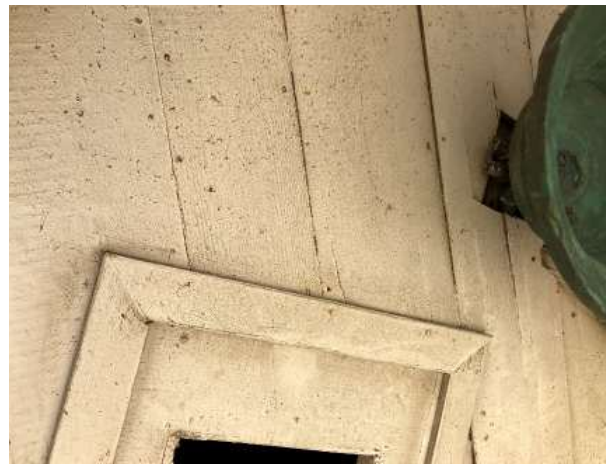
FIGURE 3-144. Slight pitting and cracking of finish layer wood under dome.

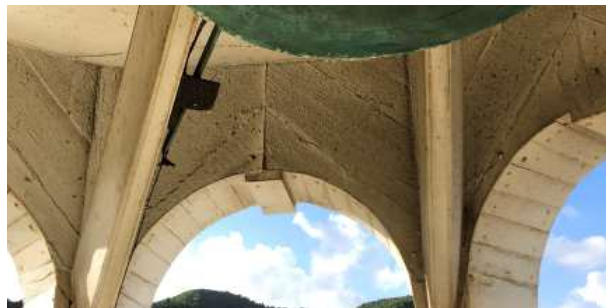
FIGURE 3-145. Slight pitting and cracking of finish layer on back side of cupola arch.

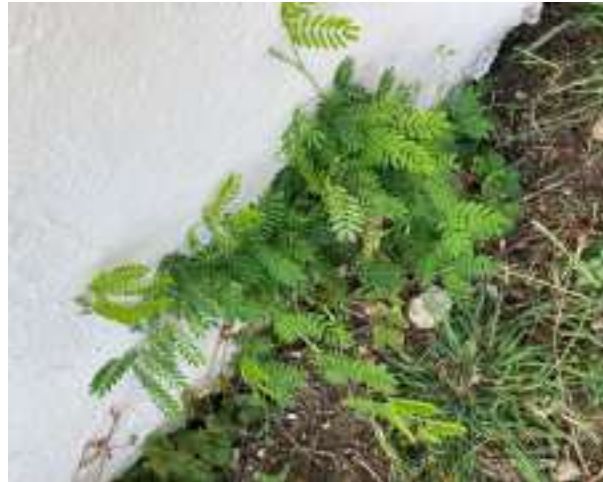
FIGURE 3-151. Root resprouting adjacent to the building

Many of the foundation elements are below grade and not directly visible. Roots from a previously removed tree are resprouting near the foundations

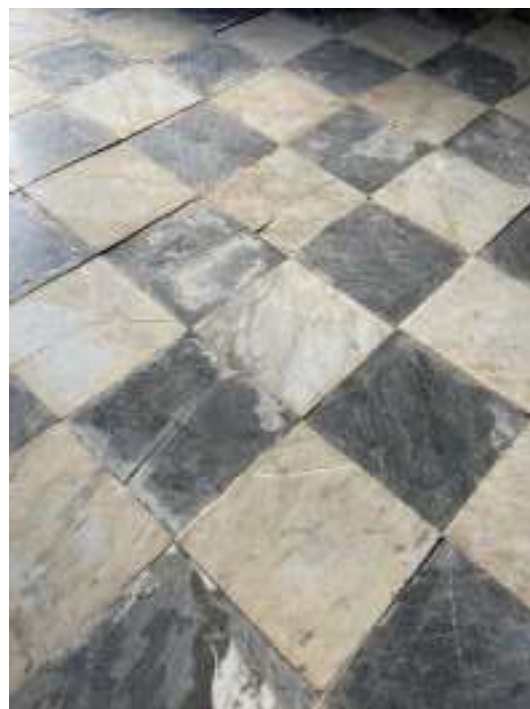
FIGURE 3-152. Cracking observed in tile floor.

Extensive tile cracking occurs throughout the floor of the church (Figure 3-152). There are several uneven areas across the flooring surface. A sand-setting bed was documented, which is a non-rigid substrate. The substrate is susceptible to differential settlements and does not provide a stiff enough backing to prevent the tile from cracking.

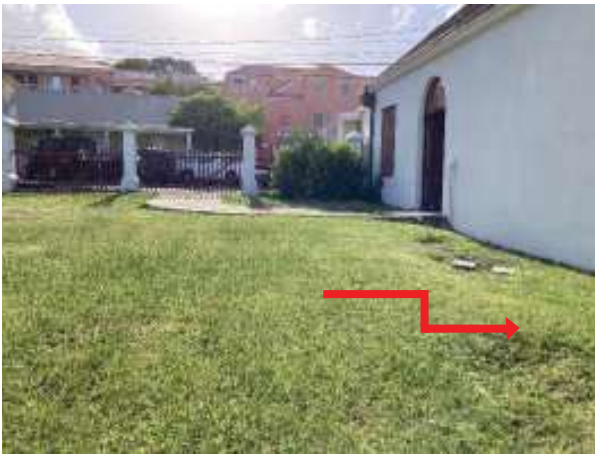
FIGURE 3-153. Site drainage toward the south wall.

There is some evidence of differential settlement at the site. Several inches of soil subsidence or erosion create a negative drainage effect on the building footing (Figure 3-153).

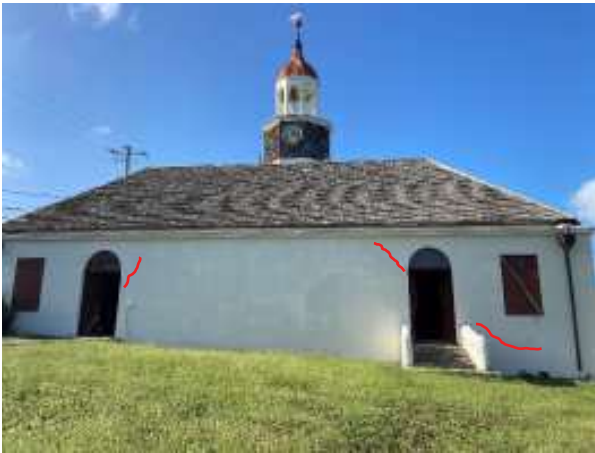
FIGURE 3-154. Observed cracking pattern on the south side. (Figure 3-151).

The observed cracking patterns indicate that the middle portion of the longitudinal walls on the north and south are settling downward. The north side appears to be caused by the heavy loading due to the adjacent steeple tower. The settlement on the south side appears to be a result of heavy loading and erosion at the building footing caused by the negative drainage towards the yard-facing wall (see

Settling at the centers of the north and south walls has led to diagonal and horizontal cracking at the east and west ends of walls, where there are piers between windows.

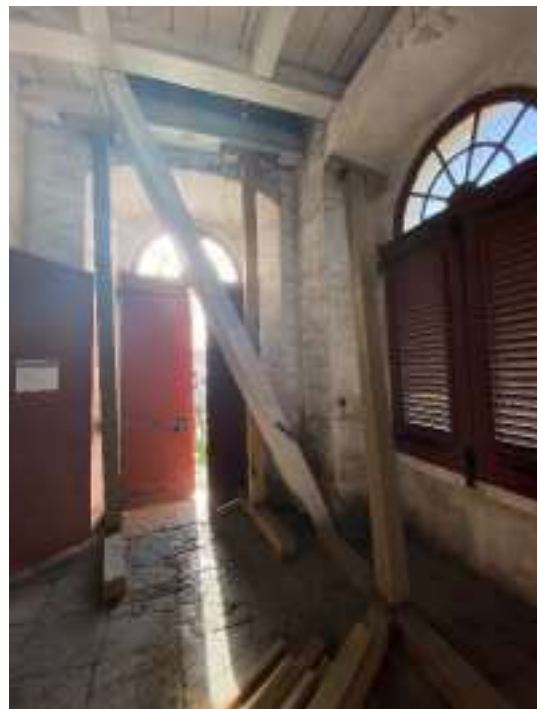
6” x 6” wood shoring posts with load distribution members at grade have been added to shore some of the wood framing and masonry arches at the ground level of the Steeple Building (see Figure 3-160).

FIGURE 3-160. Temporary shoring placed at ground floor.

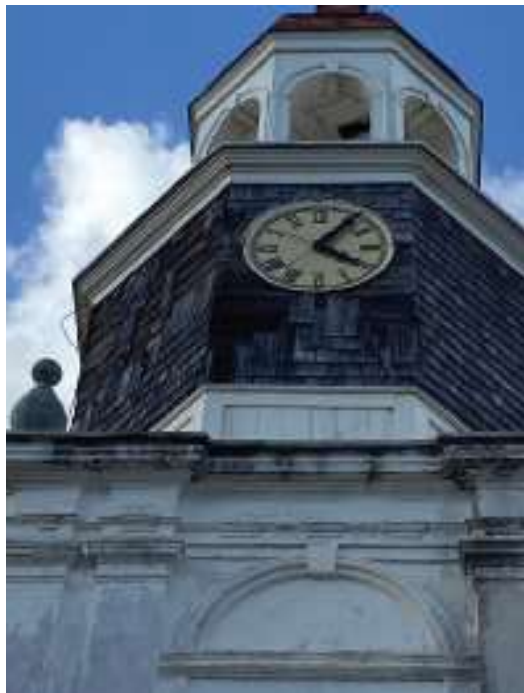
The steeple is in fair condition. Missing wood shingles are evident on the east-facing elevation of the steeple’s third tier (see Figure 3-162). It was reported on site that this damage occurred during Hurricane Maria.

FIGURE 3-162. Missing wood shingles.

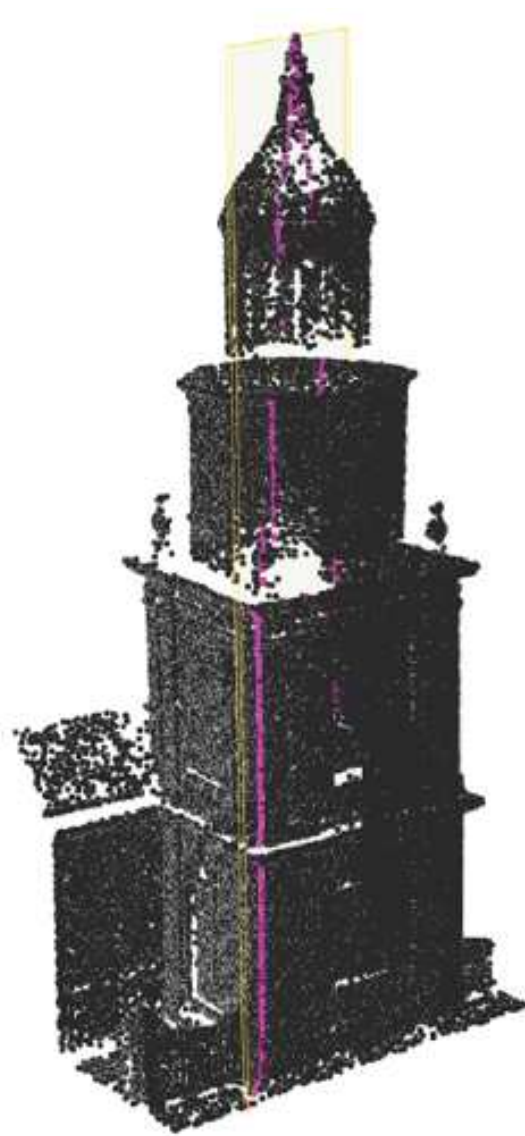
It was also noted that there is a slight lean to the upper two wood-framed tiers of the steeple. Point cloud data was reviewed to understand the extent of deformation. It was reported that this too may have been related to Hurricane Maria. Point cloud analysis of the tilt indicates leaning toward the south of approximately 4” to 5” over the height of the steeple tower (from base to tip) (Figure 3-163). How much of the measured tilt is original and how much has been caused by past settlement or significant loading events is unknown.

The measured tilt is less than 1 degree toward the south and does not significantly affect internal stresses.

FIGURE 3-163. Point cloud silhouette at north-south cut.

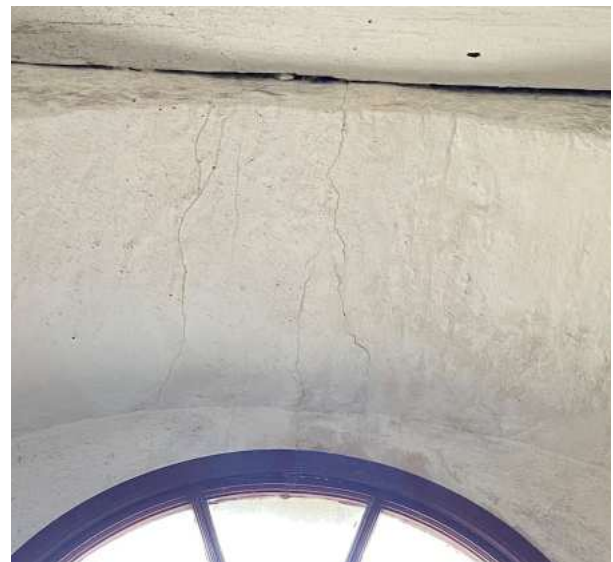
The masonry at the lower two tiers is in fair condition. Vertical cracks were noted in the masonry above the arched openings on each elevation. It is unclear if this damage is related

to lateral loading or simply self-weight due to an inadequate arch depth (see Figure 3-164). Some cracking has also occurred at the edge of arches at the lower level (see Figure 3-165).

FIGURE 3-164. Vertical cracking above arched openings.

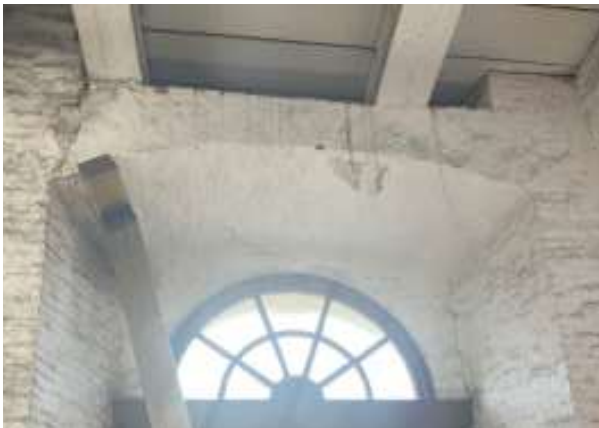
FIGURE 3-165. Vertical cracking above the arched opening at ground level.

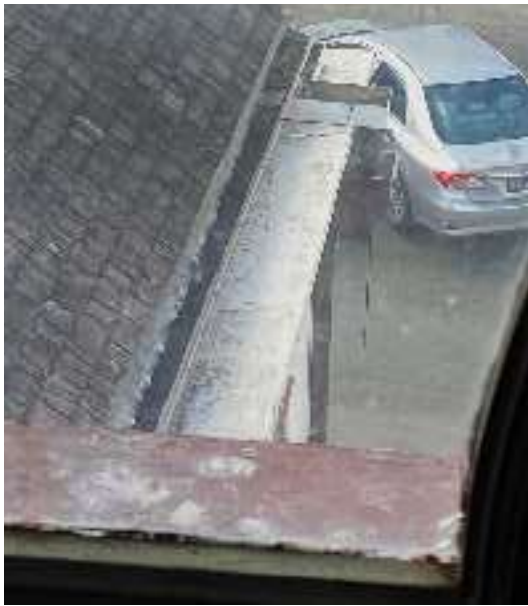
Active cracking was identified despite prior stucco patching six months before the site visit. Cracks up to approximately 1/4" wide appear to have been patched. The existing gutter is improperly sloped, and the new gutter is unable to prevent water build-up issues (Figure 3-170). The current downspout is not connected to a drainage line and exits at the building base adjacent to the footing (Figure 3-171). Some staining was observed behind the downspouts. There are moisture infiltration issues, as plastic sheeting was up in several locations at the interior face of the walls.

FIGURE 3-170. Gutter at existing Steeple Building.

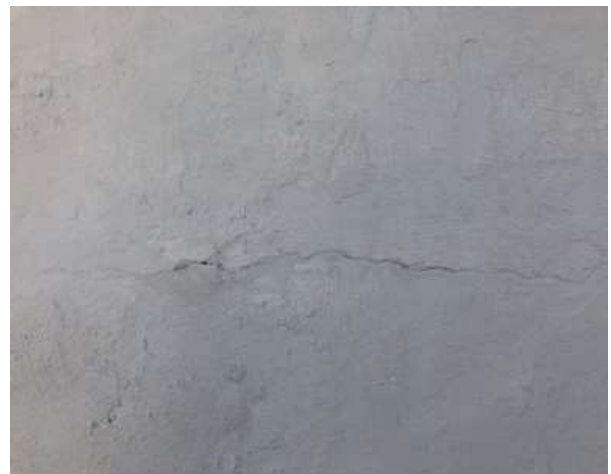
**Issue:** Cracks are found in the walls of both the interior and exterior of the main building and steeple (Figure 5-1).

FIGURE 5-1. Exterior crack.

**Recommendation:** The recommendations for crack repairs can be divided into three sections: investigation, repair, and monitoring. The first recommendation is to perform an in-depth examination of the structure of the Steeple Building’s walls where cracks and previous repairs are present. Small probes should be taken in locations exhibiting bulging, cracking, or displacement to better understand the existing conditions within the walls. The results of these probes will greatly inform the crack repair monitoring and recommendations.

Cracks that are large enough to allow water to pass into the wall assembly should have the finish material (stucco or plaster) removed sufficiently to reveal any damage to the underlying masonry. If nothing is found in the wall, plaster and stucco should be reapplied to match existing.

If a crack large enough to allow water migration (typically greater than 1/8”) is found in the interior masonry wall, crack injection should be performed. The repair material should be selected to be compatible with the physical properties of the original masonry. Information from recommended probes into the composition of the wall assembly will dictate the type of crack injection performed. In addition to injection repairs, some cracks may need to be stitched together with stainless steel dowels before replastering.

Following the repairs, the cracks should be visually checked at regular intervals using a tell-tale monitor. Monitors should be attached on either side of the crack using stainless steel anchors and epoxy, as per the manufacturer’s recommendations. As a part of regular maintenance, readings from the monitors should be recorded daily for the first seven days immediately following the repair and at least once a week for the next month. If movement is arrested, then no architectural or structural repairs are required. However, if settlement continues and causes the cracks to expand again, foundation reinforcement in the form of underpinning or deep foundations may be required.

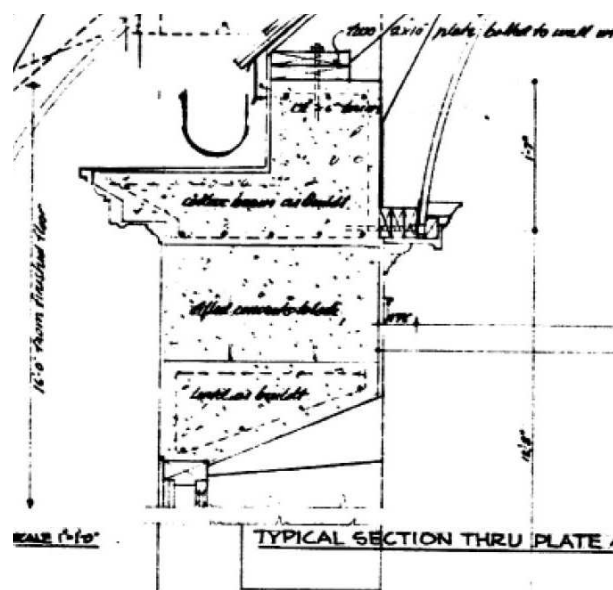
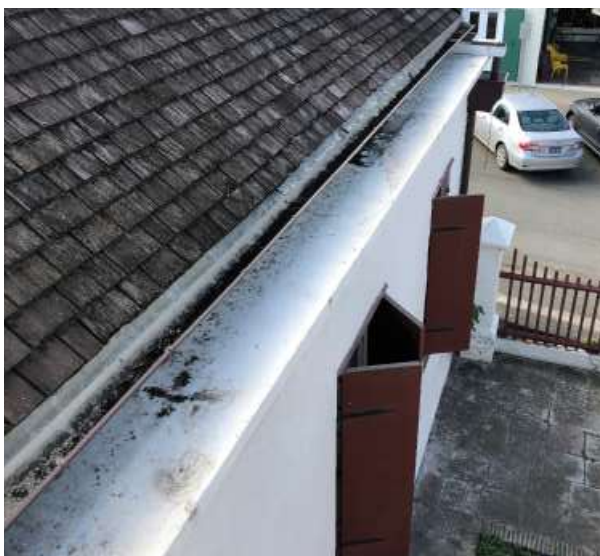
**Issue:** The tops of the exterior walls of the main building are flat horizontal surfaces. This allows for water runoff from the roof and water overflow from the gutters to pool on top of the wall, a likely source for water infiltration and runoff staining. See figures 5-2 and 5-3.

FIGURE 5-2. Typical section through wall 1960 drawings.

FIGURE 5-3. Top of wall detail.

**Recommendation:** It is recommended that a metal cap flashing be installed on the top of the walls, under the gutters, to divert water away from the interior of the building. The installation process involves attaching a pressure-treated wood nailer to the wall with a metal cap placed over it. The metal cap should be of a non-staining material (such as aluminum), painted white, and installed with a slope steep enough to direct water away but shallow enough not to create a visible line from the adjacent sidewalk. Priority should be put on retaining as much original fabric as possible

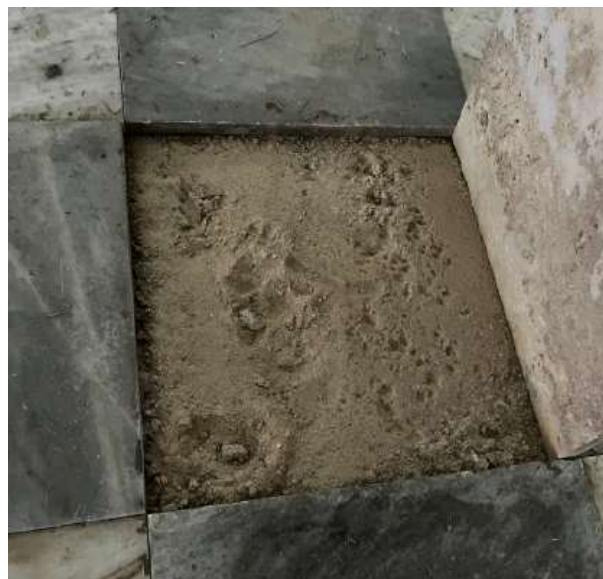
FIGURE 5-6. Floor tile setting bed.

**Issue:** The substrate under the tile floor is unknown. Currently, it appears that the tiles are laid atop compacted sand that sits directly above soil (Figure 5-6).

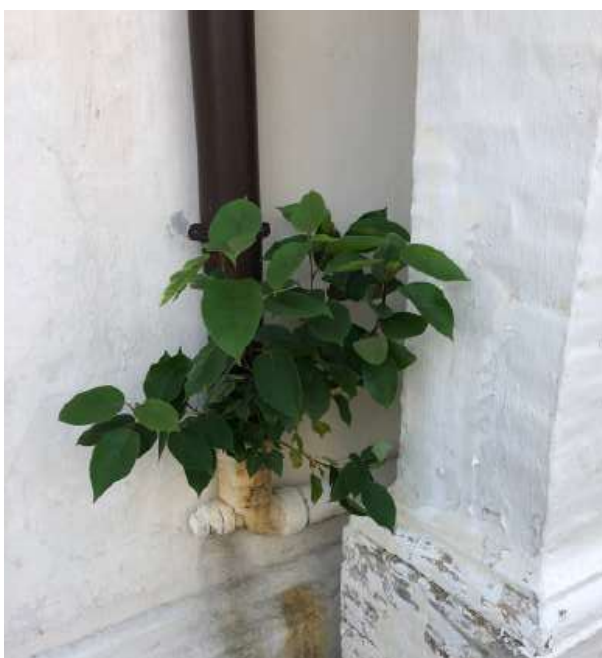
**Issue:** Biological growth in the form of vegetation and mildew can be found on the exterior of the building (Figure 5-7).

FIGURE 5-7. Plant growing through rain leader.

**Recommendation:** Regularly assess and remove vegetation that is growing within built features. Vegetation removal methods should be appropriate for the intensity of vegetation growth and the materials affected. Many chemical weed suppressants contain salts that accelerate deterioration of stone, concrete, and metal and should be avoided where those materials exist. Likewise, the use of biological suppressants with acids should be limited as they may deteriorate the stucco finish. Spot testing a small section in a discreet location should always be done first with any cleaning agent to observe any potential adverse

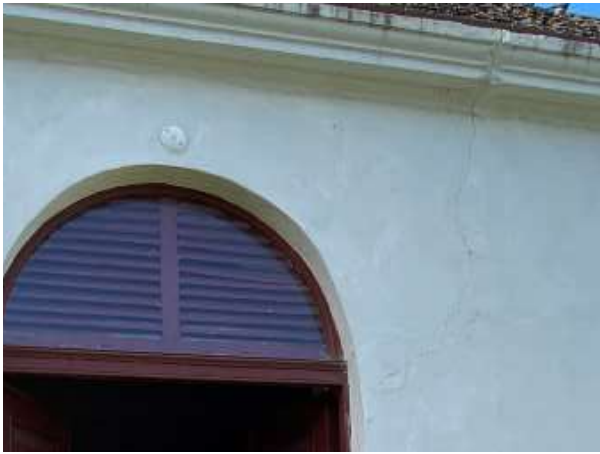
FIGURE 5-9. Example of Settlement Cracking to be Addressed

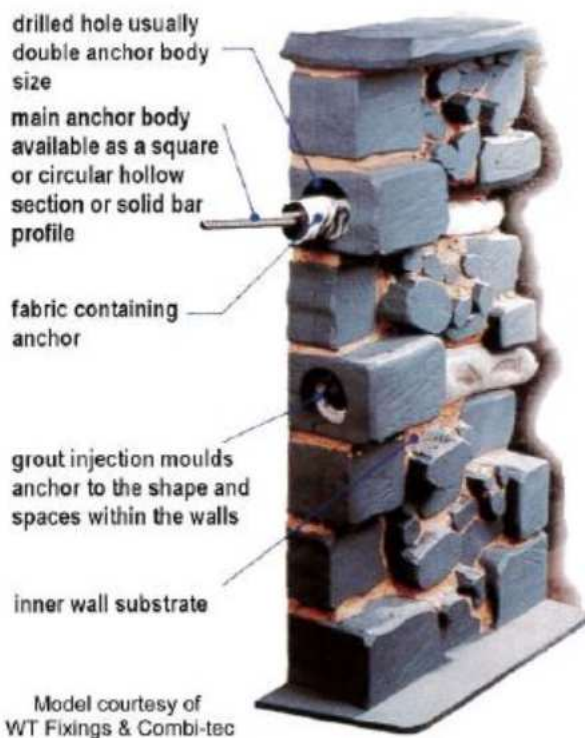
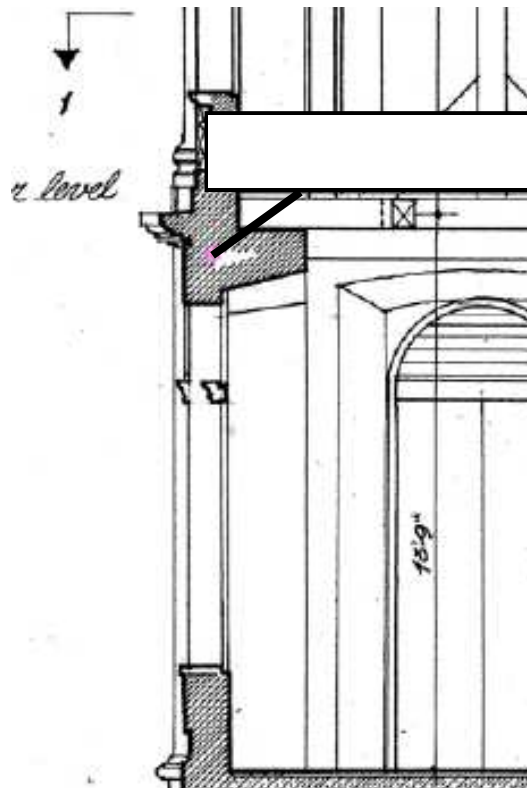
FIGURE 5-10. Example of sock anchor installation in historic masonry, and conceptual location over arches

It is recommended that horizontal dowels/sock anchors be added at the two lower masonry tier levels. Vertical cracks have developed in the arches above the arched openings and by core drilling and adding reinforcement (see Figure 5-8). The bond beams enable stress distribution among the four corners of the steeple tower, allowing efficient

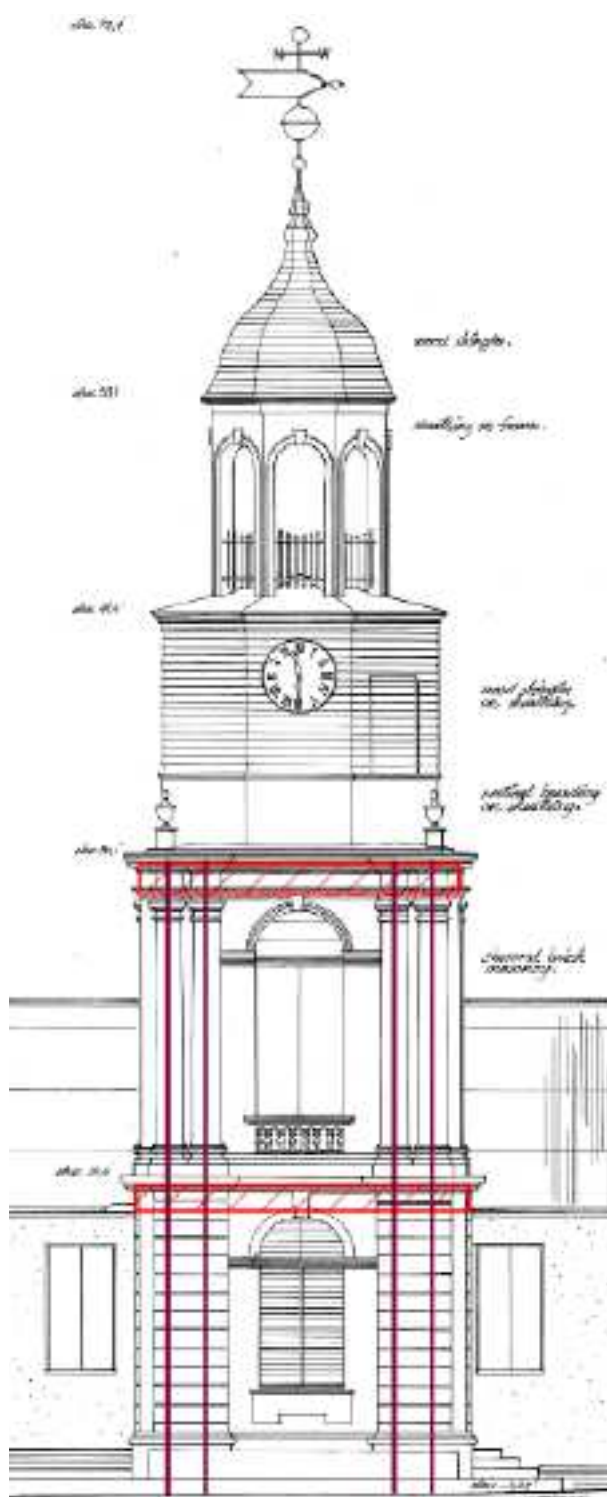
FIGURE 5-11. Location of horizontal bond beams (diagonally hatched) and vertical reinforcement locations.

During a lateral load design event, the piers are expected to be loaded in tension. The piers need to be reinforced for tensile stresses by adding vertically cored (from the top down) sock anchors to provide vertical reinforcement and strengthen the masonry portions of the steeple (Figure 5-9).

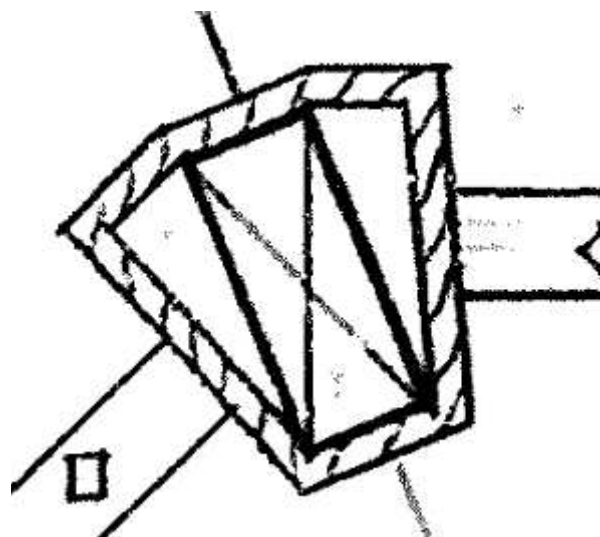
FIGURE 5-12. 1983 Reconstruction detailing of top wood framed posts.

The top wood-framed portions of the steeple require reinforcement to resist code-level forces. The intent is to keep all strengthening hidden and without visual impact. Additional structural plywood sheathing can be added to the lower wood-framed level. The new sheathing can serve as backing for the wood shingle cladding currently on that level. The structural plywood would allow efficient stress distribution among the wood posts. Strengthening the connections between the wood elements will provide an adequate load path. The upper wood-framed tier is mostly open, and new members were added during the 1983 reconstruction within a historic profile envelope (Figure 5-9). There is space adjacent to the wood members that can accommodate additional strengthening with steel plates or rods within the interior of the visible wood profile.

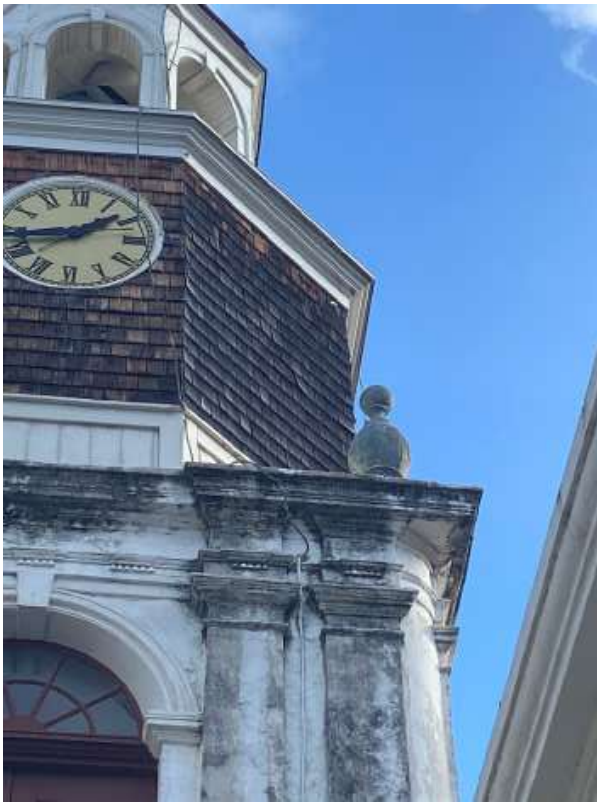
FIGURE 5-13. Finials at the top of the masonry pier

In addition, there are some vulnerable non-structural components such as the finials above each of the four corner piers at the second tier of the steeple. The hardly legible 1960 restoration set shows what appears to be the finials with an interior 5/8" diameter steel pin reinforcement. Their presence could not be confirmed during the site visit (see Figure 5-10 and Figure 5-11).

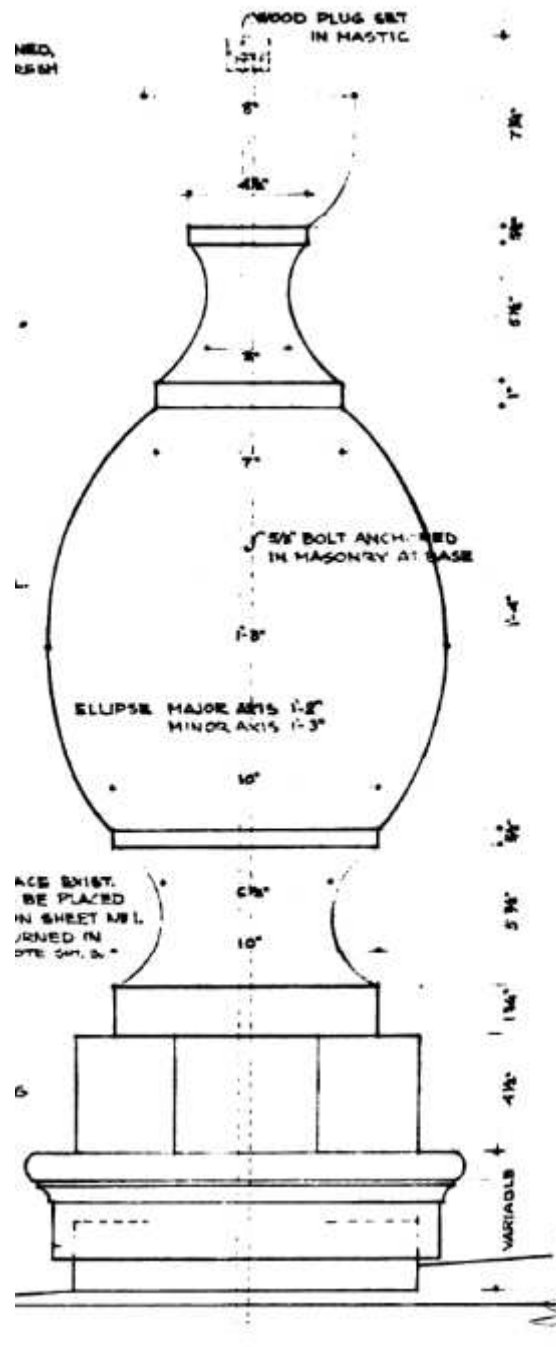
FIGURE 5-14. Hardly legible finial detail
