# Historic Architecture

design guidelines for a historic district  
St. John's, Antigua

by Paul C. Cloyd, P.E.  
U.S. Peace Corps Volunteer

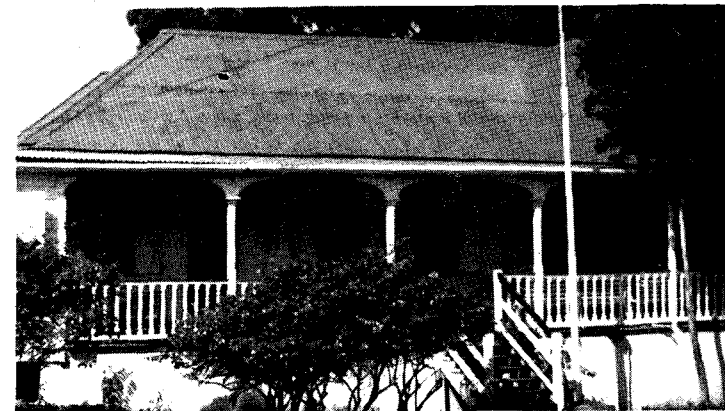
Vernacular: A mode of building based on regional forms and materials. The design of the historic buildings of St. John's is derived from the 18<sup>th</sup> and 19<sup>th</sup> century styles described above but modified to meet local needs with available skills and materials.

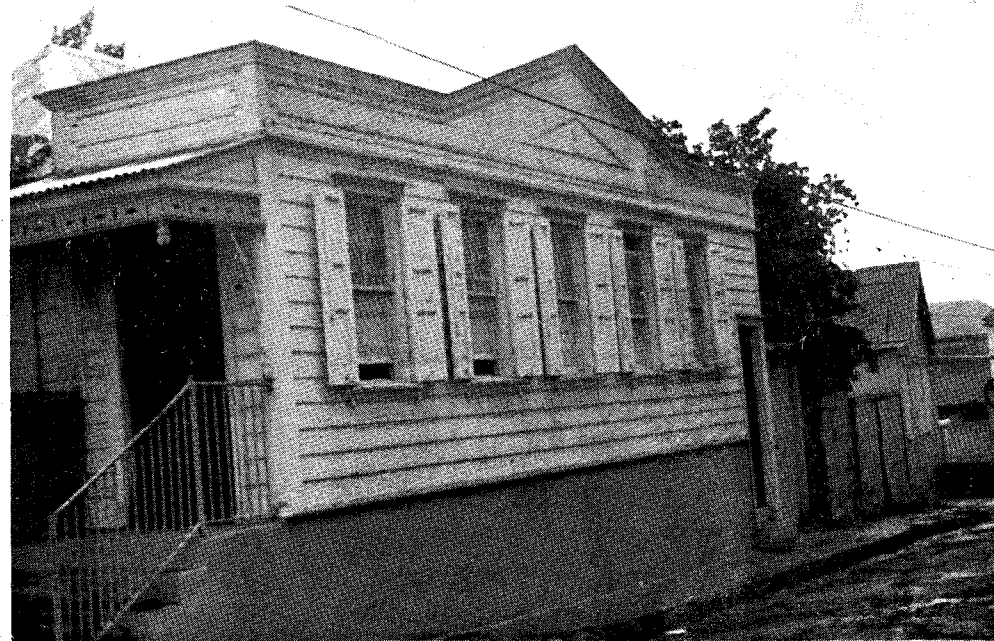
Residence with enclosed verandah and parapet wall and pediment

The steeply pitched bi- and tri-partite gable and hip roof are a vital component of the vernacular design of St. John's. The steep roof pitch has a functional purpose because it is advantageous in resisting uplift in high winds. On some structures the pitch is as steep as 10 in 12. (a rise of 10 to a run of 12). Verandahs are sheltered by much shallower pitched roofs. These would be constructed with a break from the main. In the event the verandah roof was lifted the main roof would remain intact.

In the mid to latter 19<sup>th</sup> century the verandahs became enclosed. Their roofs would be concealed behind a parapet wall. This too is not merely decorative but also aids in reducing uplift from high winds.

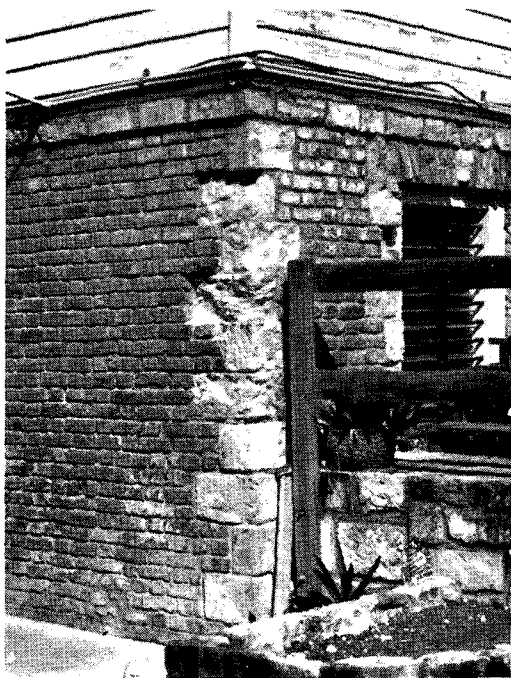
Today a trend of stripping off these protective plaster coatings has developed. It is understandable that the masonry finish is found to be more attractive and interesting. However, the susceptibility to crumbling from weathering remains. This is in addition to the historically inaccurate scene which results.

deteriorated stone quoins  
at Redcliffe Quay

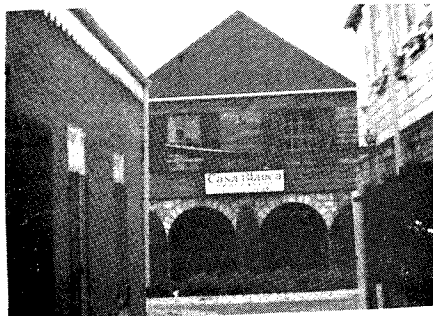
Many of the signs now tend to be flush type and they appear to be a very traditional type in St. John's. These are signs painted directly onto the wall surface or placed against the building surface. These were oriented to pedestrians

flush sign of inappropriate material and lighting

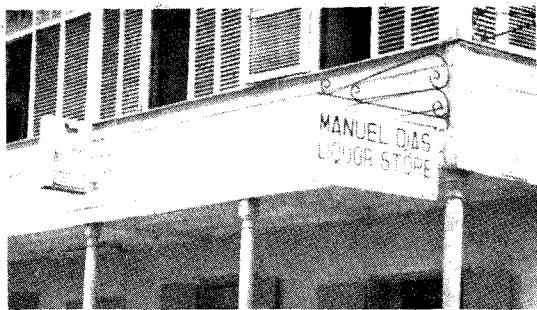
good example of traditional hanging sign in foreground, sign in background is inappropriate

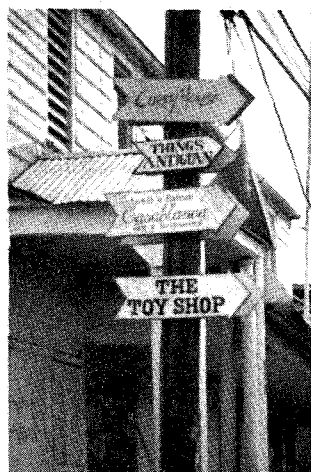
inappropriate off premises directional sign.

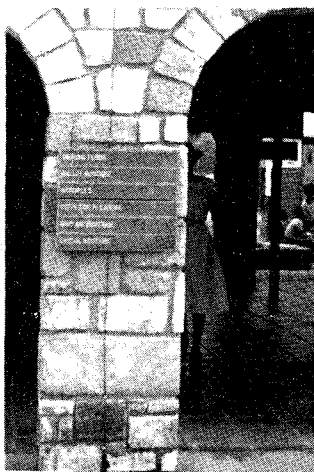
well located sign but poor material and color, vertical dimension should dominate

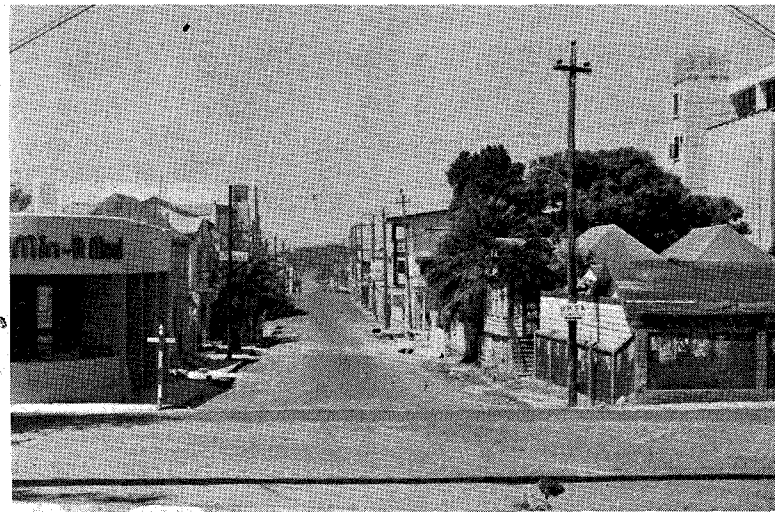
lower High st. c.1900 J.F.

The style of new structures is out of character with the streetscape.

This view of lower High street shows the Harbor Master's House still remains. The building at the right foreground of the c.1900 photograph is the old market place. The roof of this appears to be flat metal panels with standing seams. No historic roof of this type is now found in St. John's.

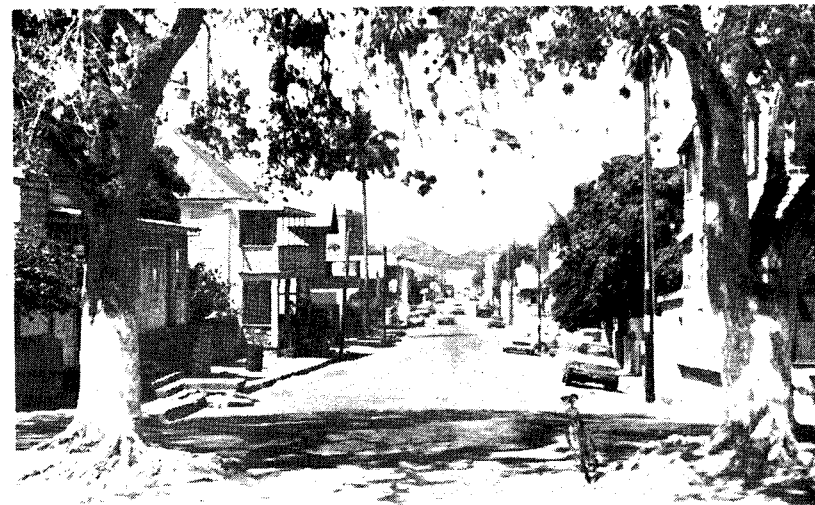
Alterations can be compatible such as the west outside steps on the D.C.A. building. (left foreground). The adjacent west buildings has had a verandah and windows of incompatible materials added to it

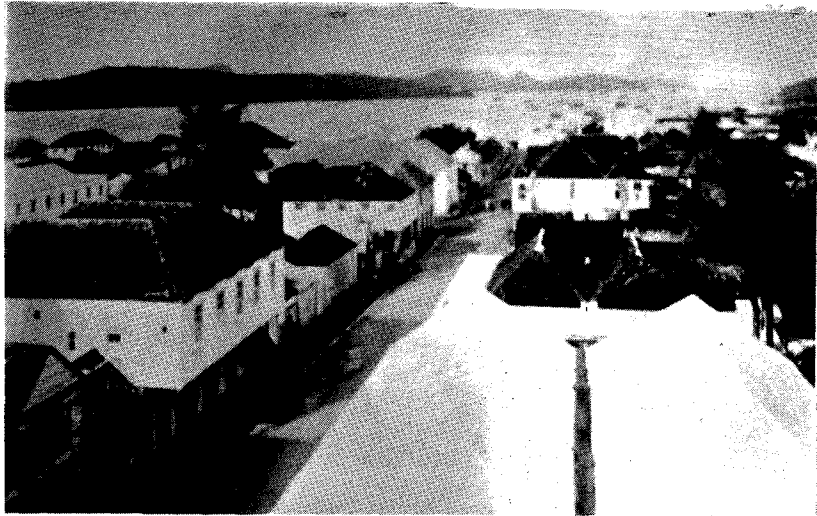
many traditional  
roof forms remain  
in St. John's

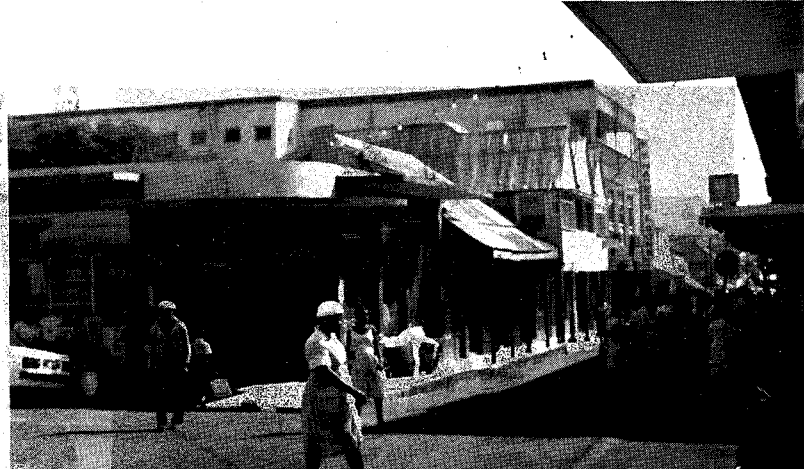
ST. JOHN'S c. 1949 D.V.N

these views illustrate how  
non-comparable the  
historic and the modern  
street scene

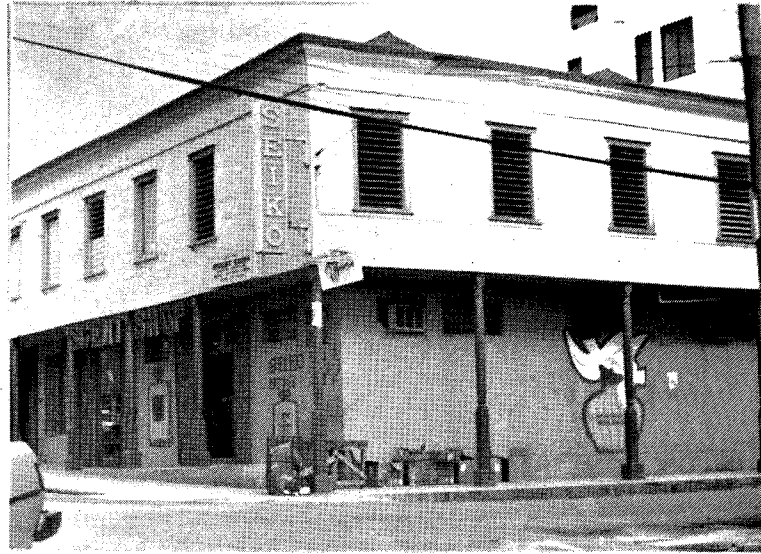
southeast corner of intersection  
of Thames and High Street. D.V.N.  
c. 1920

Here the double hung  
windows have been replaced  
by modern jalousie  
windows which are less  
compatible to the building's  
style.

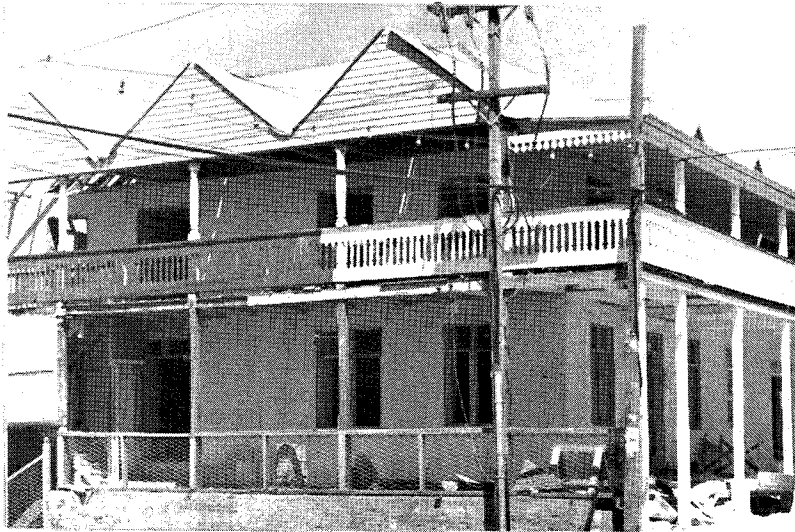
the old post office, northwest  
corner of Thames and High Street  
c. 1920 D.V.N.

This is another example of  
inappropriate jalousie windows  
replacing the traditional.  
Other details not accurately  
restored include railing and  
window shutters

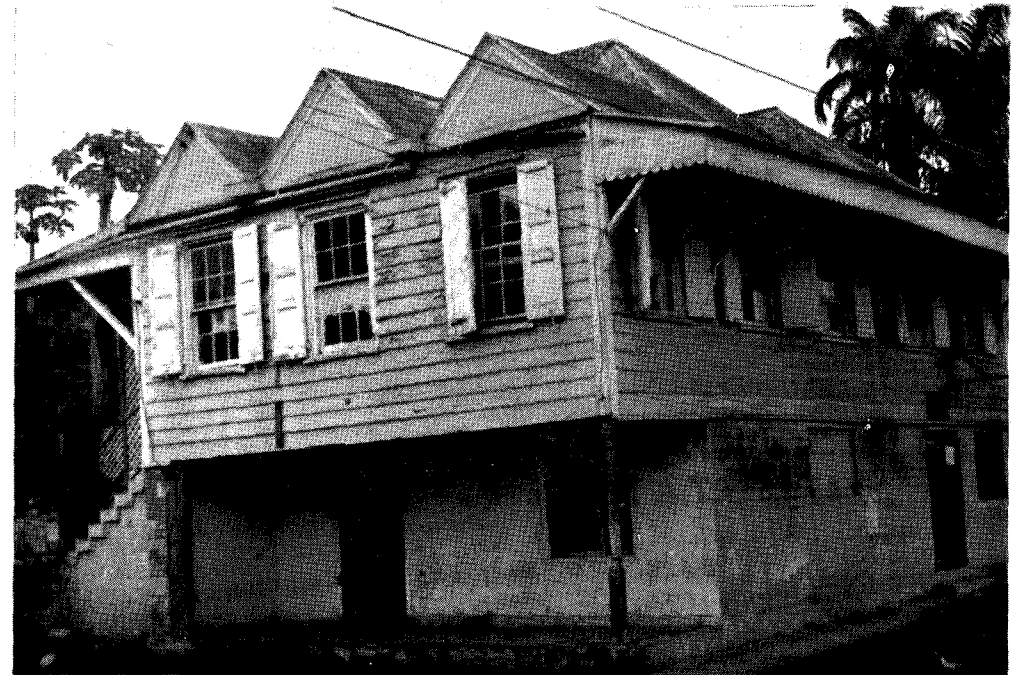
bldg. no. 63-A →

bi- and tri-partite  
roofed commercial/  
residential structures

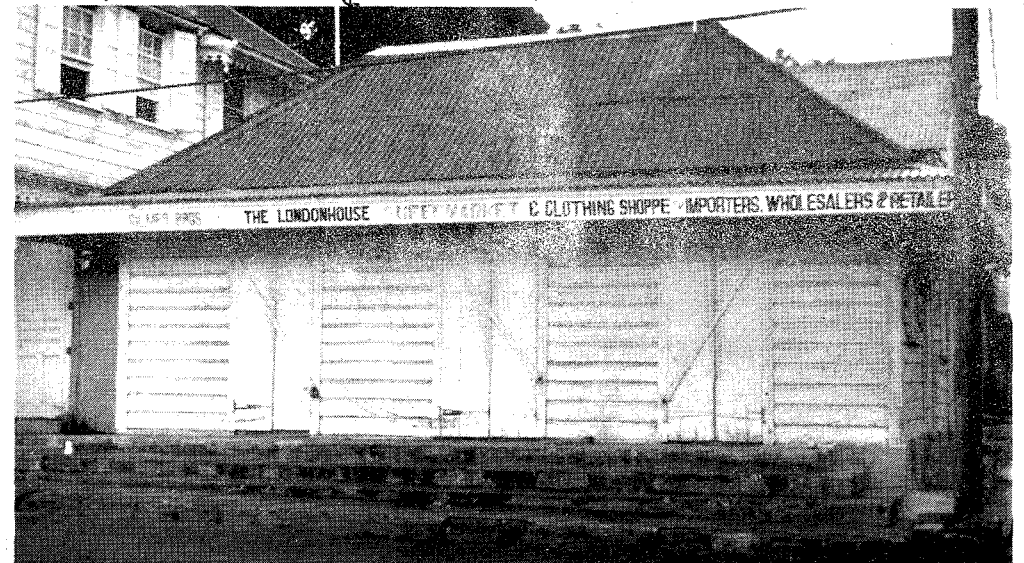
bldg. no. 56-D →

extended cottage below in commercial use
