Sampling Trip Report → Tatu wells (Lage Bldg.)

## SAMPLING TRIP REPORT

Site Name: Tutu wells site, St. Thomas, USVI  
TDD No.: 02-9411-007  
Sampling Date: 7 December 1994

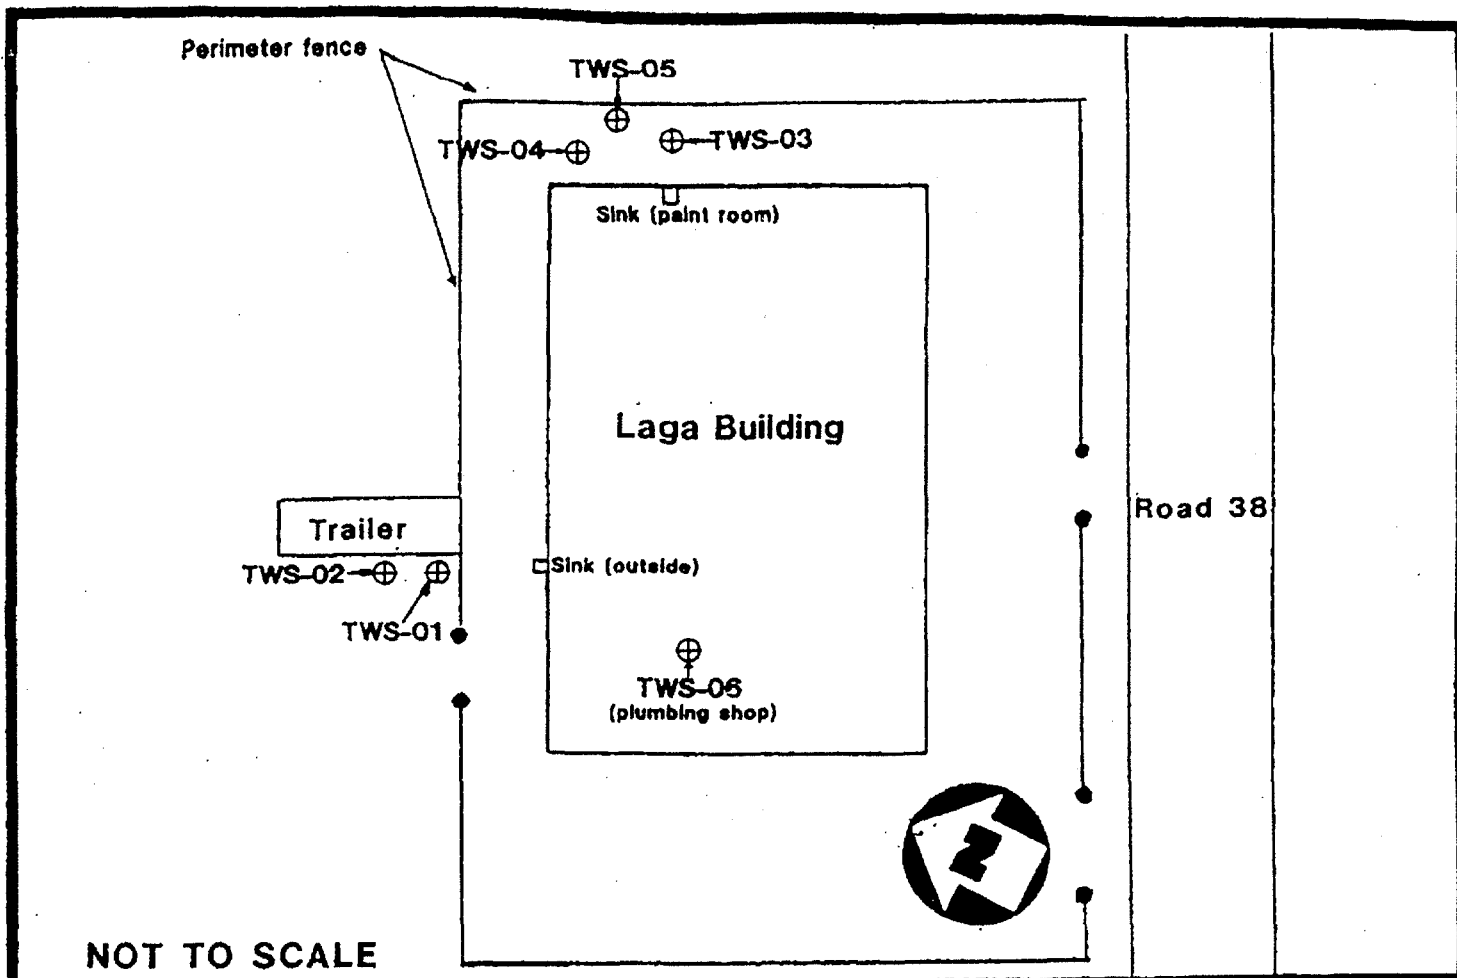
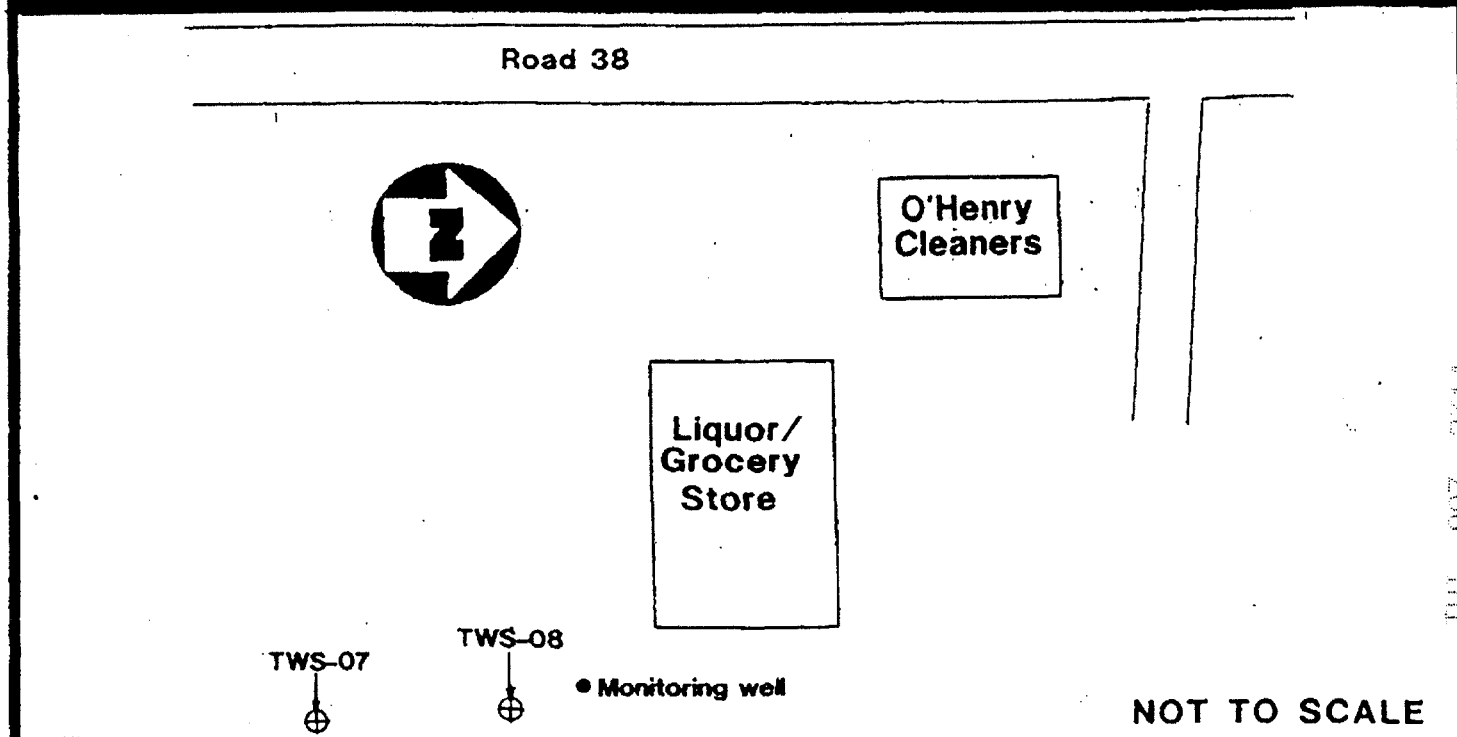
Figure 2.

Sample Location Map

| Sample No. | Date | Matrix | Description |
|---|---|---|---|
| TWS-01 | 12-07-94 | Soil | Grab sample from soil north of the Laga Building. Collected at 33'2" from the sink outside the north face of the building. Prior to sampling, the location was screened with the organic vapor analyzer (OVA) obtaining readings of >10 units while the photoionization detector (PID) gave approximately 8 units. The top 24" of soil was removed with dedicated stainless steel hand auger and the sample collected with a dedicated plastic scoop and placed in a dedicated stainless steel bowl. After filling the two 40-mL VOA vials, the soil in the bowl was thoroughly mixed and transferred to a 32-oz glass jar. Sample to be analyzed for volatile and semivolatile organics. Shipped as dangerous goods (Solid containing flammable liquid, n.o.s. (benzene); UN 3175). |
| TWS-02 | 12-07-94 | Soil | Grab sample from soil north of the Laga Building. Collected at 36' 5" from the sink outside the north face of the building. Prior to sampling, the location was screened with the OVA obtaining readings of approximately 10 units while the PID gave 5-6 units. The top 19" of soil was removed with dedicated stainless steel hand auger and the sample collected with a dedicated plastic scoop and placed in a dedicated stainless steel bowl. After filling the two 40-mL VOA vials, the soil in the bowl was thoroughly mixed and transferred to a 32-oz glass jar. Sample to be analyzed for volatile and semivolatile organics. Shipped as dangerous goods (Solid containing flammable liquid, n.o.s. (benzene); UN 3175). |

| Sample No. | Date | Matrix | Description |
|---|---|---|---|
| TWS-03 | 12-07-94 | Soil | Grab sample from soil east of the Laga Building. Collected from the discharge point of a sink located inside the paint storage room. The overlying water was removed and the sampling location screened with the OVA obtaining readings of 30 units. The top 1/4" of soil was removed with a dedicated garden trowel and the sample collected with a dedicated plastic scoop and placed in a dedicated stainless steel bowl. After filling the two 40-mL VOA vials, the soil in the bowl was thoroughly mixed and transferred to a 32-oz glass jar. Sample to be analyzed for volatile and semivolatile organics. Shipped as dangerous goods (Solid containing flammable liquid, n.o.s. (benzene); UN 3175) |
| TWS-04 | 12-07-94 | Soil | Grab sample from soil east of the Laga Building. Collected from a low area where water discharged from a sink located inside the paint storage room accumulates. Sampling location was screened with the OVA obtaining readings not different than background levels (0.2 unit). The top 4" of soil was removed with dedicated garden trowel and the sample collected with a dedicated plastic scoop and placed in a dedicated stainless steel bowl. After filling the two 40-mL VOA vials, the soil in the bowl was thoroughly mixed and transferred to a 32-oz glass jar. Sample to be analyzed for volatile and semivolatile organics. Shipped as environmental sample. |
| TWS-05 | 12-07-94 | Soil | Grab sample from soil east of the Laga Building. Collected from a shallow ditch where water discharged from a sink located inside the paint storage room flows. Sampling location was screened with the OVA obtaining readings not different than background levels (0.2 unit). The top 4" of soil was removed with dedicated garden trowel and the sample collected with a dedicated plastic scoop and placed in a dedicated stainless steel bowl. After filling the two 40-mL VOA vials, the soil in the bowl was thoroughly mixed and transferred to a 32-oz glass jar. Sample to be analyzed for volatile and semivolatile organics. Shipped as environmental sample. |
| TWS-06 | 12-07-94 | Oil | Composite sample of two holes in the concrete floor of the plumbing shop. Holes are 1-1/2" diameter and approximately 4" deep with a hard bottom. PID monitoring of the holes conducted on 21 November gave readings between 50 and 130 units. The oil in the holes was initially collected with a dedicated 40-mL syringe but it broke during sampling and a dedicated thin glass tube was used to collect the remaining oil. Oil was placed in sampling jars as it was being collected. Oil in the holes was only sufficient to fill two 40-mL VOA vials. No more sample was available. Sample to be analyzed for volatile and semivolatile organics. Shipped as dangerous goods (Flammable liquid, n.o.s. (benzene); UN 1993). |
